# 2018 REGIONAL STORMWATER

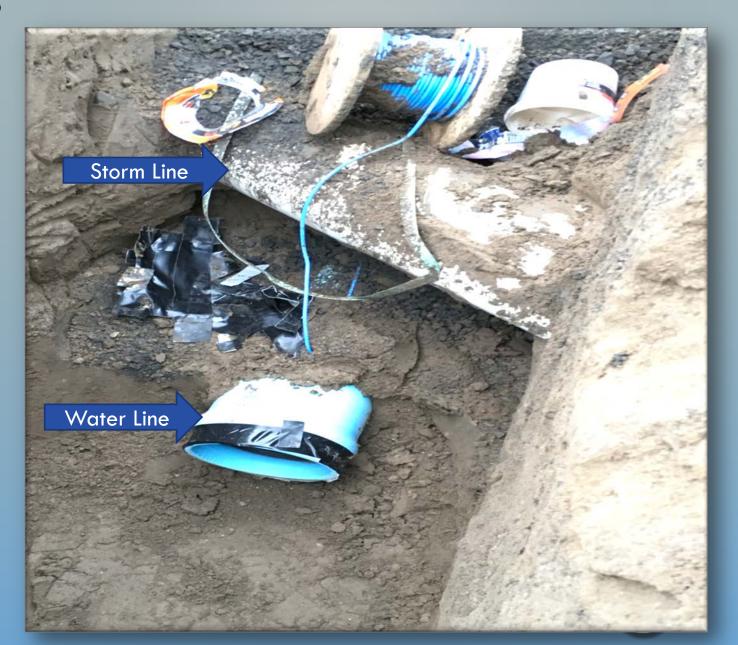
# SUNRISE DRIVE

PIPE WAS PATCHED YEARS AGO AND ALLOWED FOR INSUFFICIENT FLOW , ALSO PONDING BY BASIN BECAUSE ORIGINAL BASIN WAS SET TO HIGH.

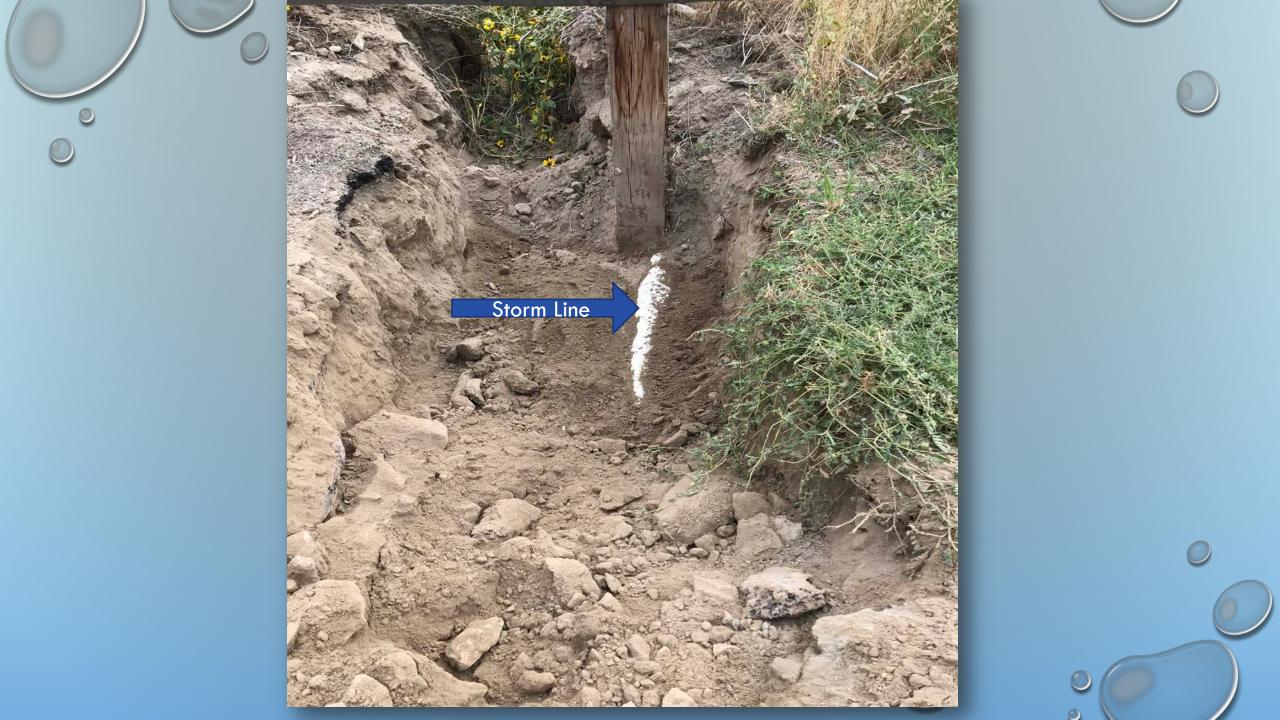
## 22 SNAKE RIVER ROAD

## GUARDRAIL POST WAS DRIVEN THROUGH PIPE , CAUSING EROSION

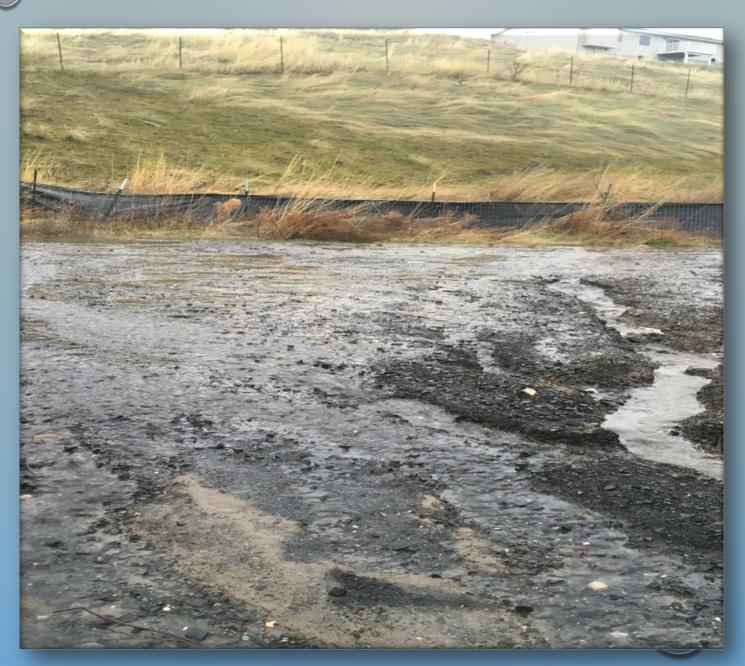
# RIDGEVIEW ACCESS ROAD

POND OVERFLOW WATER FROM ABOVE CAUSING MAJOR EROSION, WITH NO SYSTEM BELOW TO CONVEY THE WATER

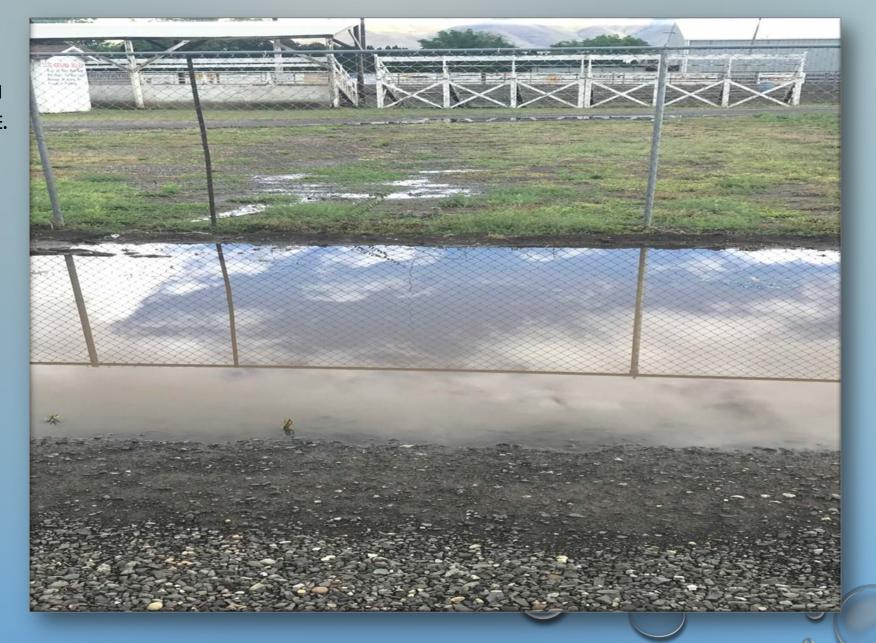
## POUND LANE SADDLE CLUB

WATER FROM ROADWAY PONDING AND FLOODING ADJACENT PROPERTY, WITH NO STORM SYSTEM IN PLACE.

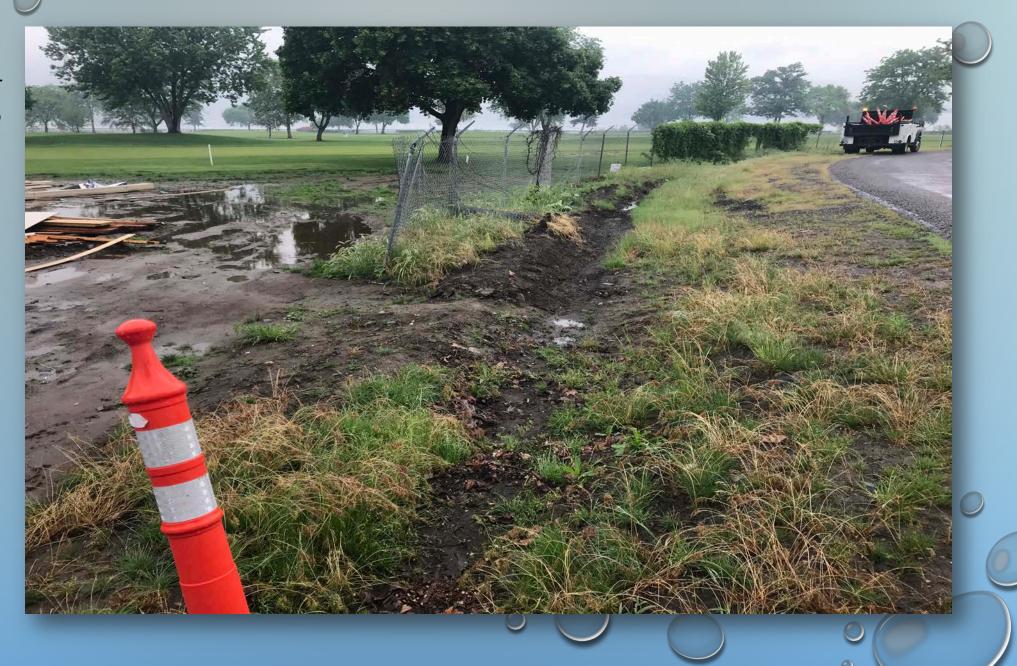
## 16<sup>TH</sup> AND POPLAR

WATER FROM ROADWAY WAS FLOODING ADJACENT PROPERTIES WITH NO STORM SYSTEM IN PLACE.

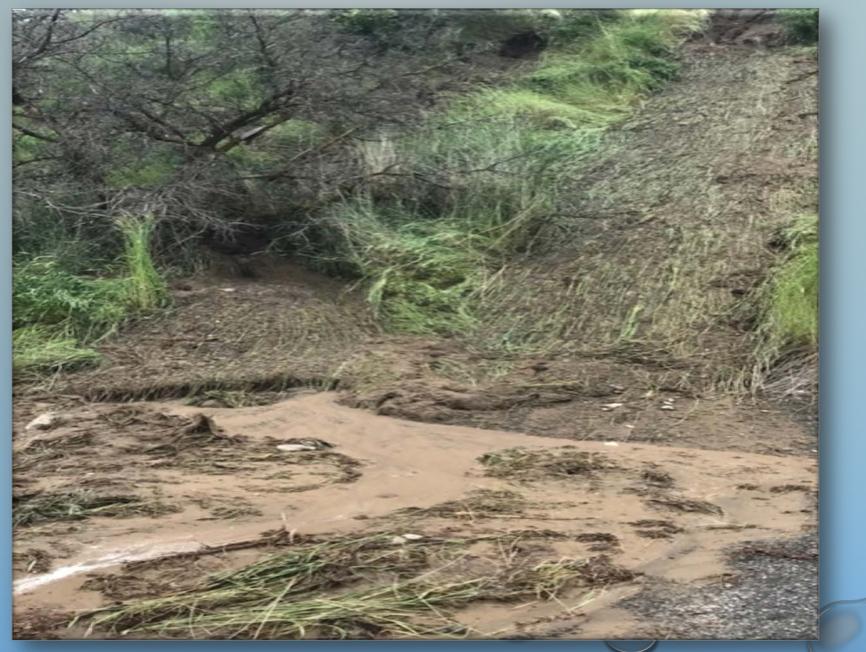
## FAIRGROUNDS MUD SLIDE

DRAIN-GRATE BECAME CLOGGED WITH DEBRIS AND WATER WAS NOT ABLE TO FLOW INTO STORM SYSTEM.
