Stormwater Work Projects 2014

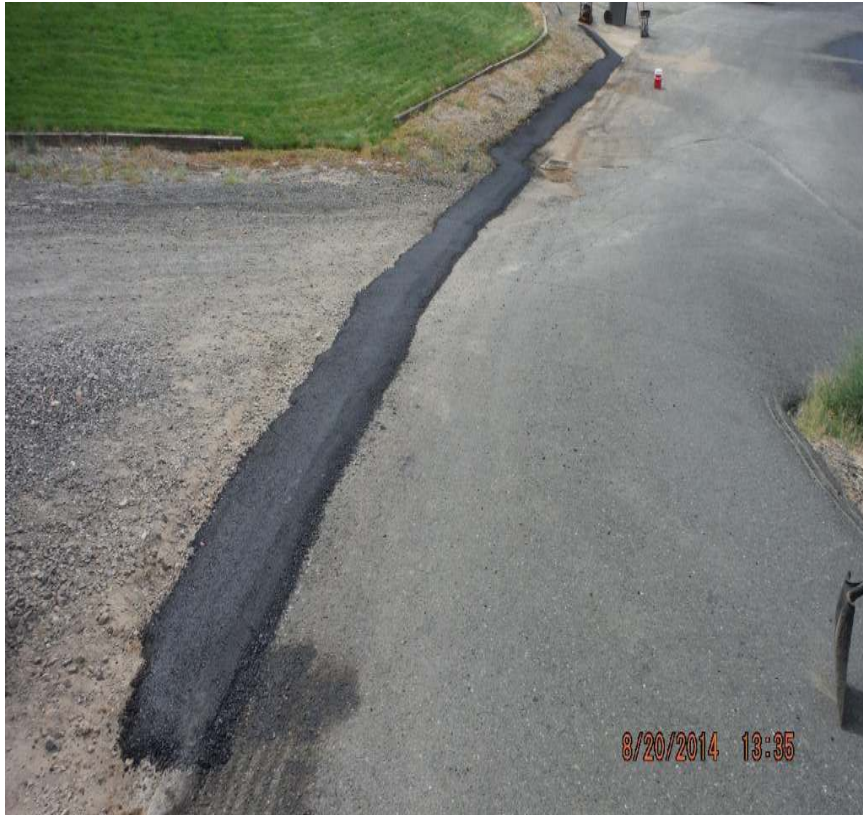
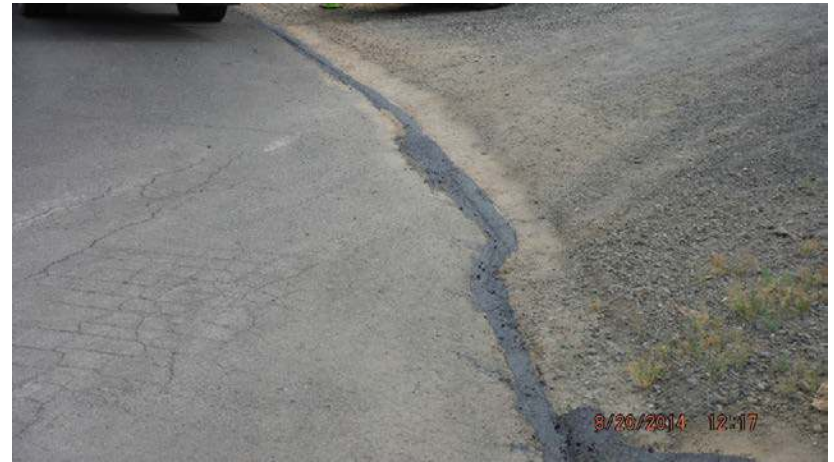
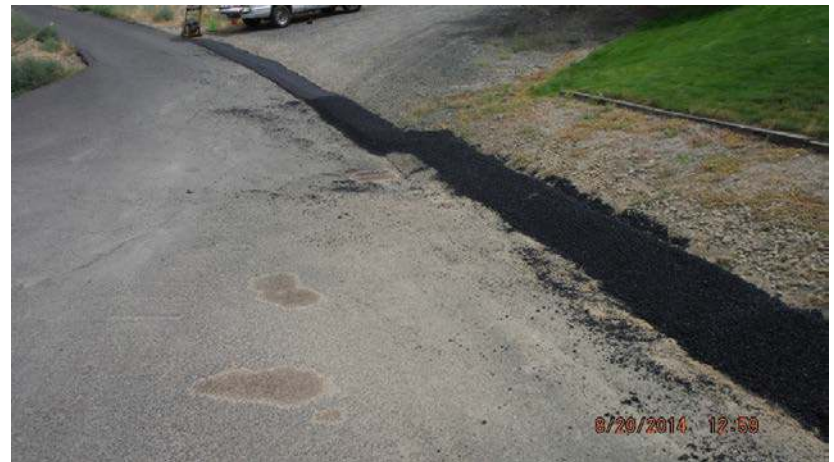
Riverview and Wilson Ln.

- Gravel would wash off of the Driveway at Quarry Rd and also Wilson Ln. The material would continuously plug the catch basin.

- The asphalt was cleaned, tack was applied and a larger asphalt berm was installed.

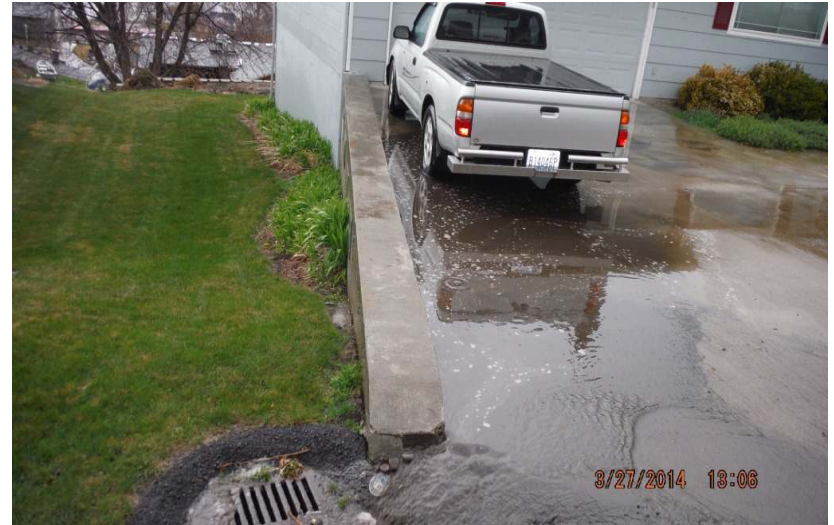
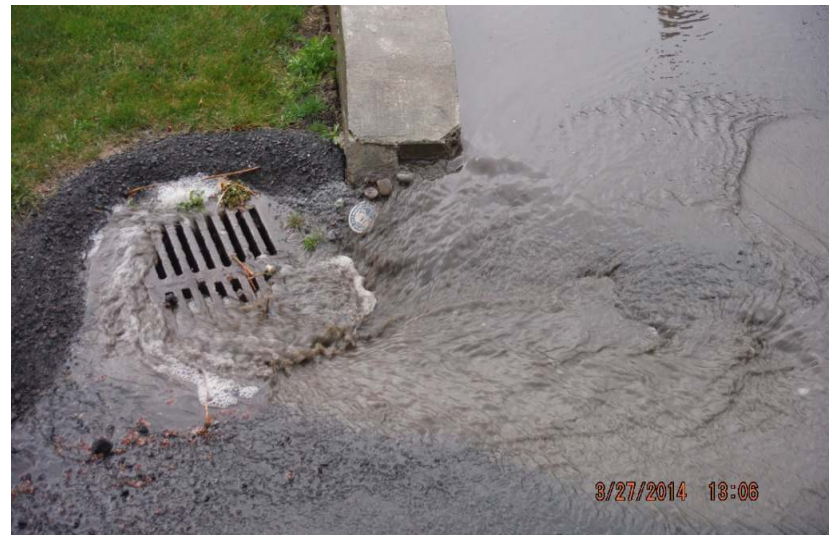
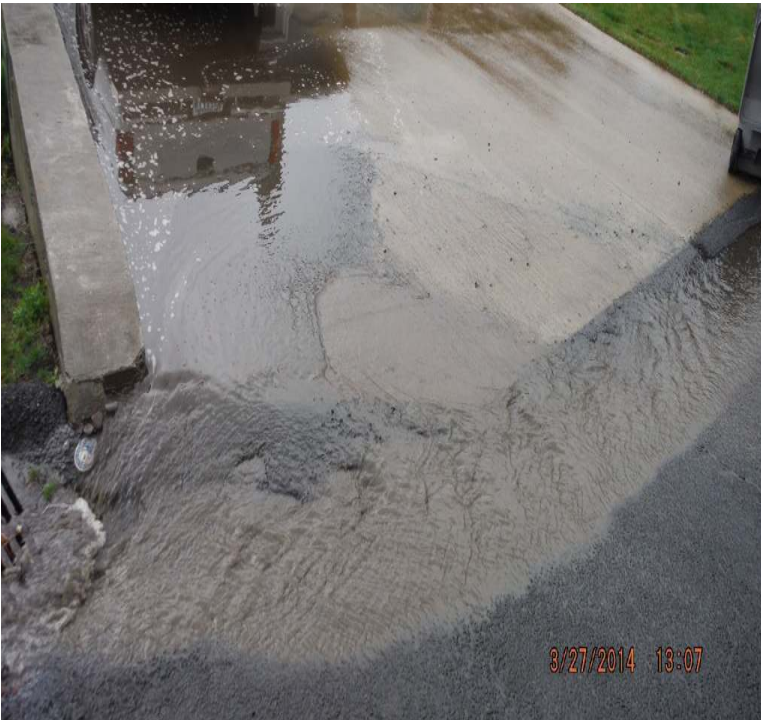
403 4th St.

- Existing asphalt berm was too small and failing. Water would flow over the berm and flood the driveway.

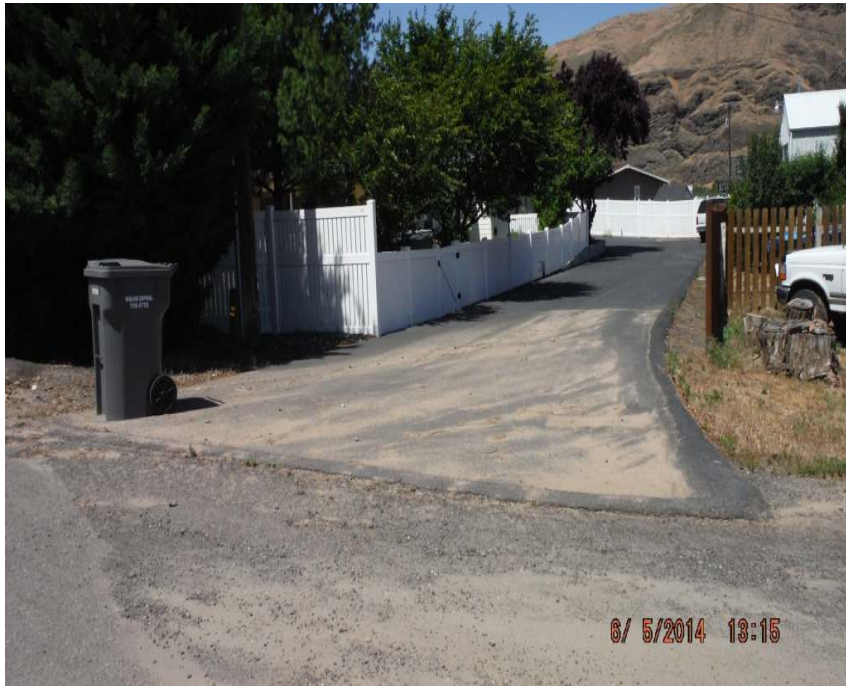
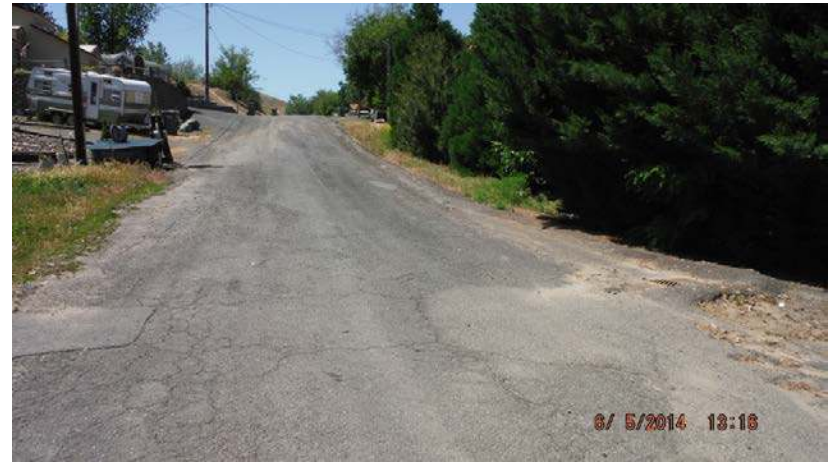
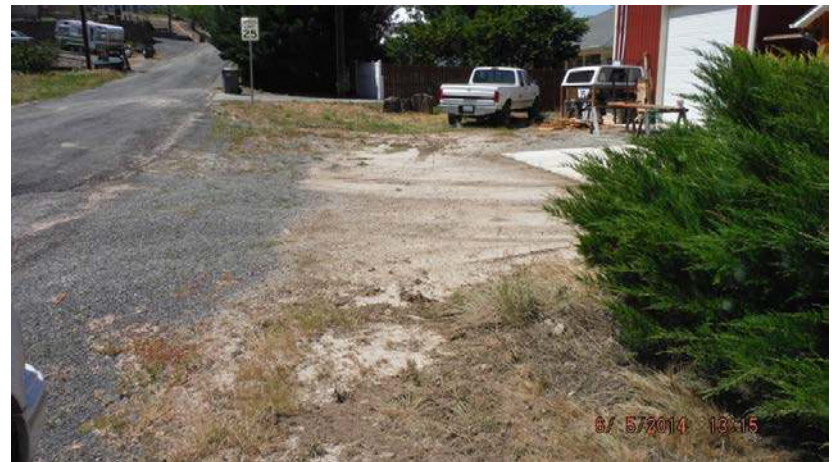
4th and Wilson

- Culvert outfall was overgrown and silted in. This caused the culvert and catch basin to plug and overflow, flooding next two residence's driveways.

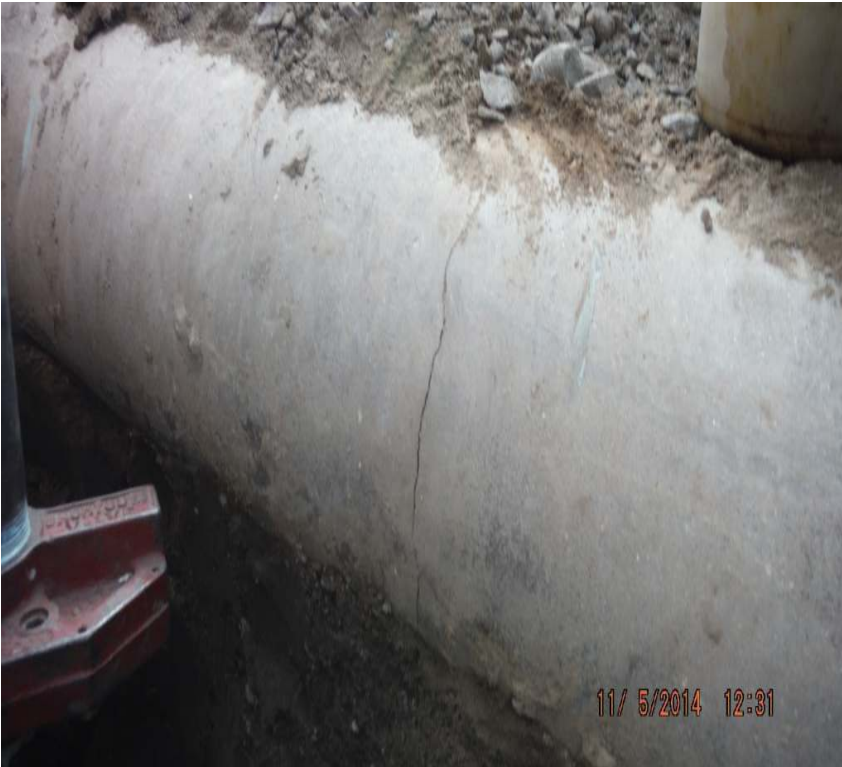
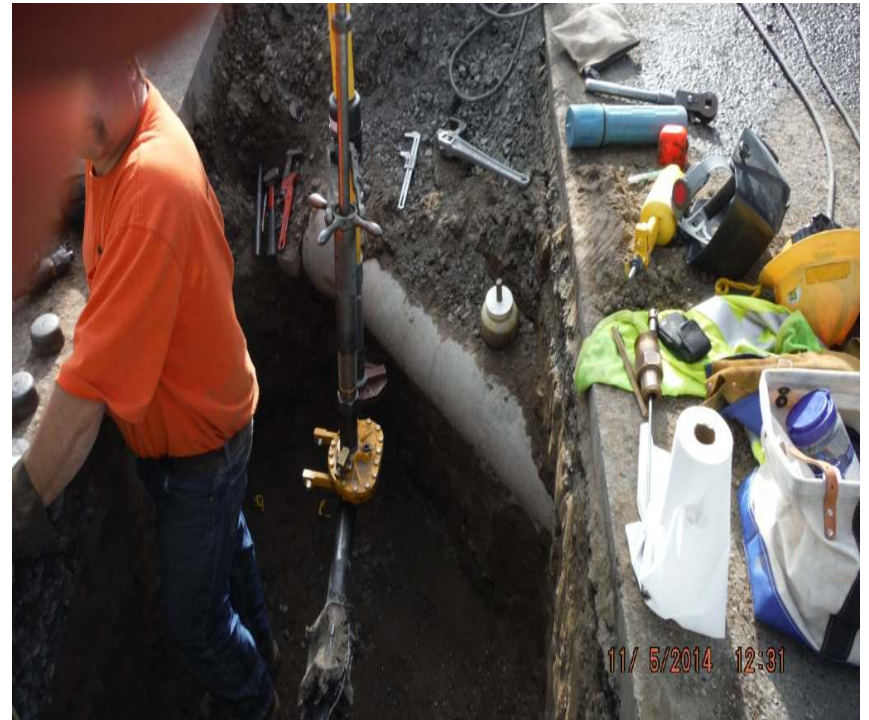
13th and Libby

- Avista discovered a small crack in the concrete storm line. While they were conducting maintenance on the gas line.

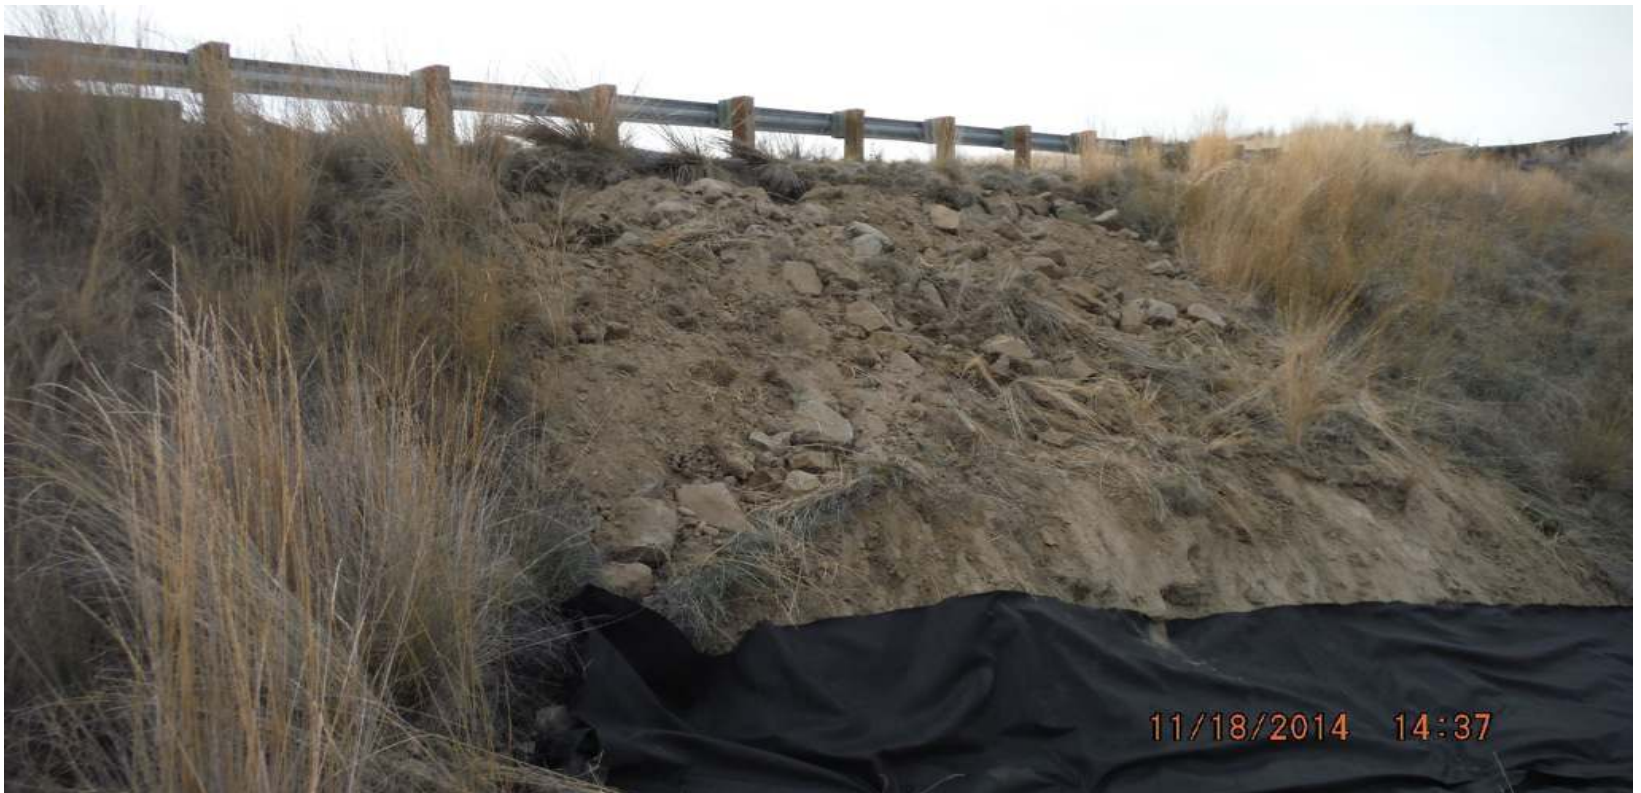
Lolo Ln.

- Hillside and drainage ditch was eroding.

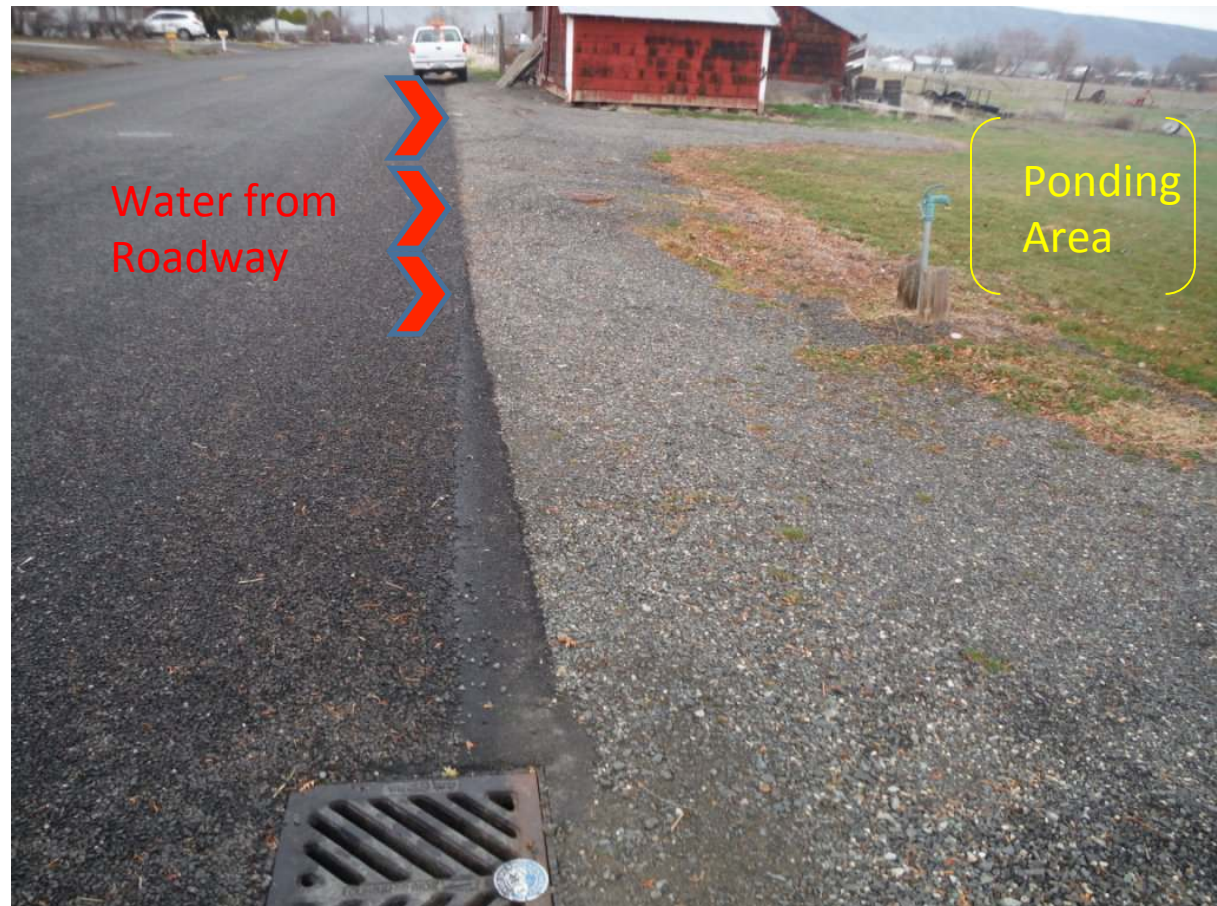
2683 Critchfield (Bolen)

Received a customer complaint that water from the roadway was ponding on his property and not making it to the Catch Basin on the roadway

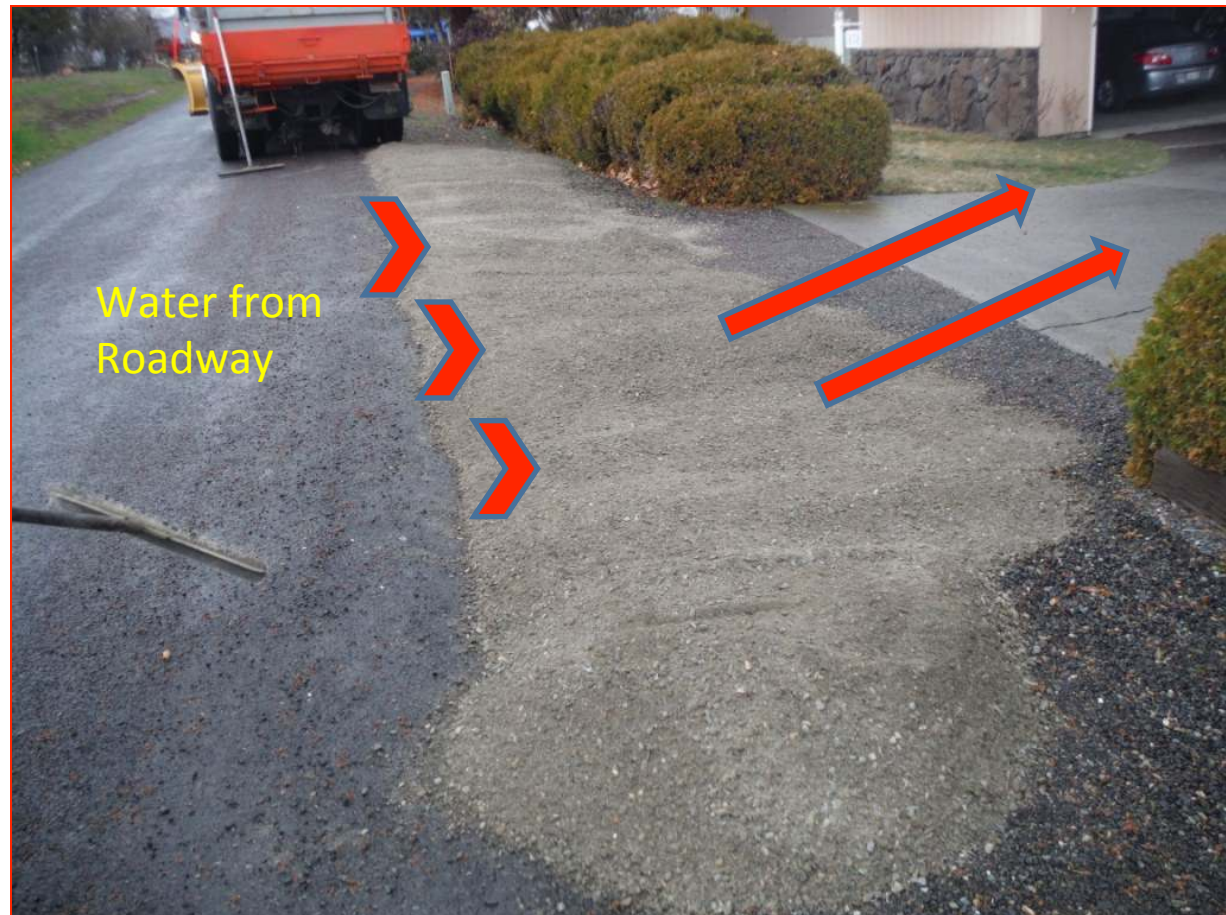
1808 Valleyveiw (Knight)

Same as the previous, received a complaint of water sheeting off the roadway and flooding the customer's garage.

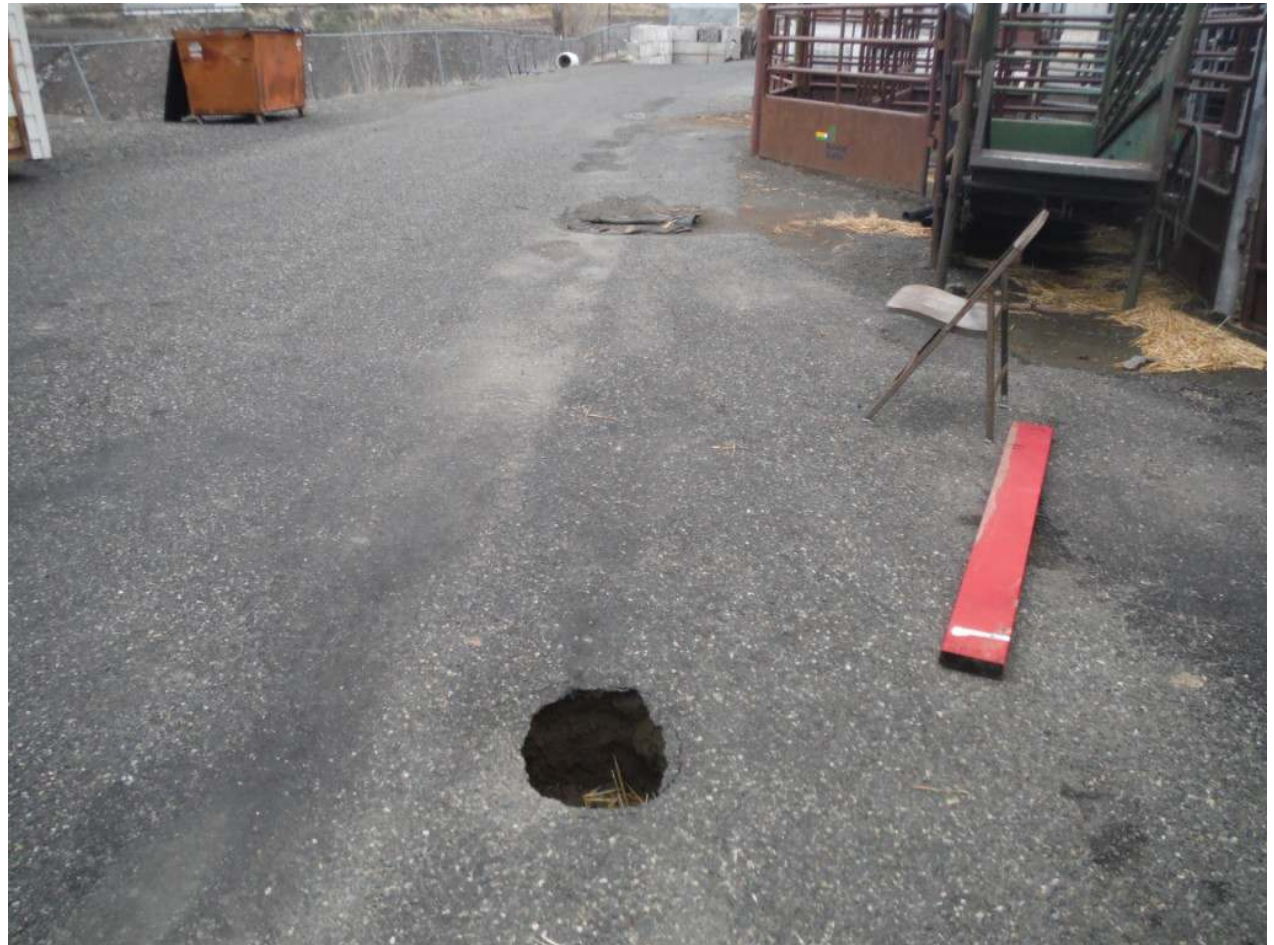
Asotin County Fairgrounds

Staff from the Fairgrounds reported a large sink hole behind the hog barn.

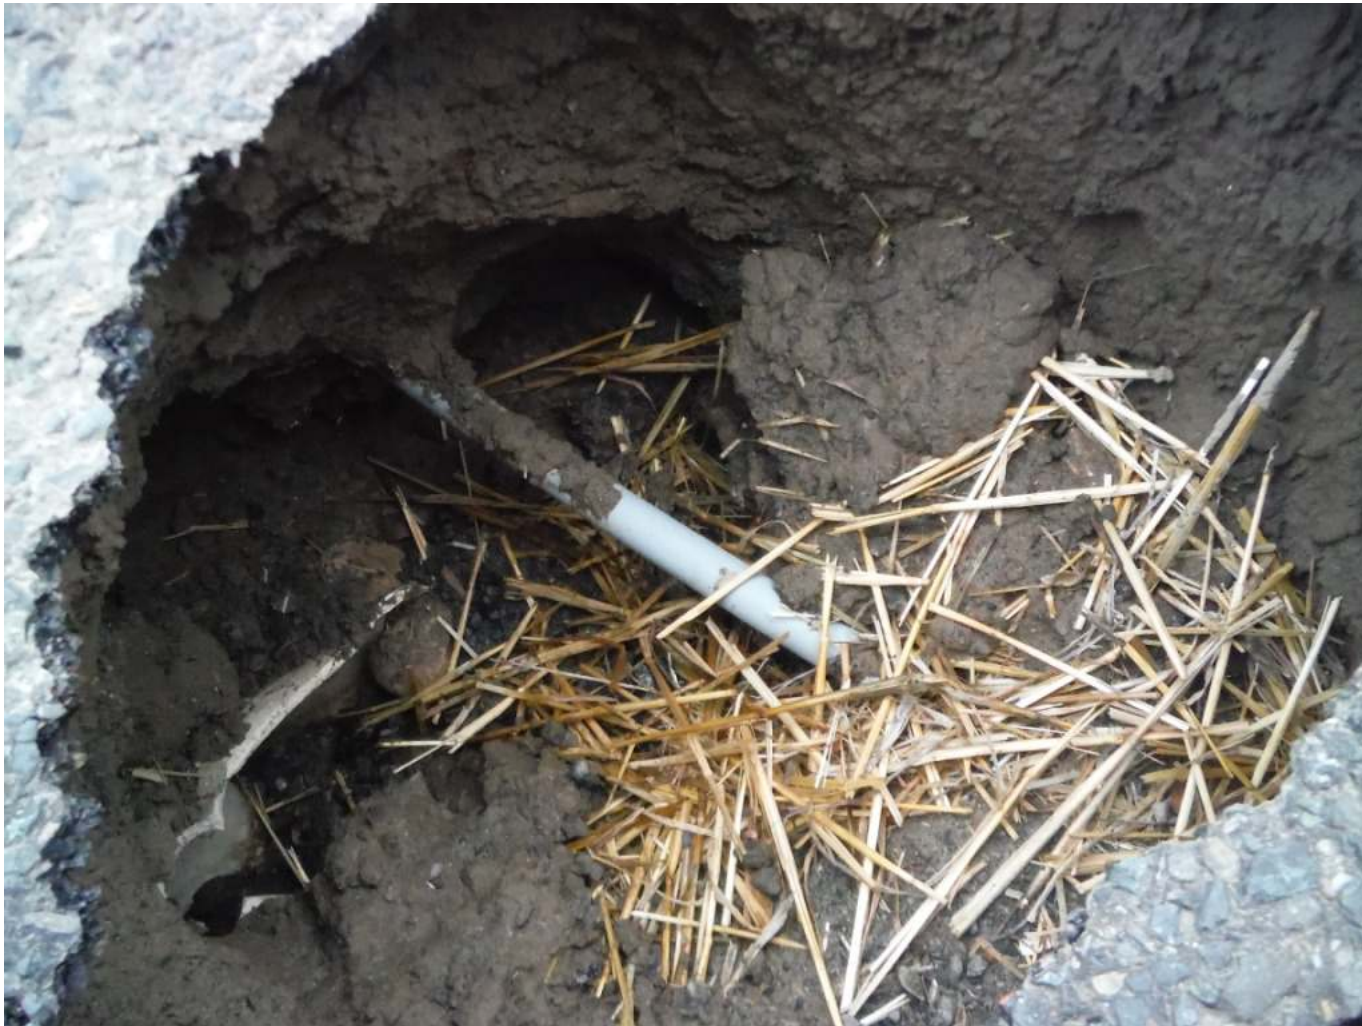
Asotin County Fairgrounds

It was determined that when the electrical conduit was run to another building behind the problem area, it was bored through the existing stormwater pipe.

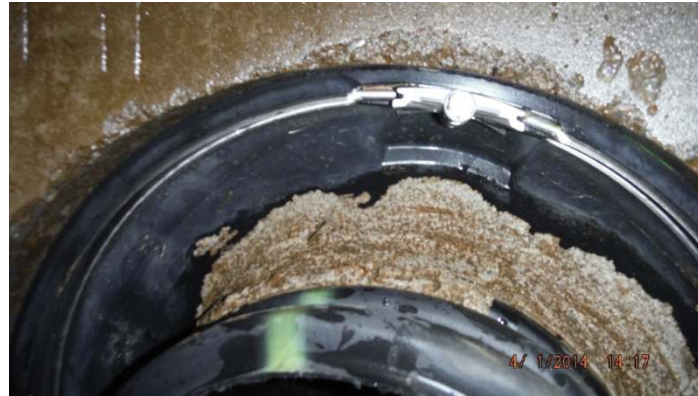
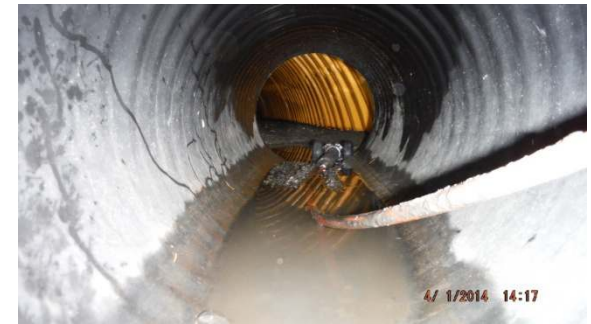
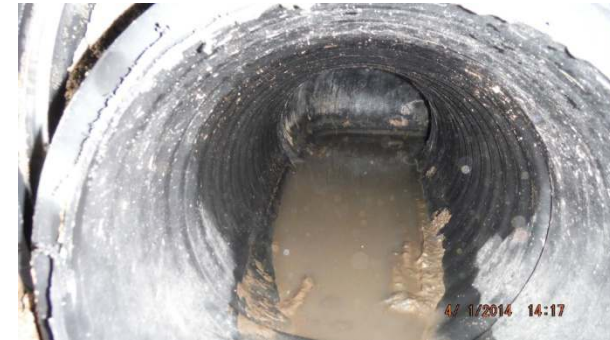
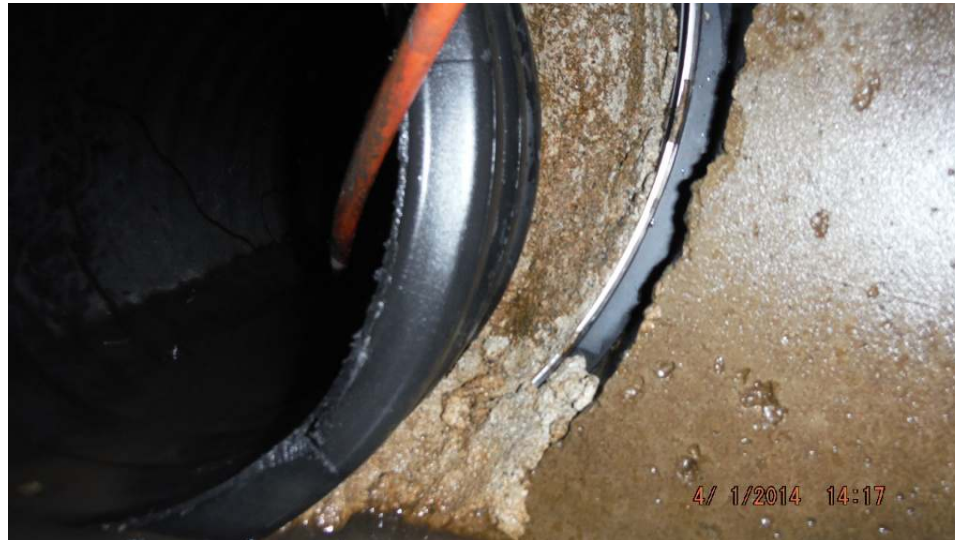
C.S.I.

Utilizing the camera system, we were able to ascertain that the Stormwater system near his driveway was sound and sealed, with no defects found. We were furthermore able to show him the picture evidence of the sealed system.

It was more likely that the problem occurred due to poor compaction when the concrete drive was installed.

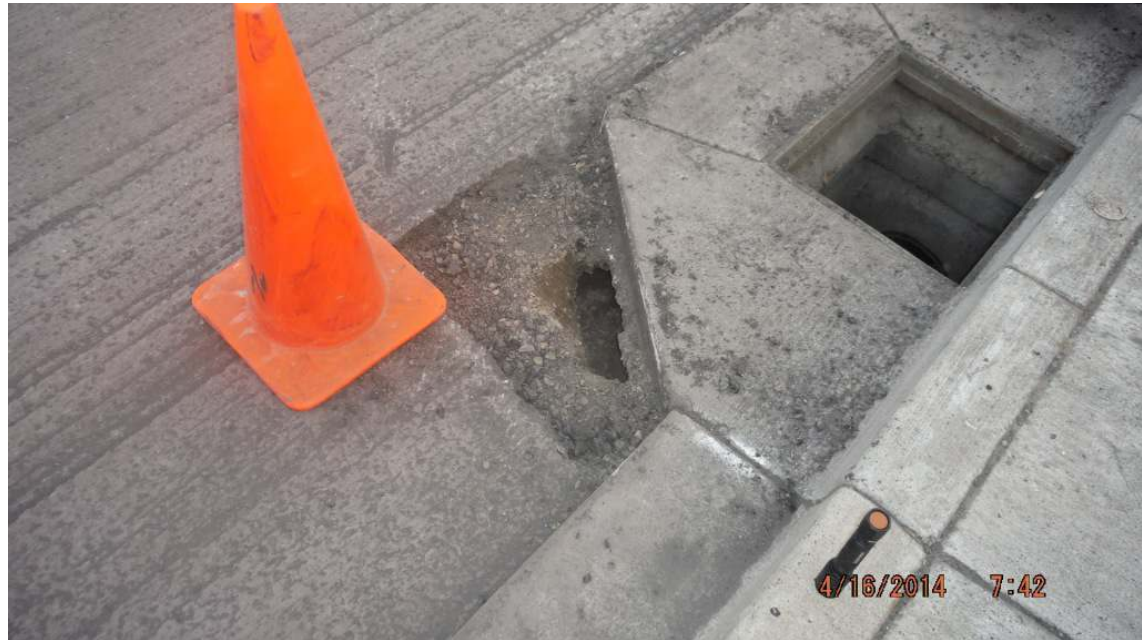
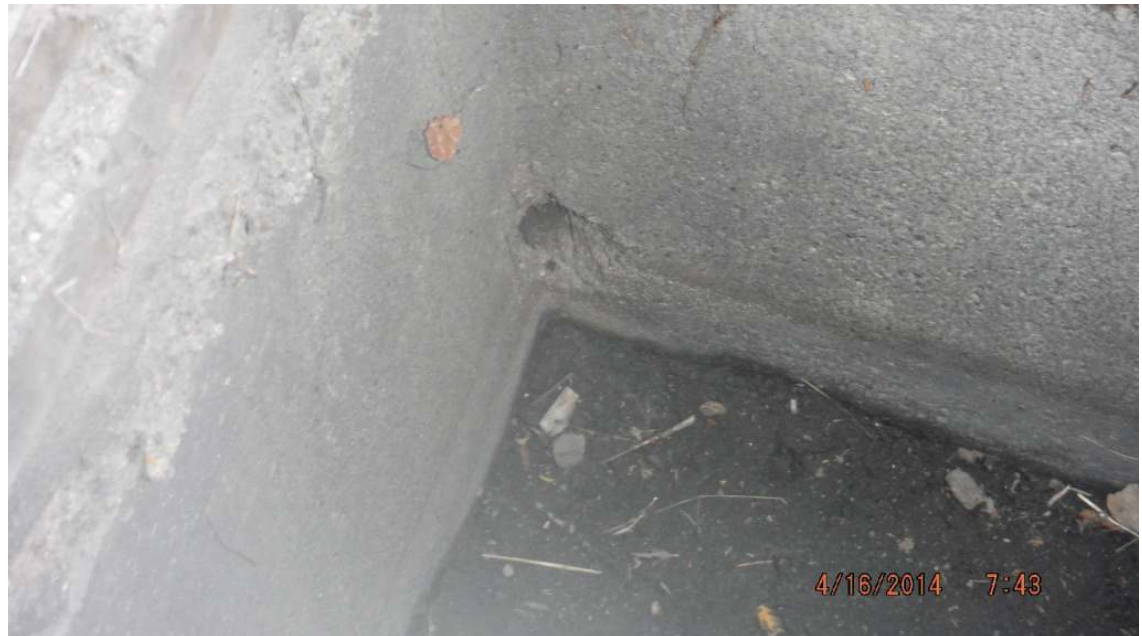
15th & Maple

Sometimes you do get lucky! This Catch Basin was slated to be inspected in the 2nd half of County system inspections during the winter of 2014-15. However when the overlay project started and it was ground down, we found that a failure was developing, that had not yet shown itself.

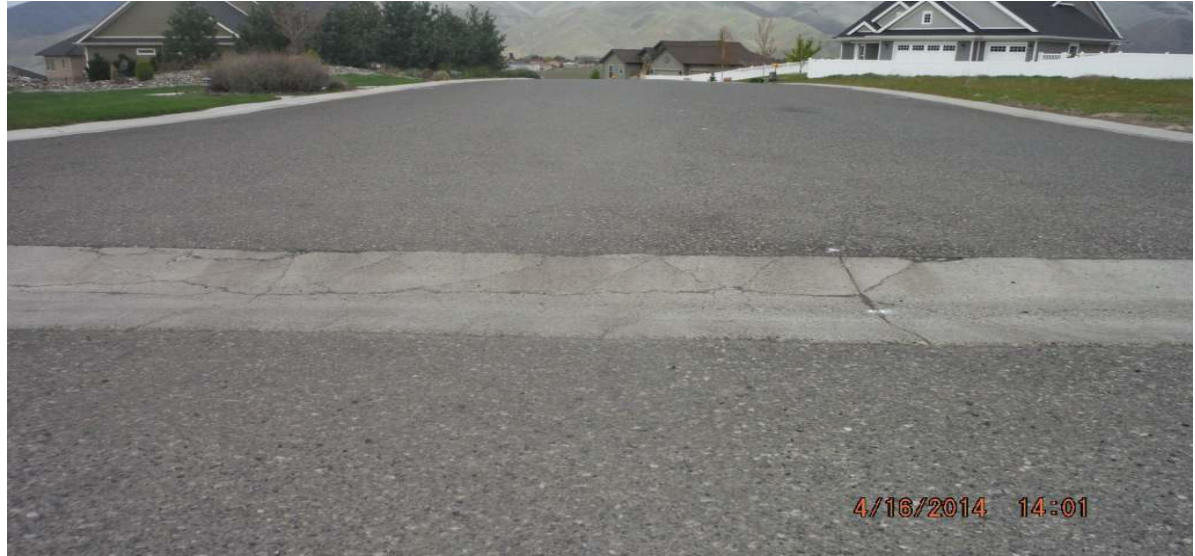
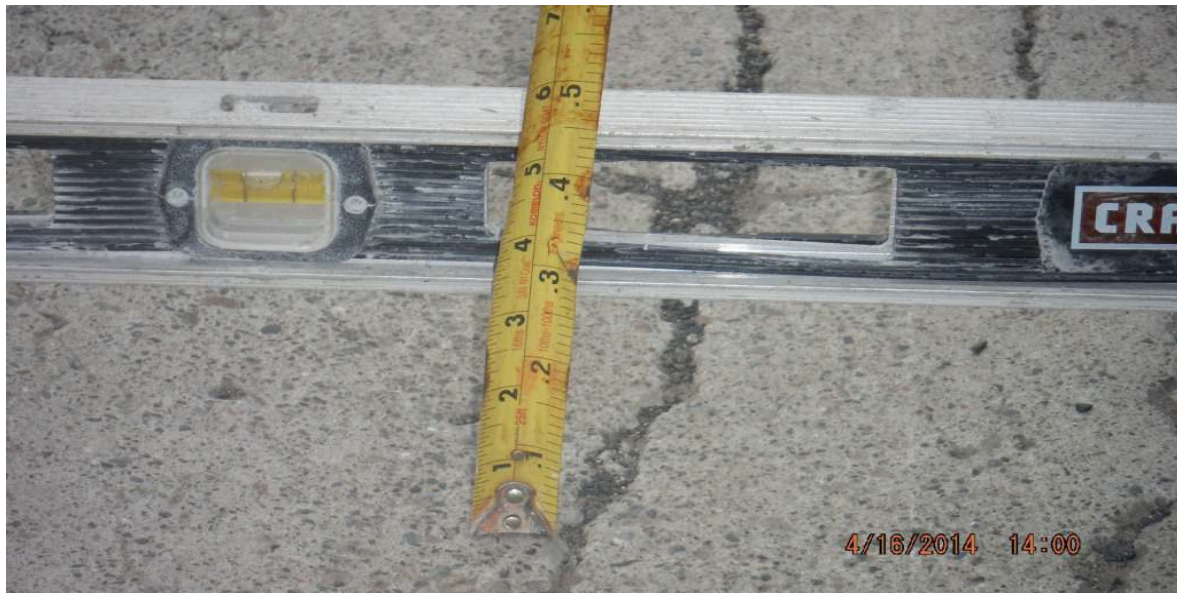
3rd Ave. & Deer Pointe Dr.

A cross drain across the roadway was installed improperly and was causing a traffic hazard.

Not only was the cross drain starting to break apart, but cars were bottoming out when they drove across the drain.

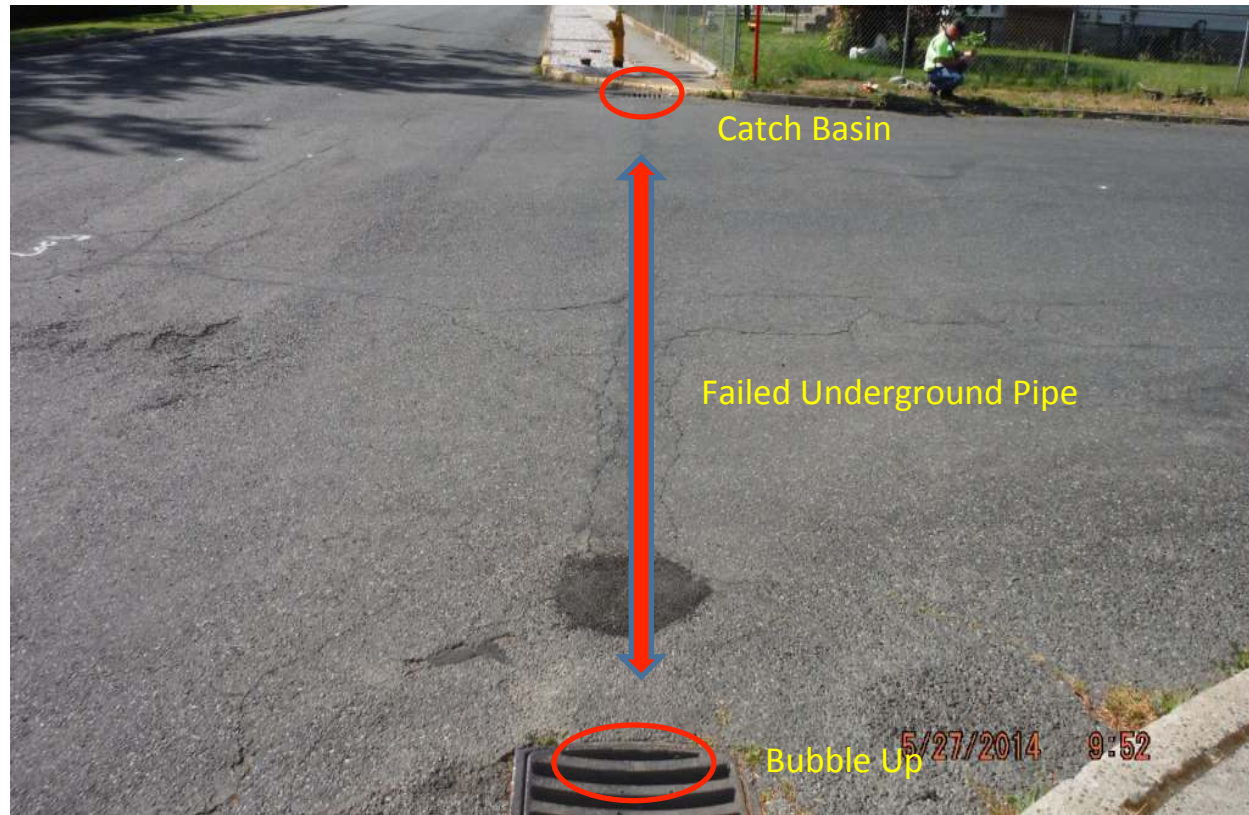
Poplar & Riverview

Last winter during our system inspections, we found a couple suspect areas in the County and the City of Clarkston that had sink holes developing. These areas were slated to be cut out and inspected to ascertain if the reasoning for the sinkhole was infiltration or failure.

A couple of months later, the Clarkston Road Crew found that one of the problem areas had developed a much larger hole, and it was evident that there was pipe failure underneath.

They temporarily filled the hole for traffic safety until the repair work could be carried out.

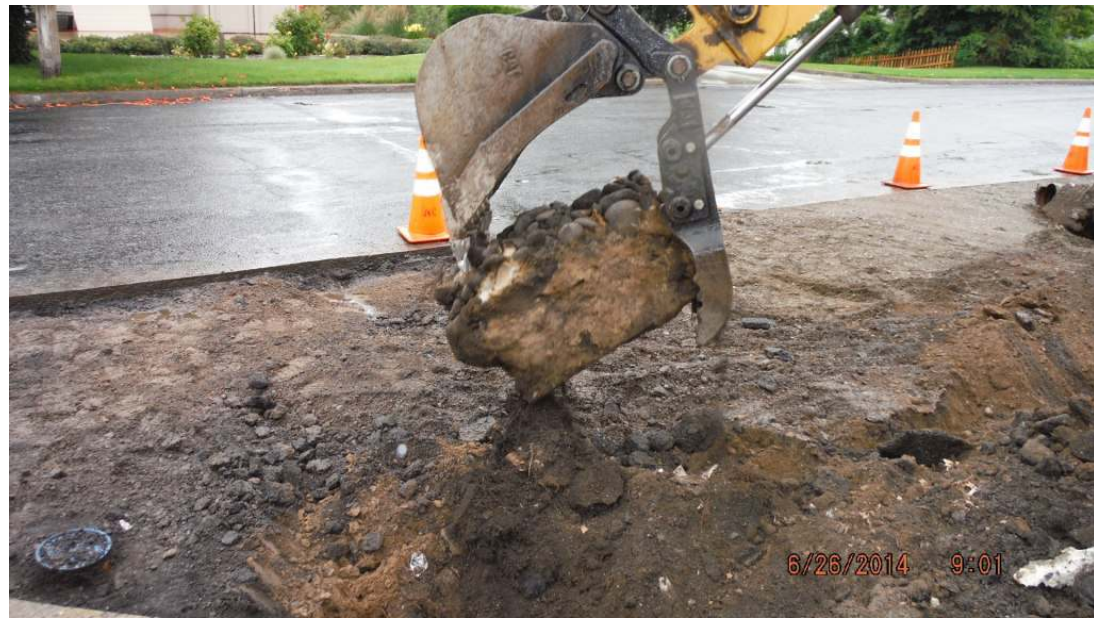
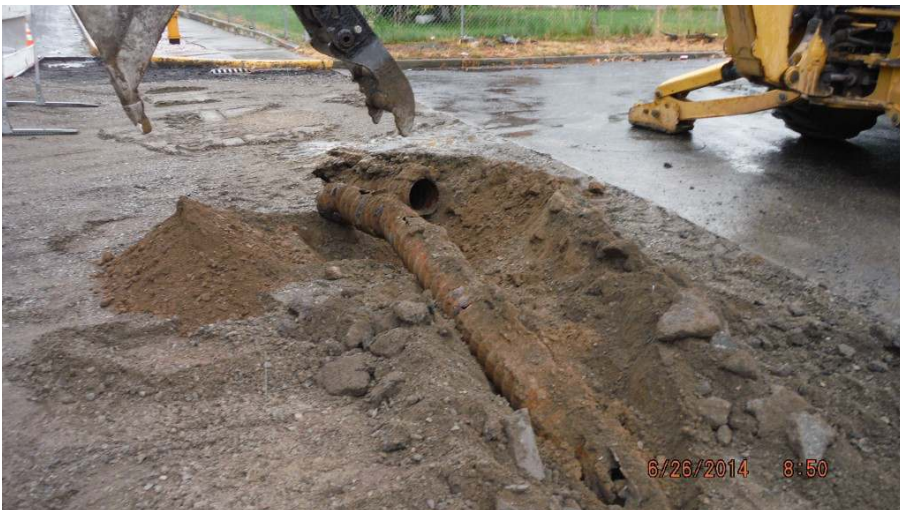
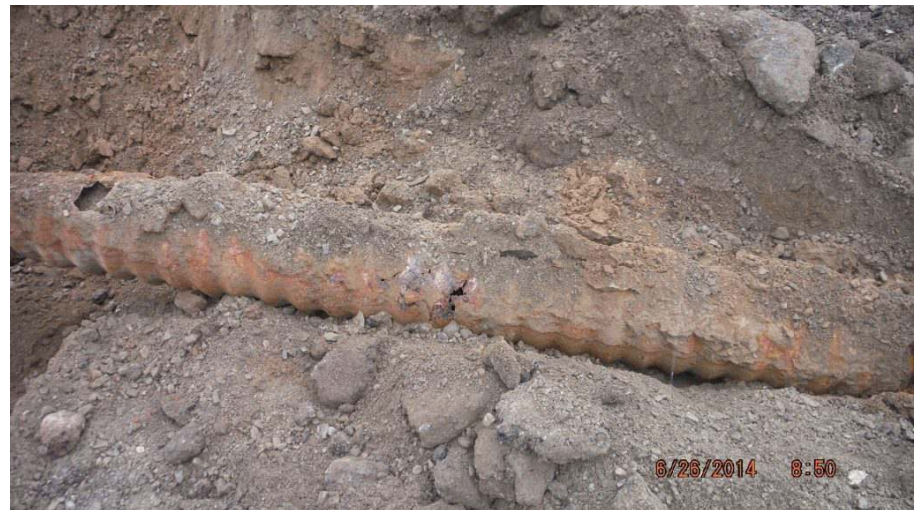
Poplar & Riverview

As you can see, the piping was in very bad shape.

Next the existing structures were removed, along with the failed underground piping.

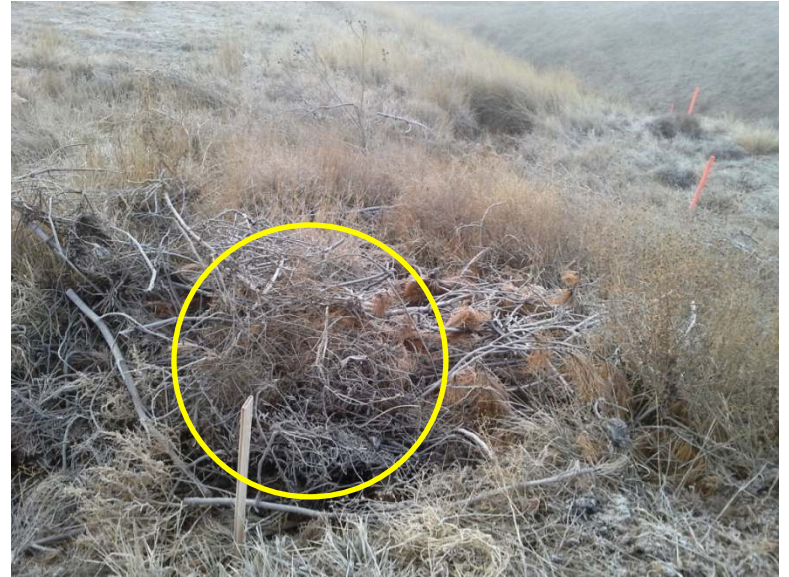
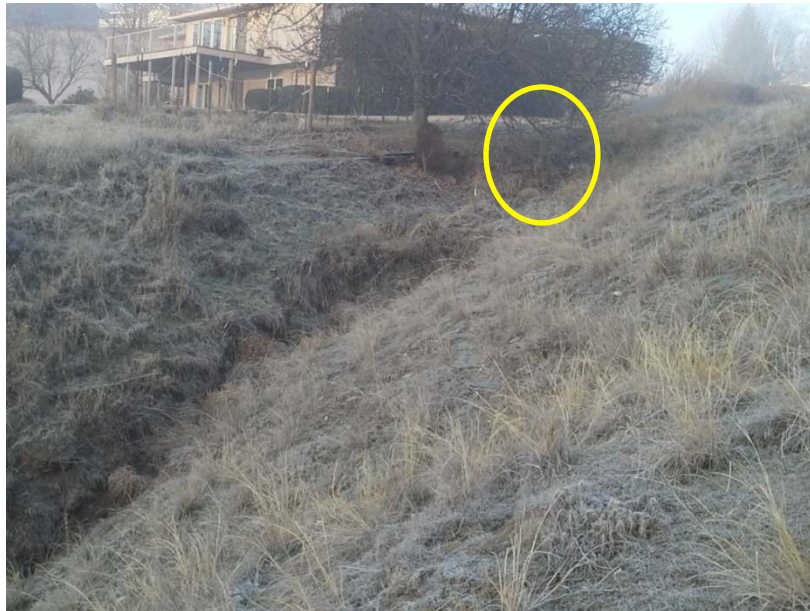
Swallows Crest Ct.

The 2 Catch Basins that spill into this drainage had been creating tremendous undercuts into the hillside where they spilled out approximately 15ft behind the curb lines.

In addition, homeowners had been creating a hazard by covering these unsightly voids with brush.
