Known Problem Areas		
The Ridges Urban Stormwater Retrofit Design Project Asotin County, WA		
	MAR-2020 PROJECT NO. 190377	BY: EBP REVISED BY: ---
		MAP NO. 1

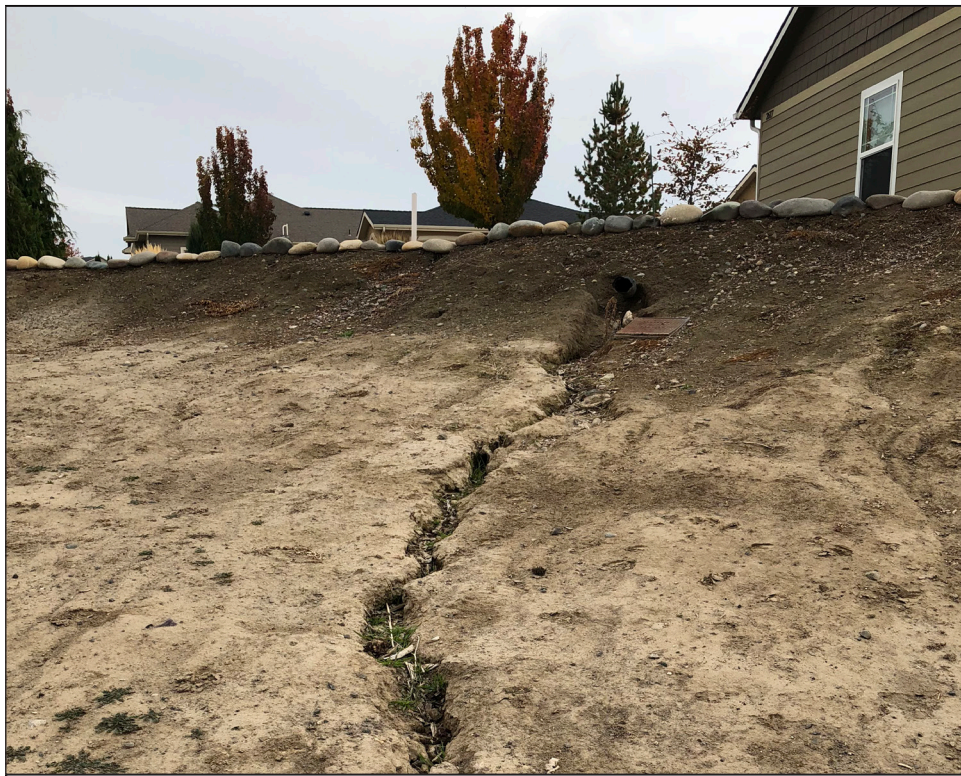
Problem Area #1 - Hillside erosion at the end of 3rd Avenue.

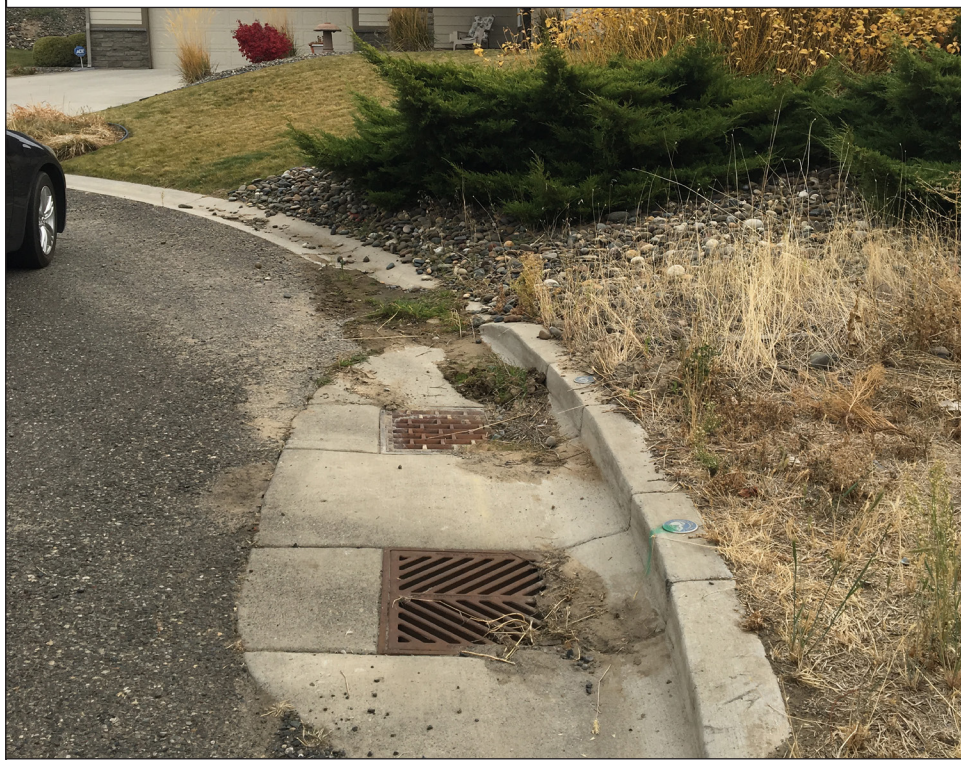
Problem Area #3 - Sediment plugging at the end of Deer Pointe Drive.

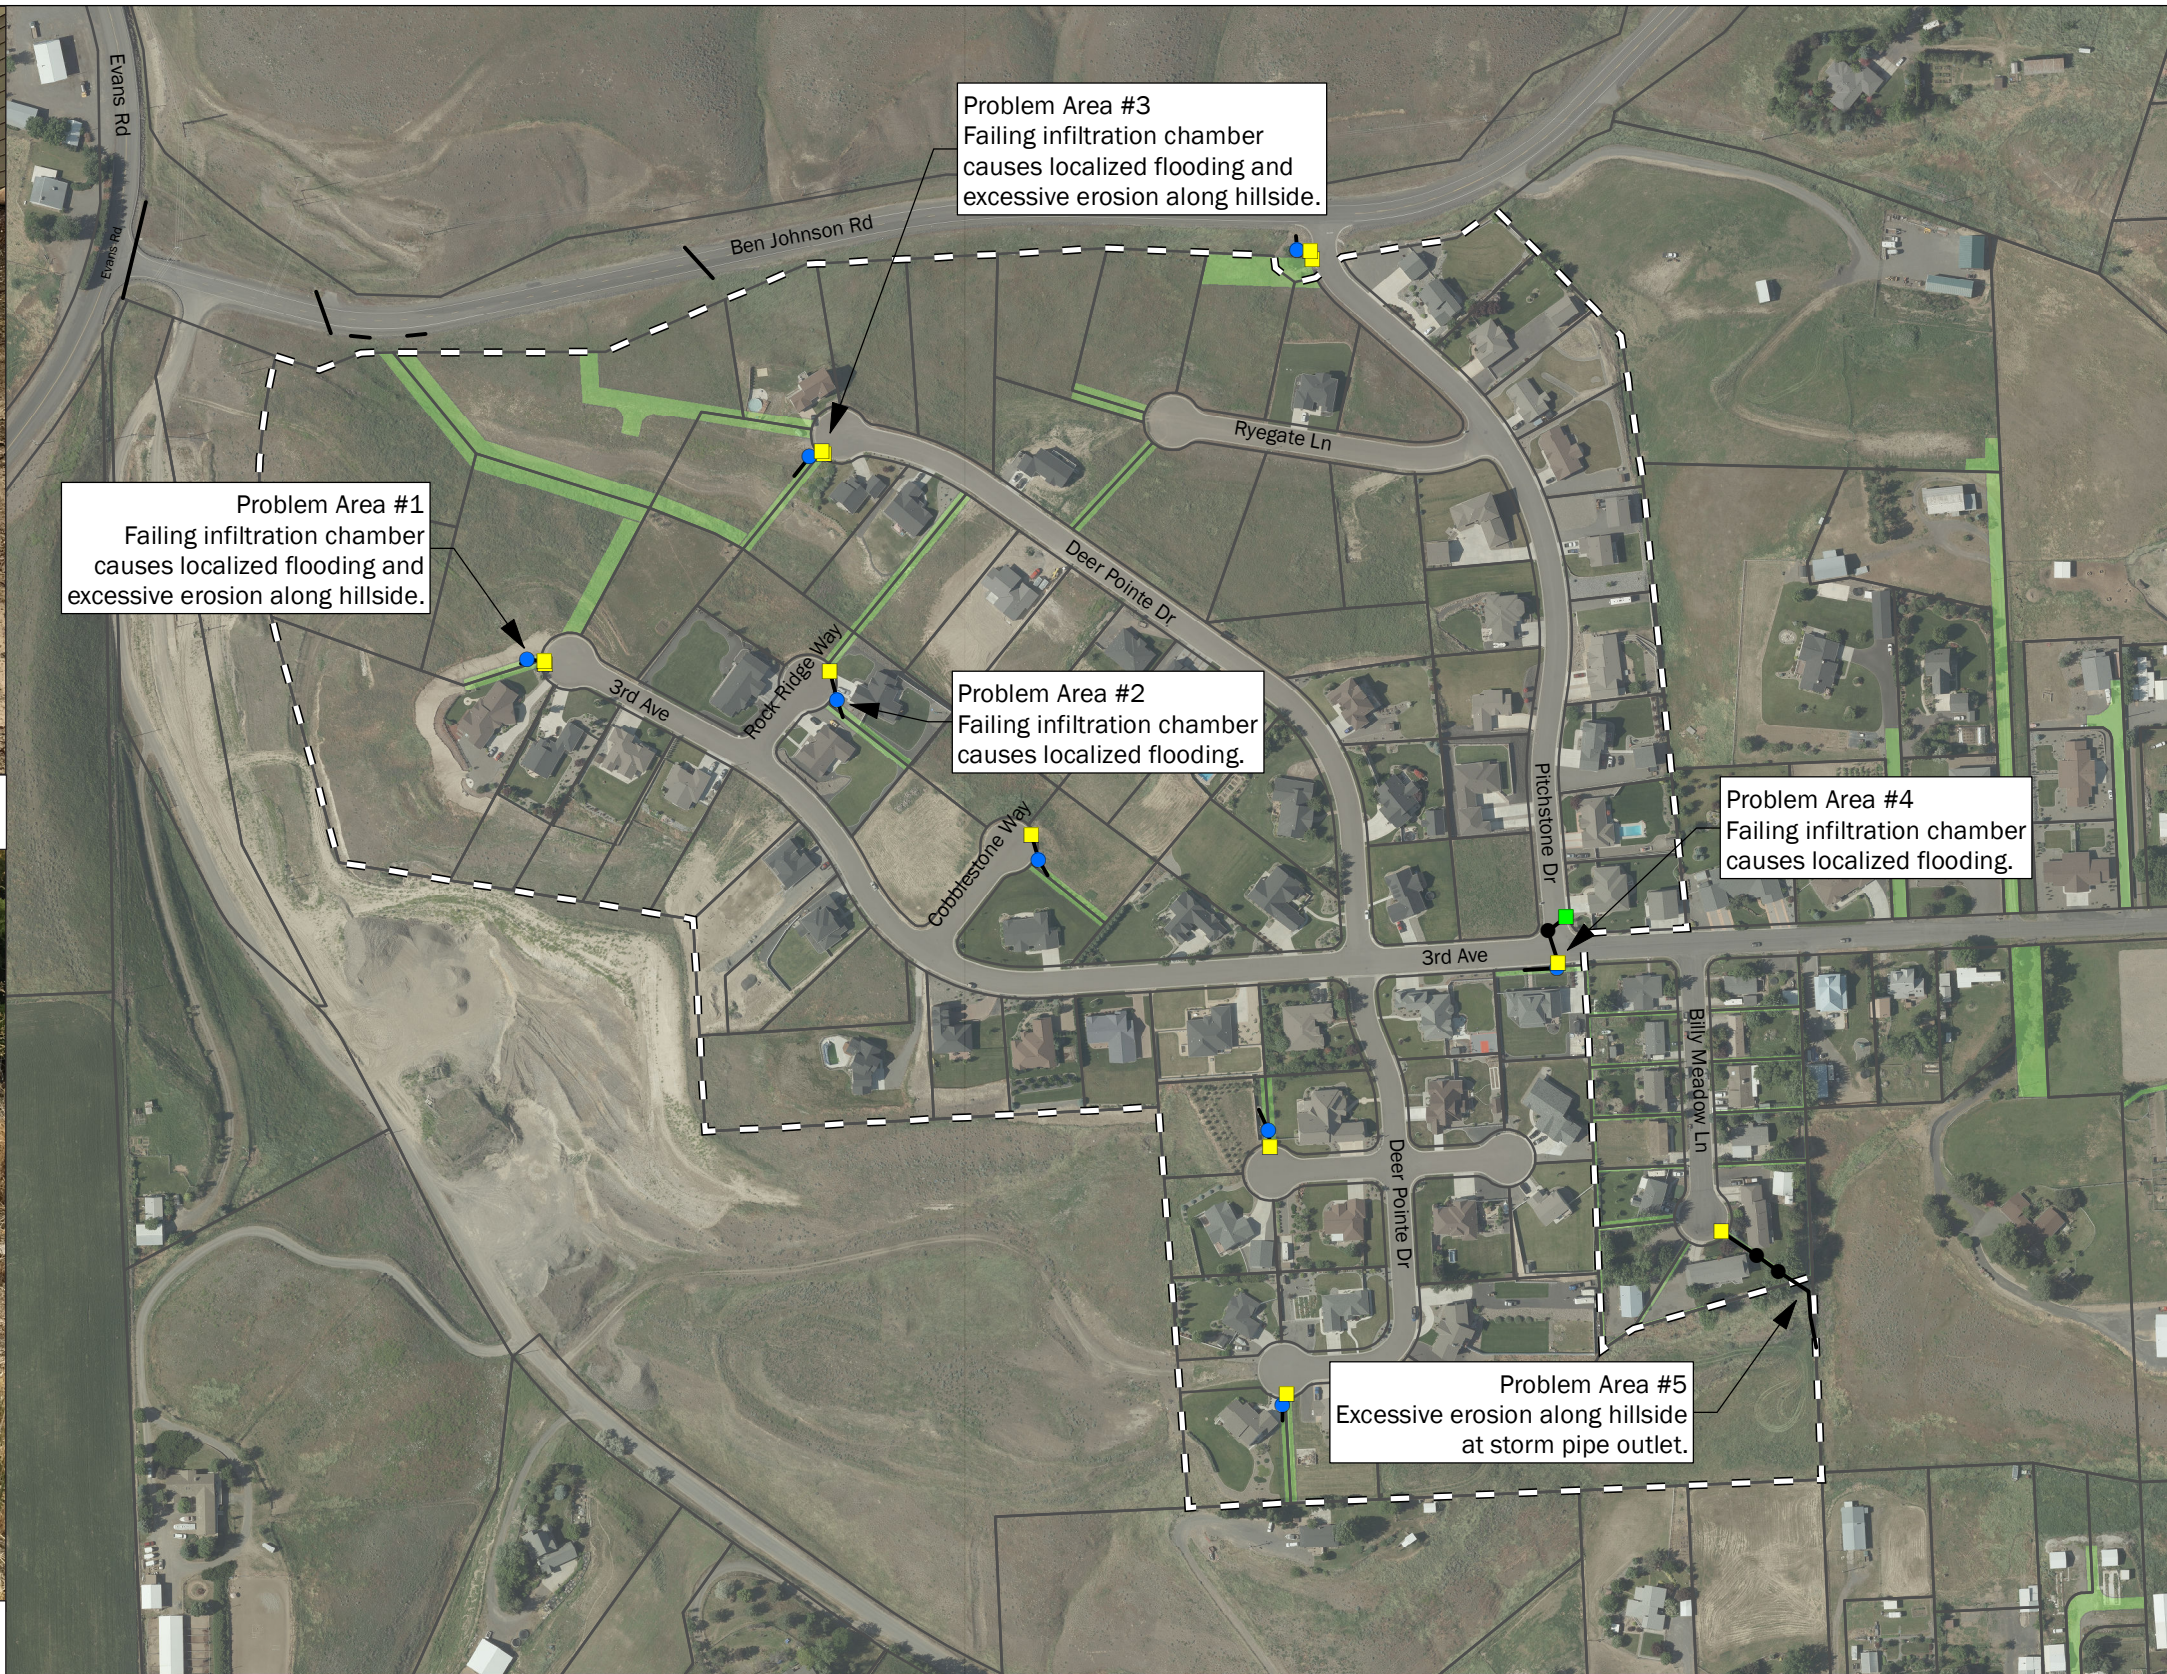
Problem Area #1
Failing infiltration chamber
causes localized flooding and
excessive erosion along hillside.

Problem Area #3
Failing infiltration chamber
causes localized flooding and
excessive erosion along hillside.

Problem Area #2
Failing infiltration chamber
causes localized flooding.

Problem Area #4
Failing infiltration chamber
causes localized flooding.

Problem Area #5
Excessive erosion along hillside
at storm pipe outlet.
