Stormwater Work Projects 2014

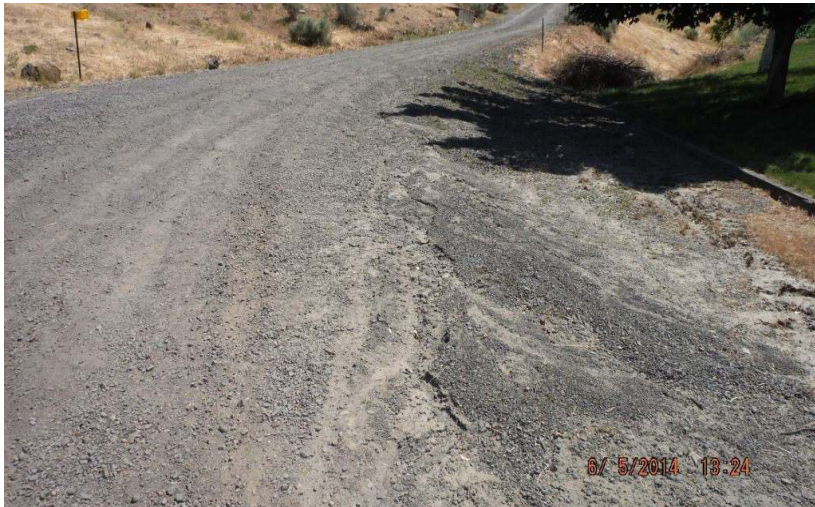
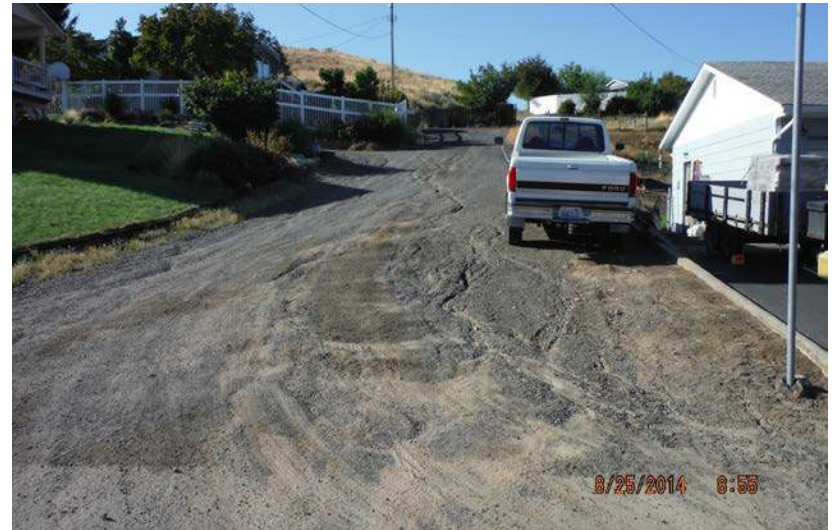
Riverview and Wilson Ln.

- Gravel would wash off of the Driveway at Quarry Rd and also Wilson Ln. The material would continuously plug the catch basin.

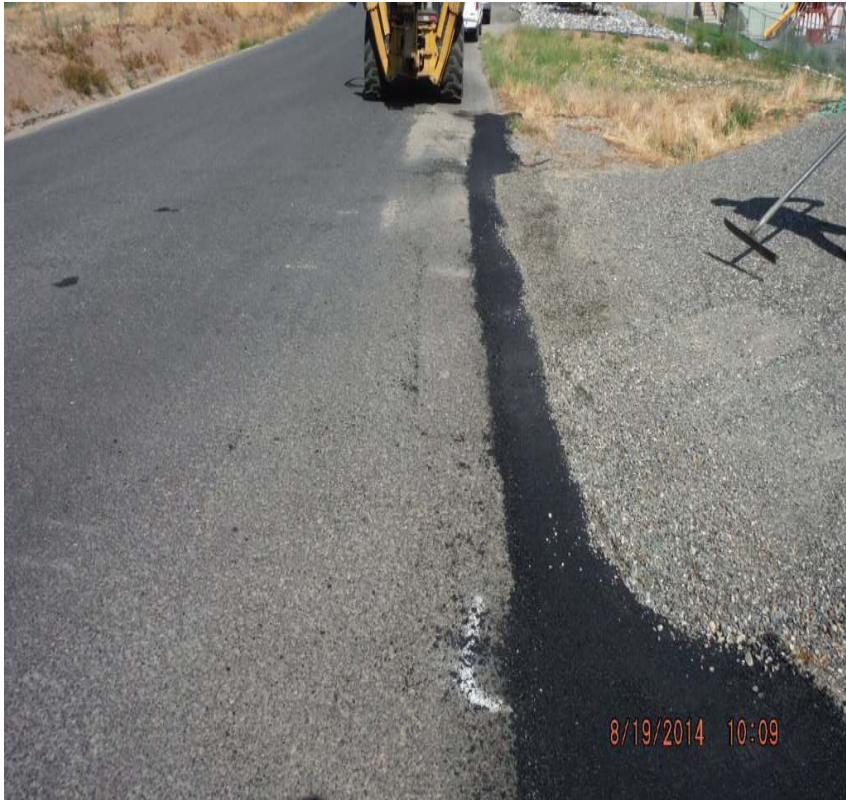
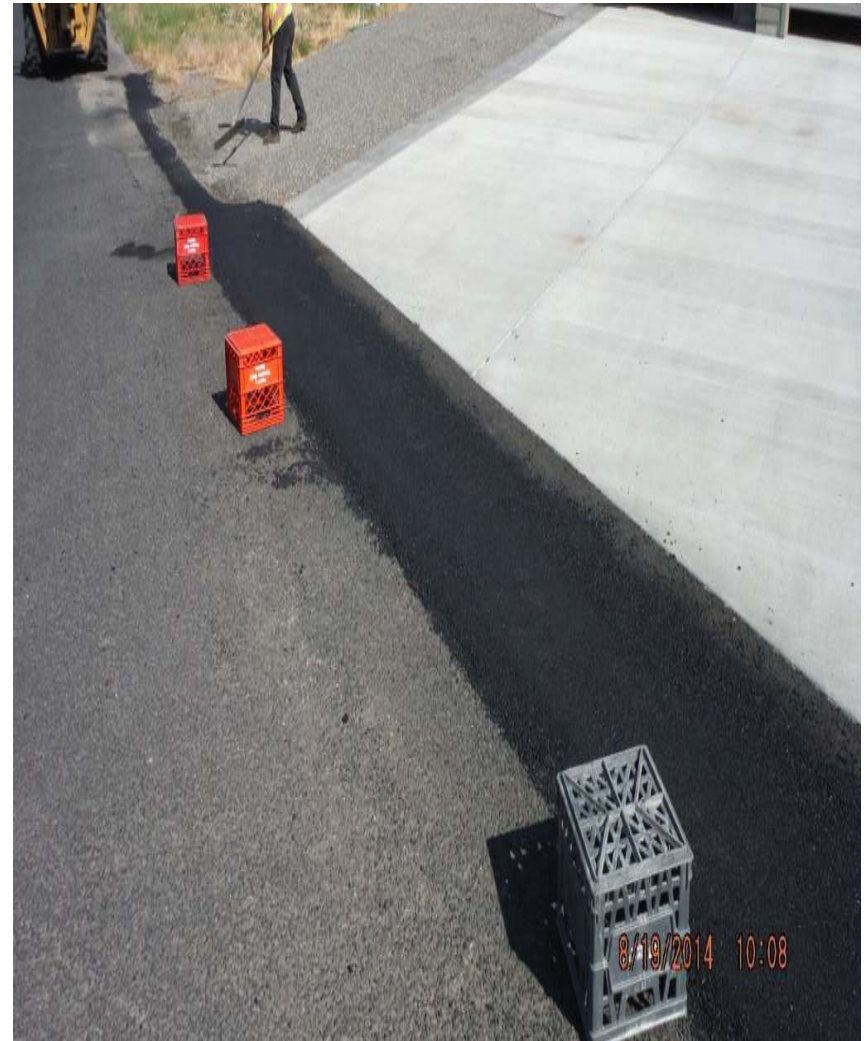
2432 Linda Ln.

- It was determined that the existing asphalt berm needed to be built up and extended.

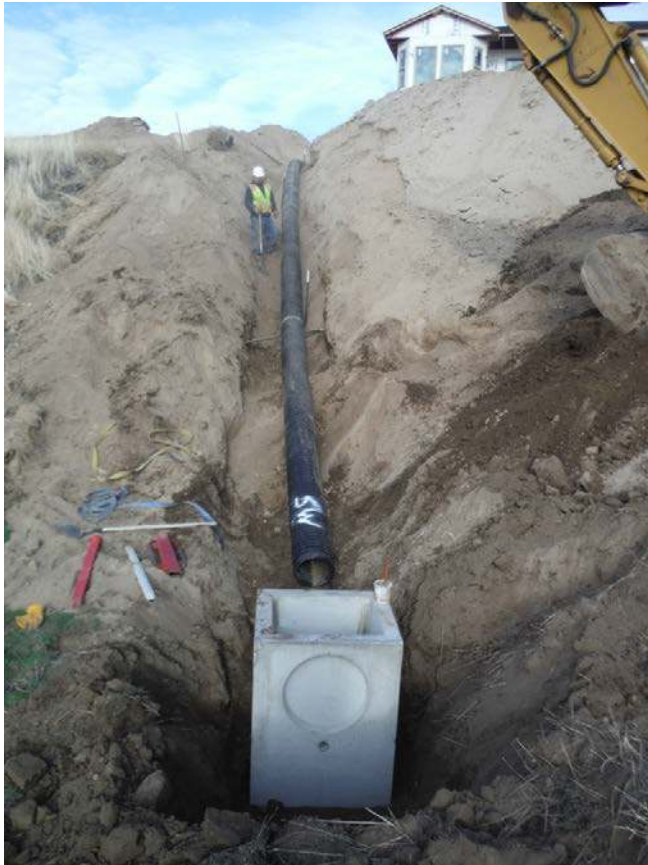
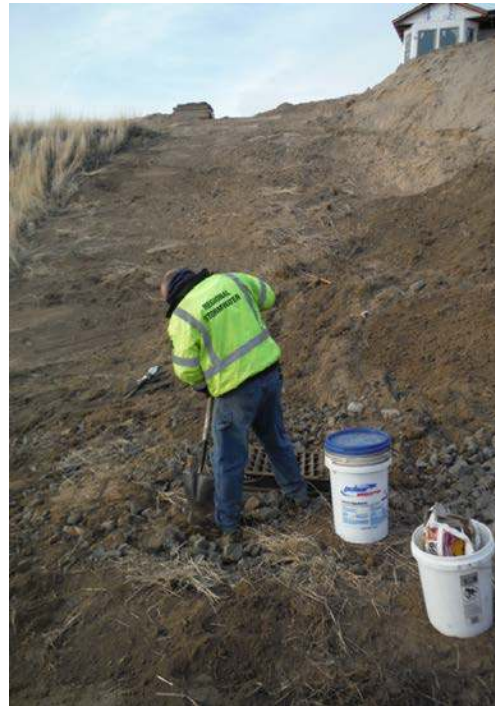
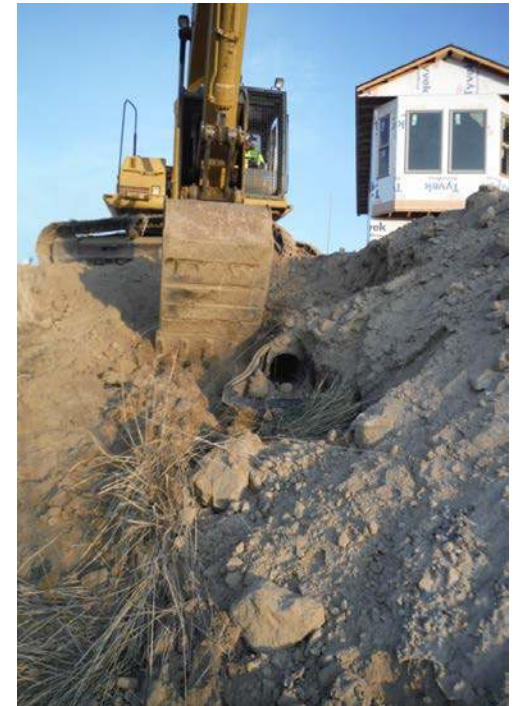
Remington Way

- Outfall needed to be extended into the bottom of the draw and piped into a new bubble up.

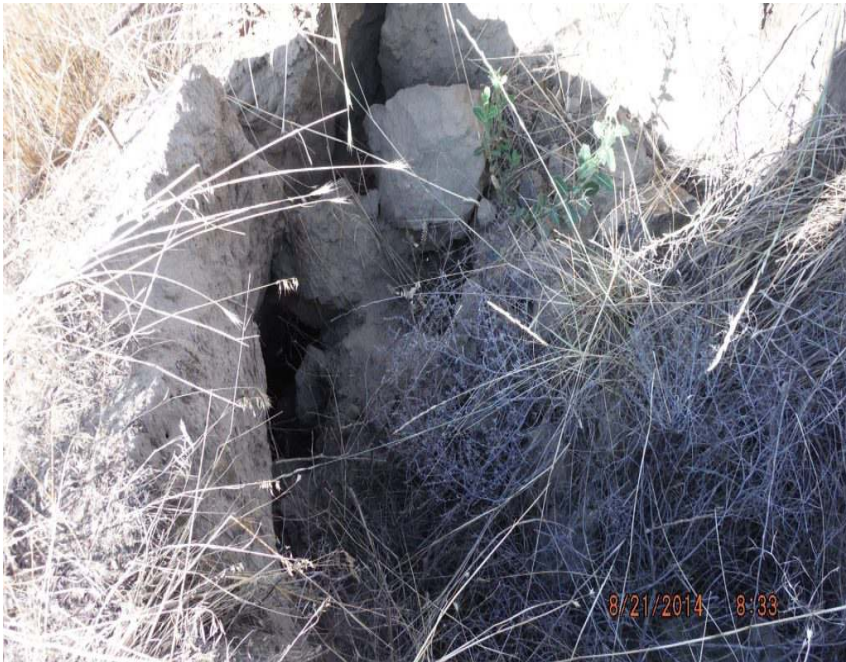
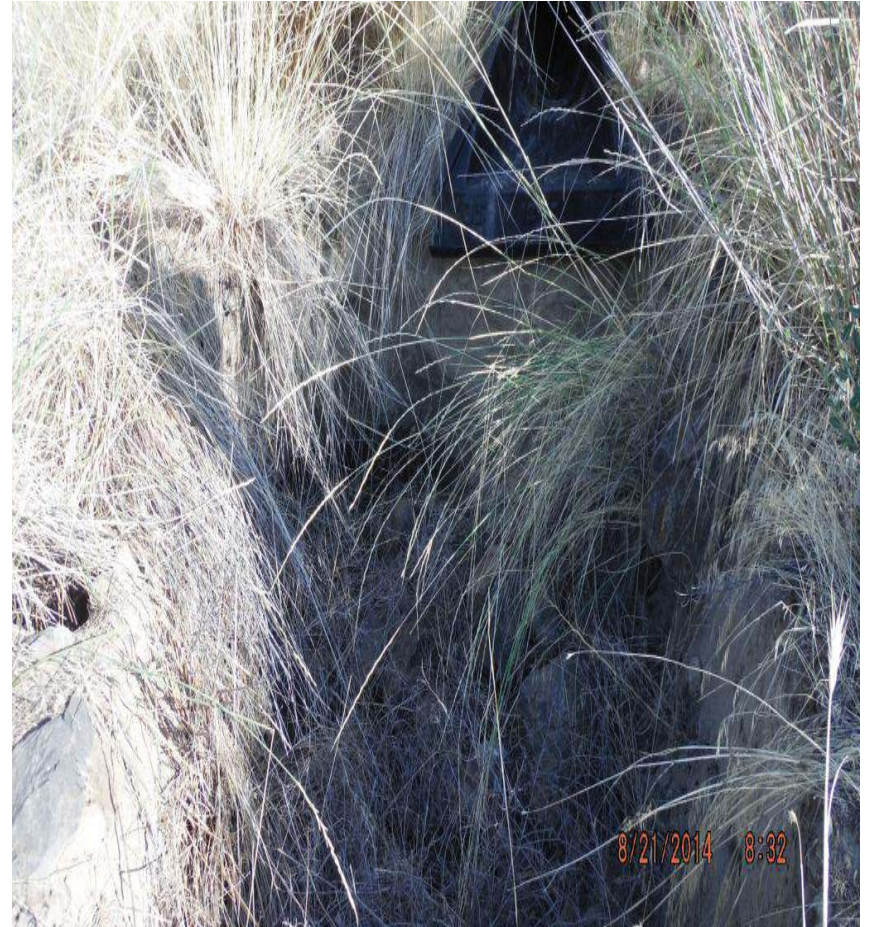
Colt Canyon

- Original outfall had eroded and started to washout the hillside.

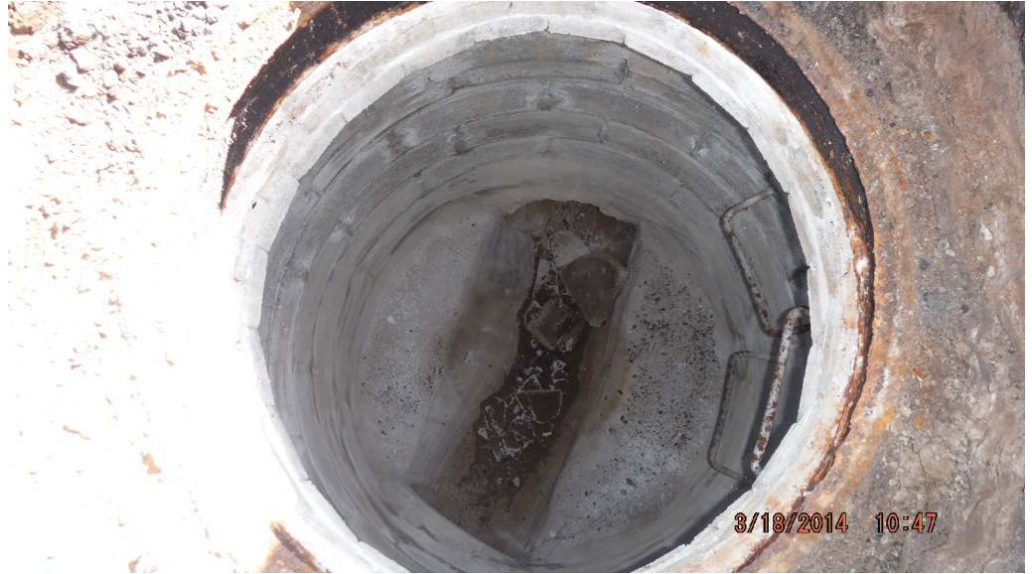
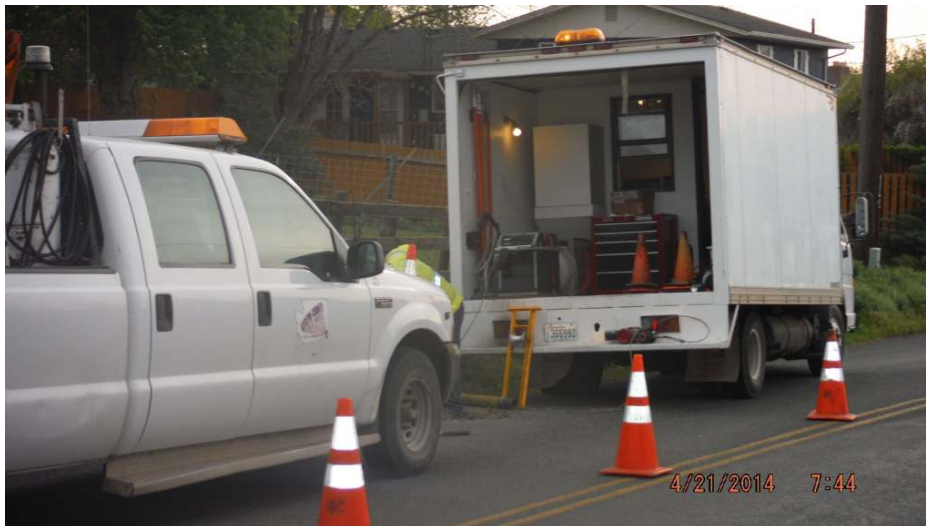
18th Ave. Abandoned Line Exploration

After locating all of the manholes that were covered by pavement, we dug them up and began checking the pipes for integrity and condition. The City of Clarkston assisted us by utilizing their camera truck to do most of the line exploration.

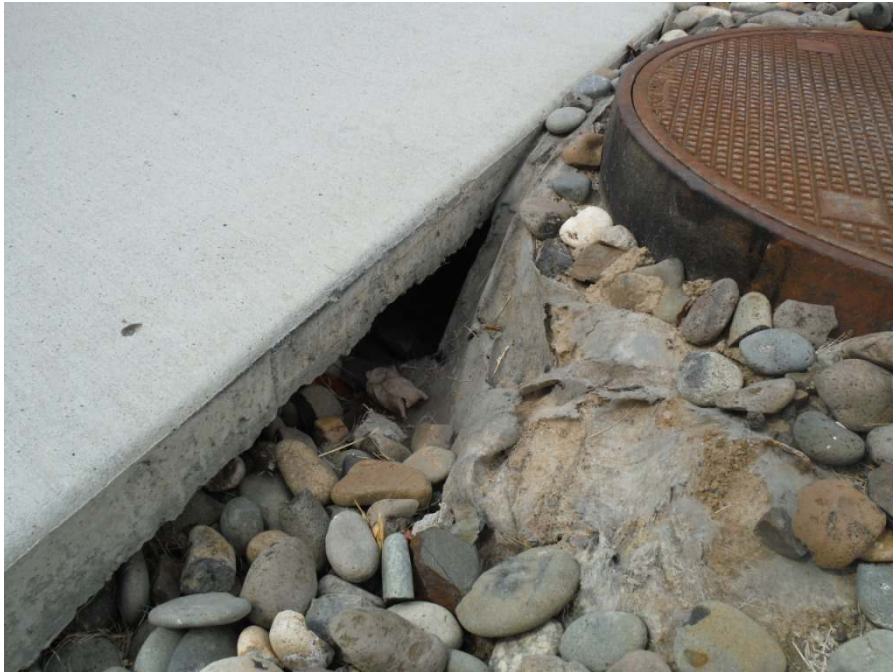
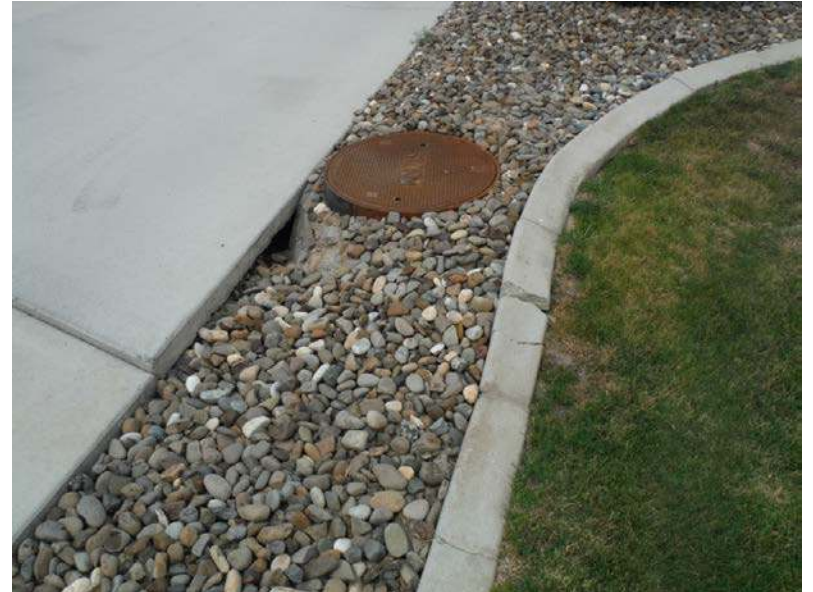
Money Savings

A customer wanted to tear out his driveway and have it repaired because he thought the problem stemmed from a failure of the nearby underground Stormwater System.

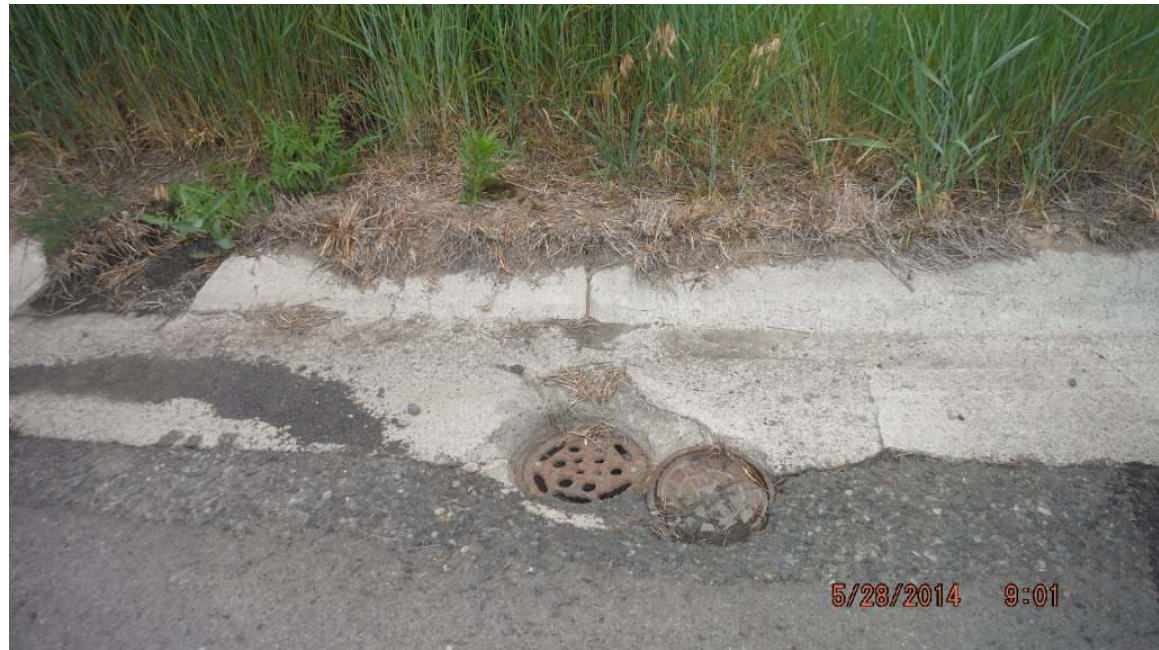
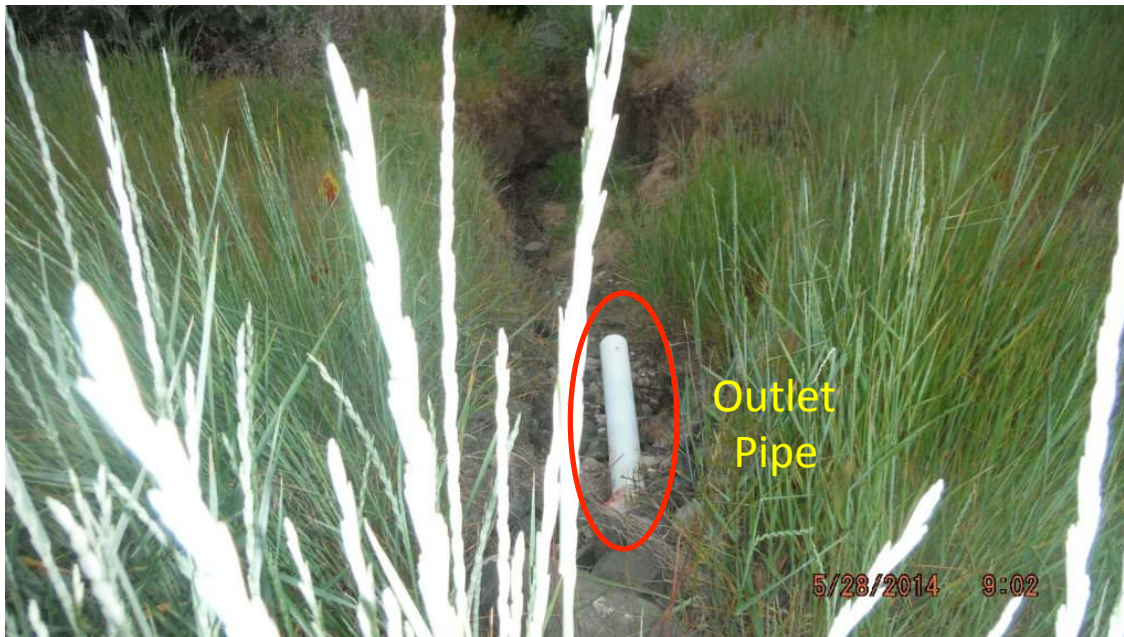
Nicklaus Dr.

A curb drain had been installed at the base of the curb and drained out through a pipe on the back side of the curb into the existing drainage.

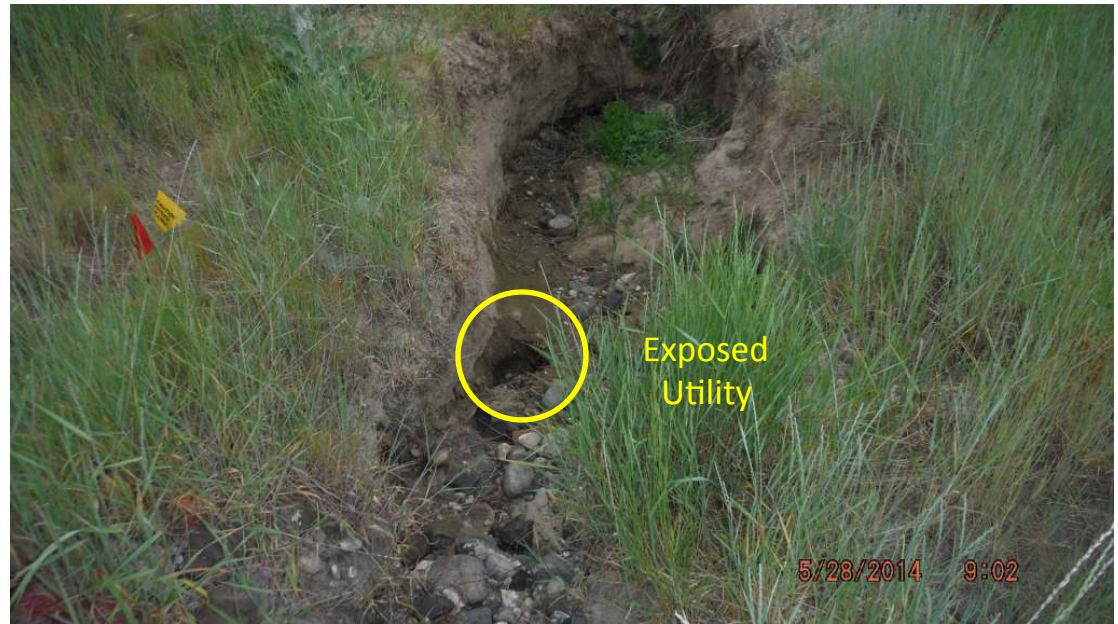
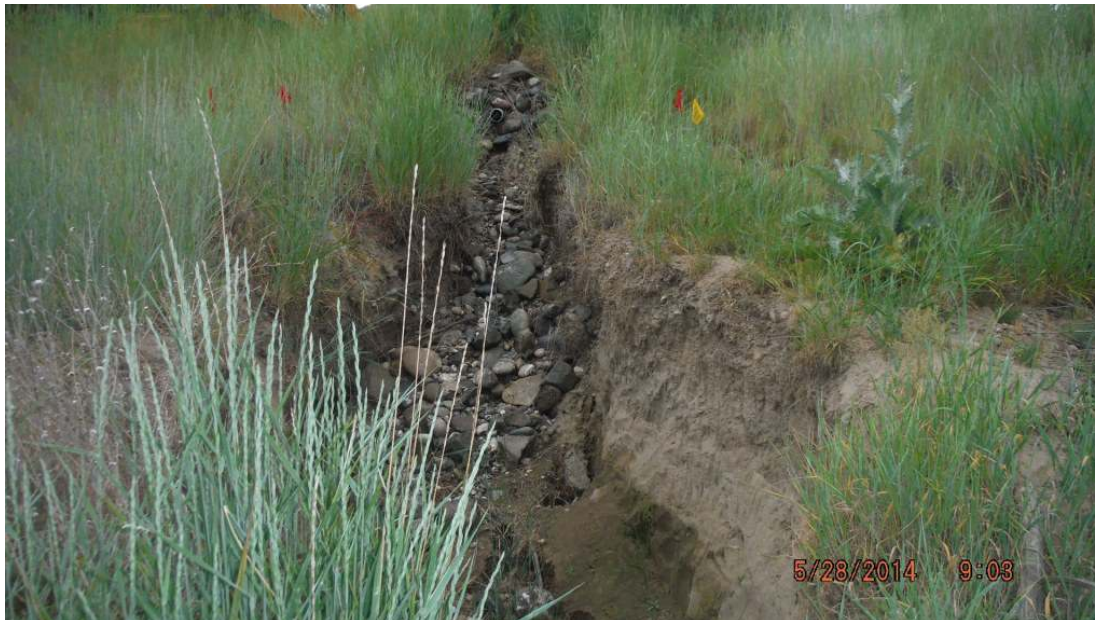
Nicklaus Dr.

Over the course of time and constant water flow, the pipe outlet eroded away a considerable sized hole.

The hole was so deep in fact that it had exposed the underground utilities that run under the pipe outlet.

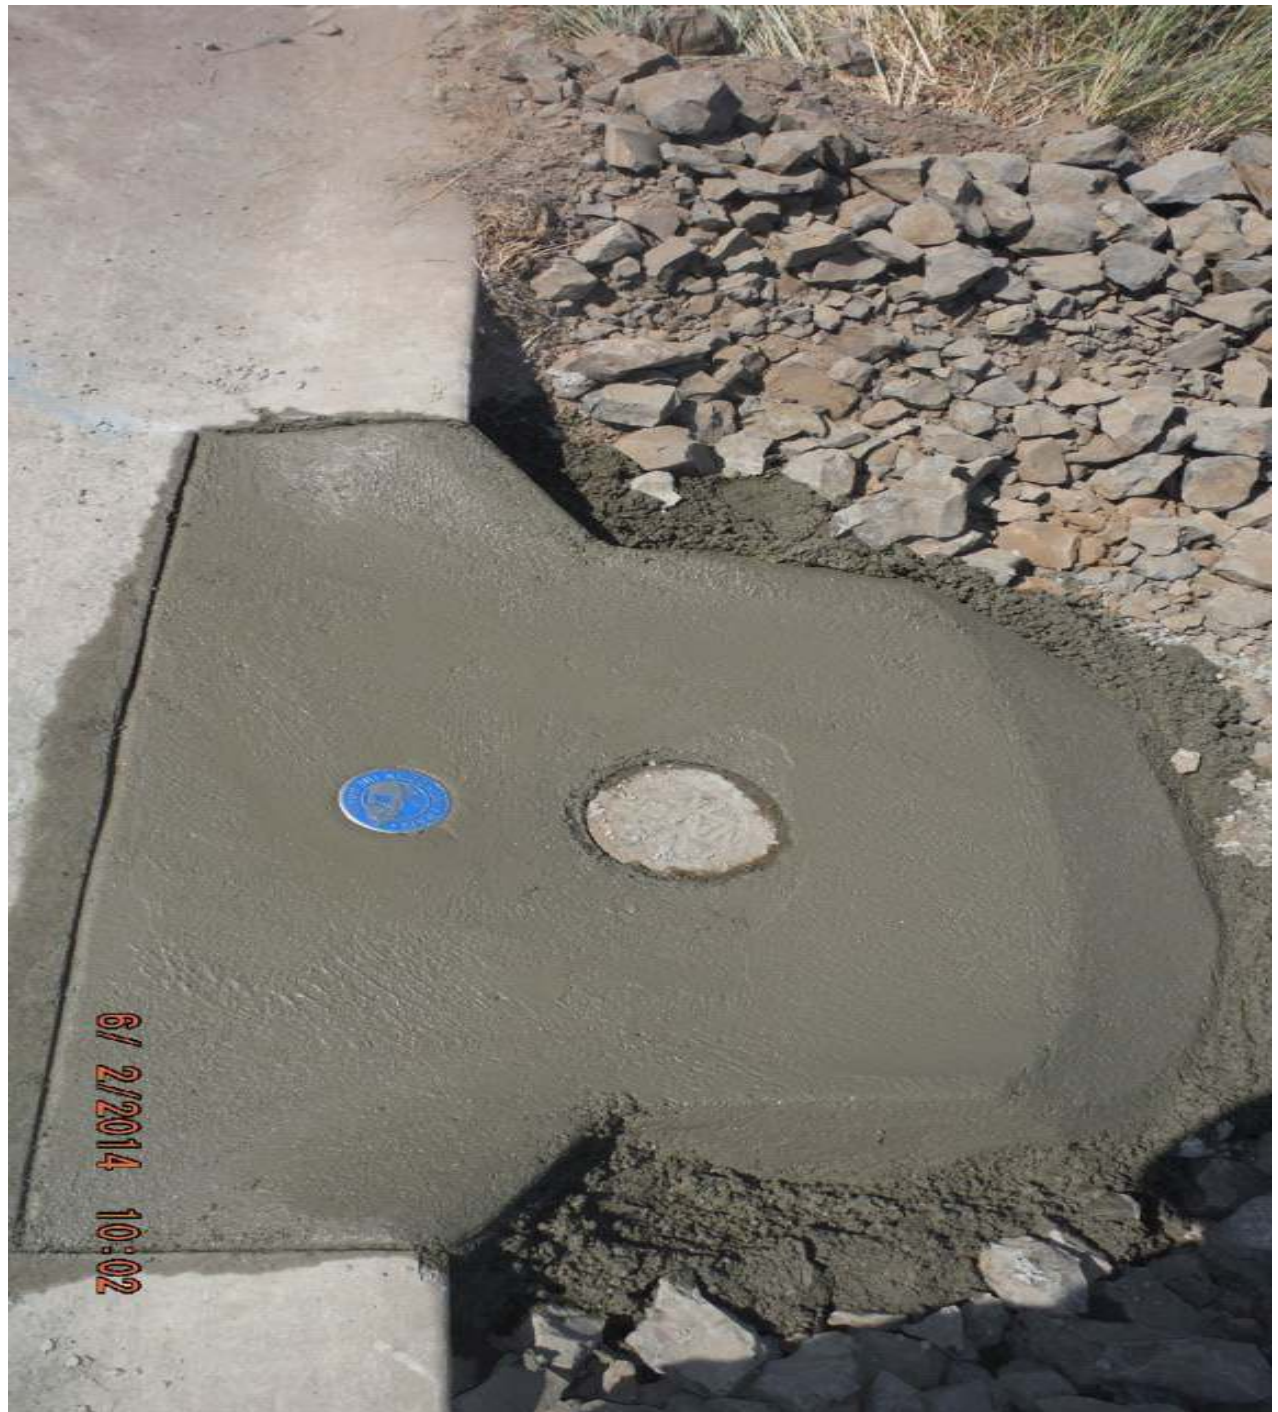
Nicklaus Dr.

A riser for a PUD water valve was dead center in the low area where the spillway needed to be.

We incorporated it into the project!
