# 2018 REGIONAL STORMWATER

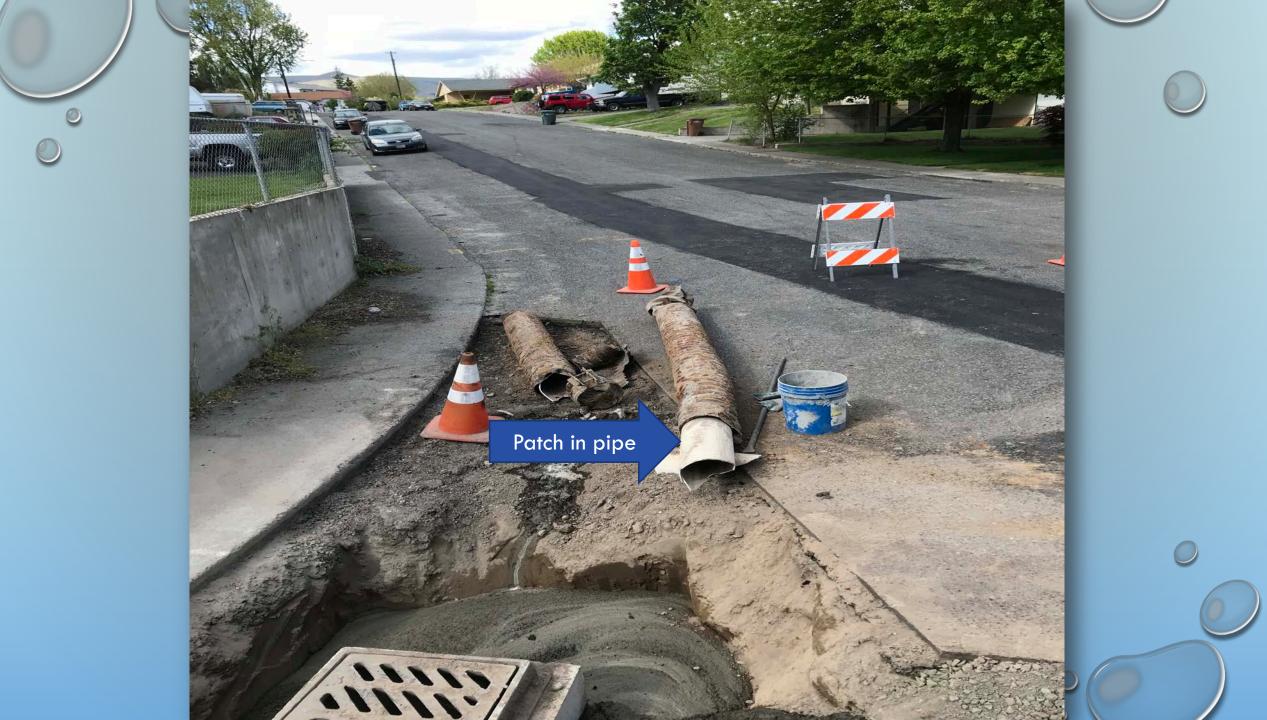
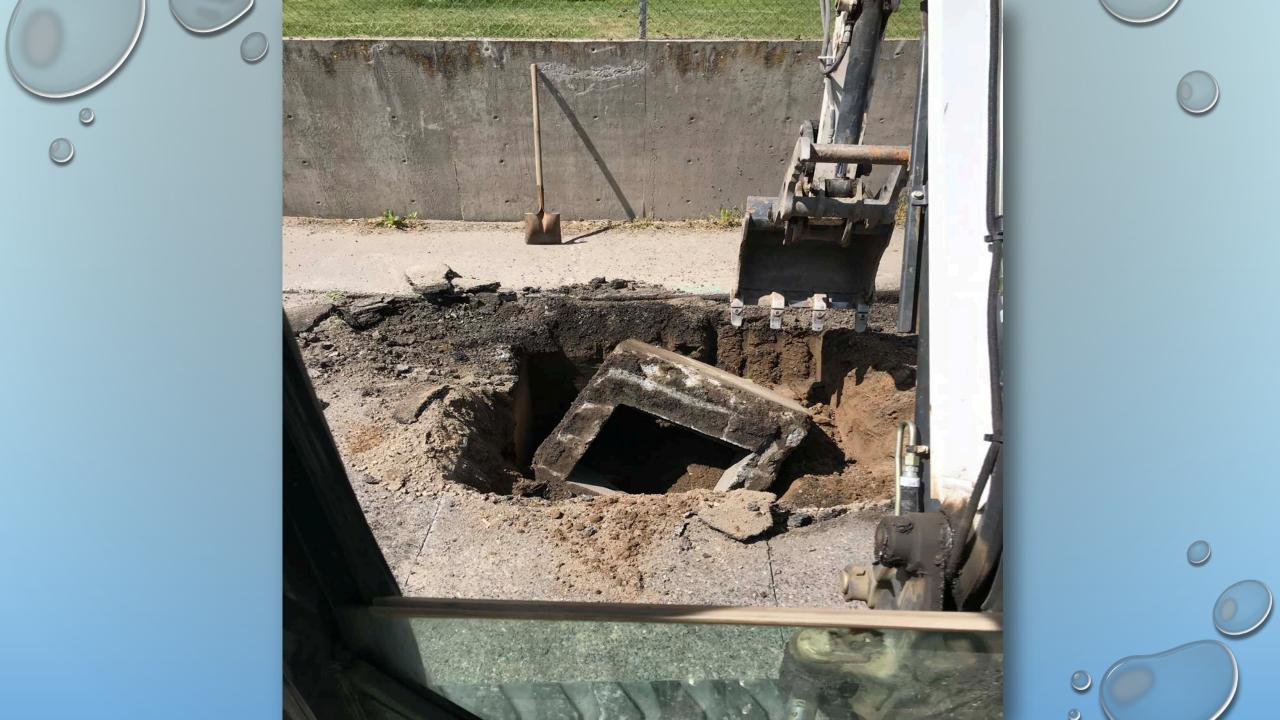
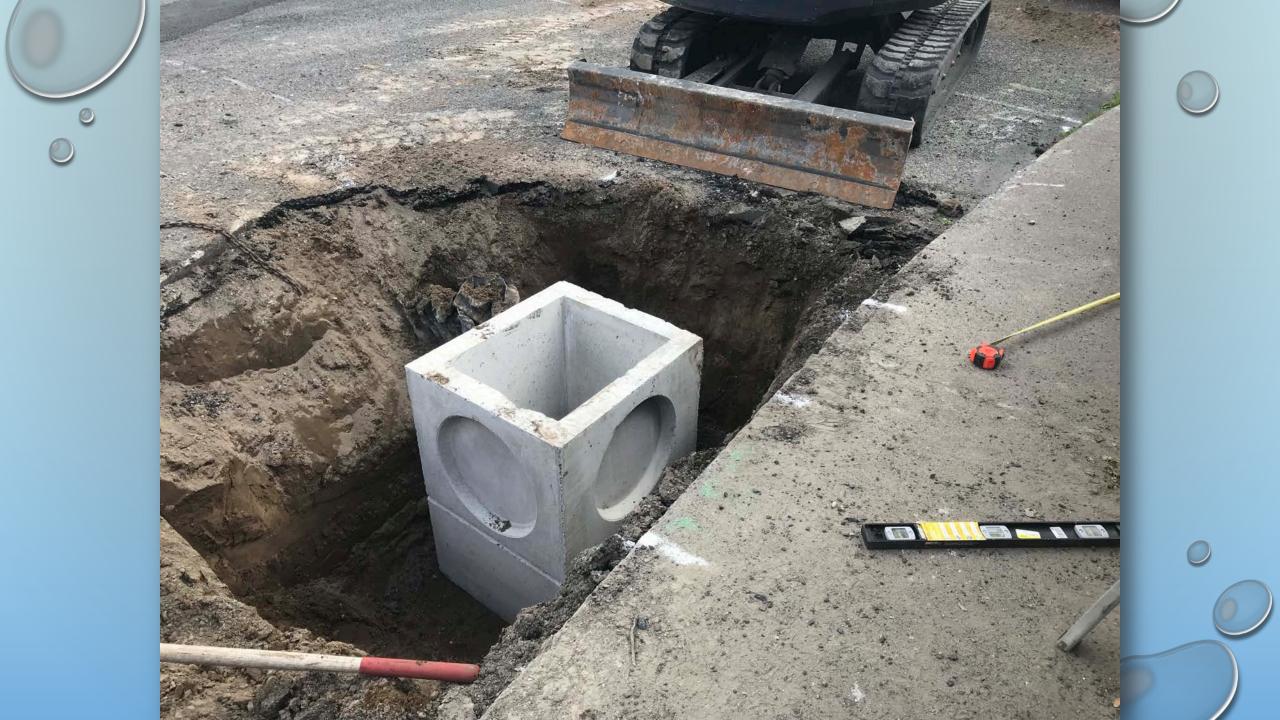
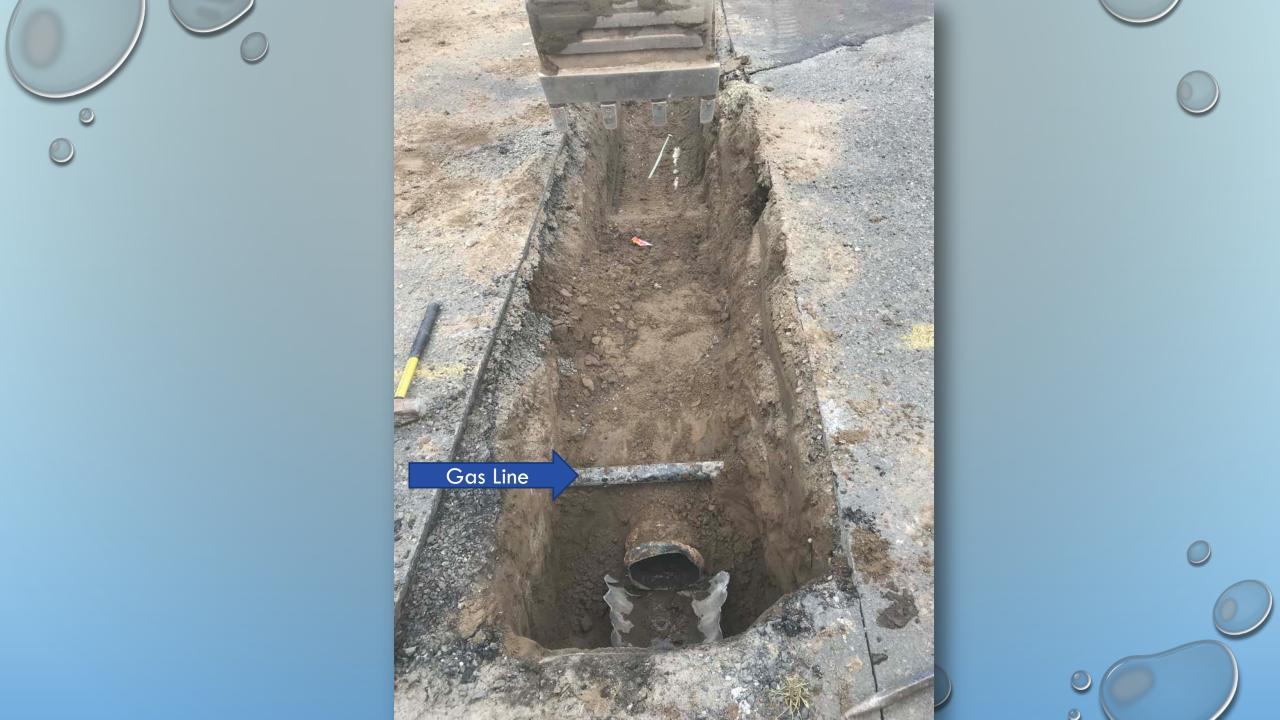
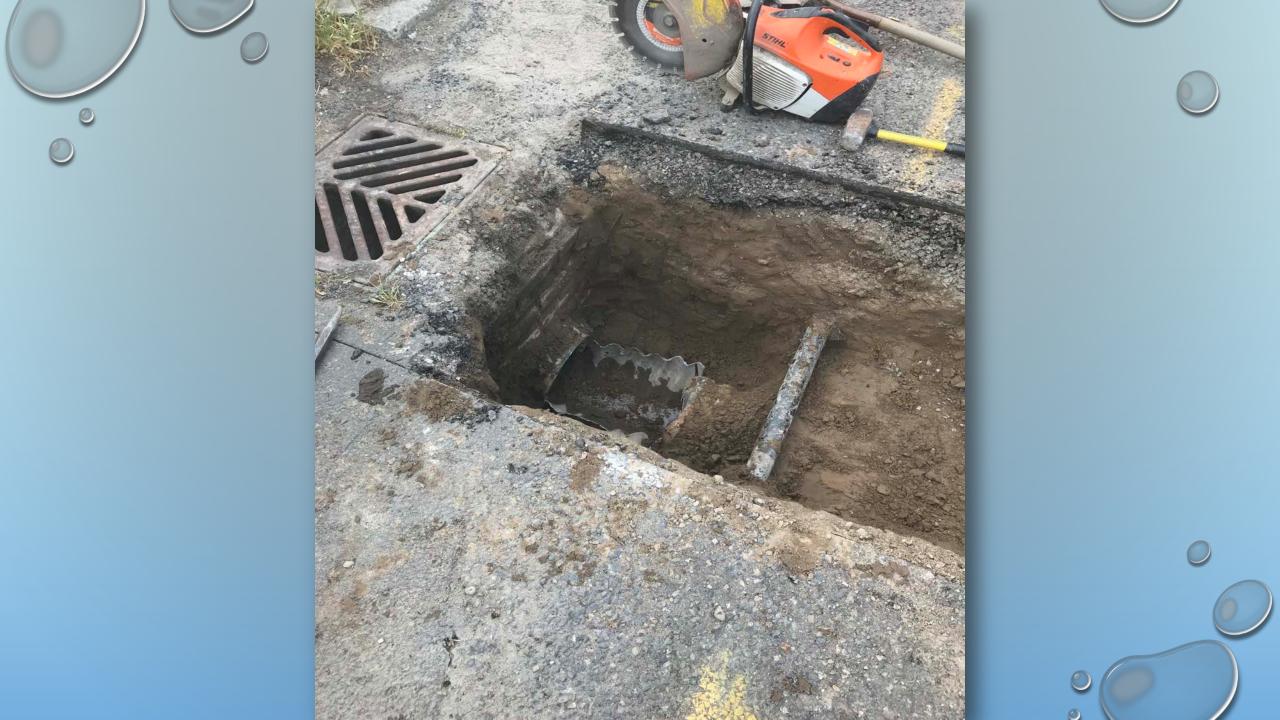
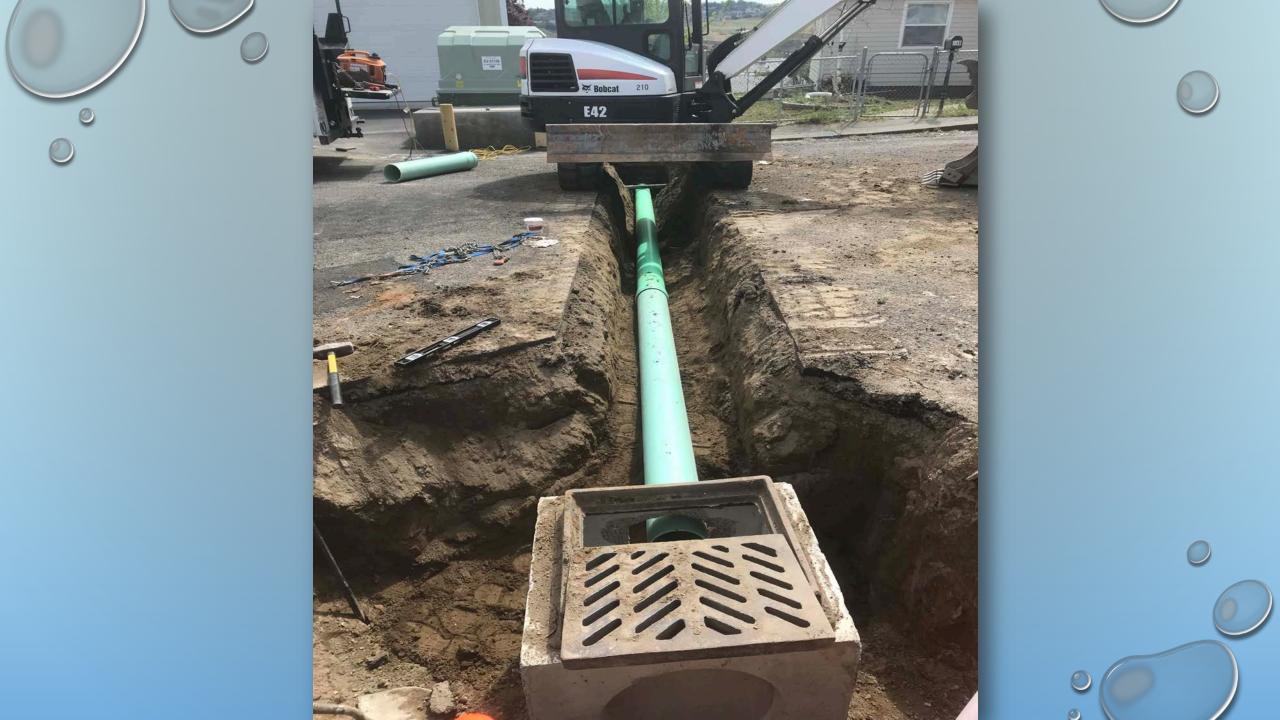
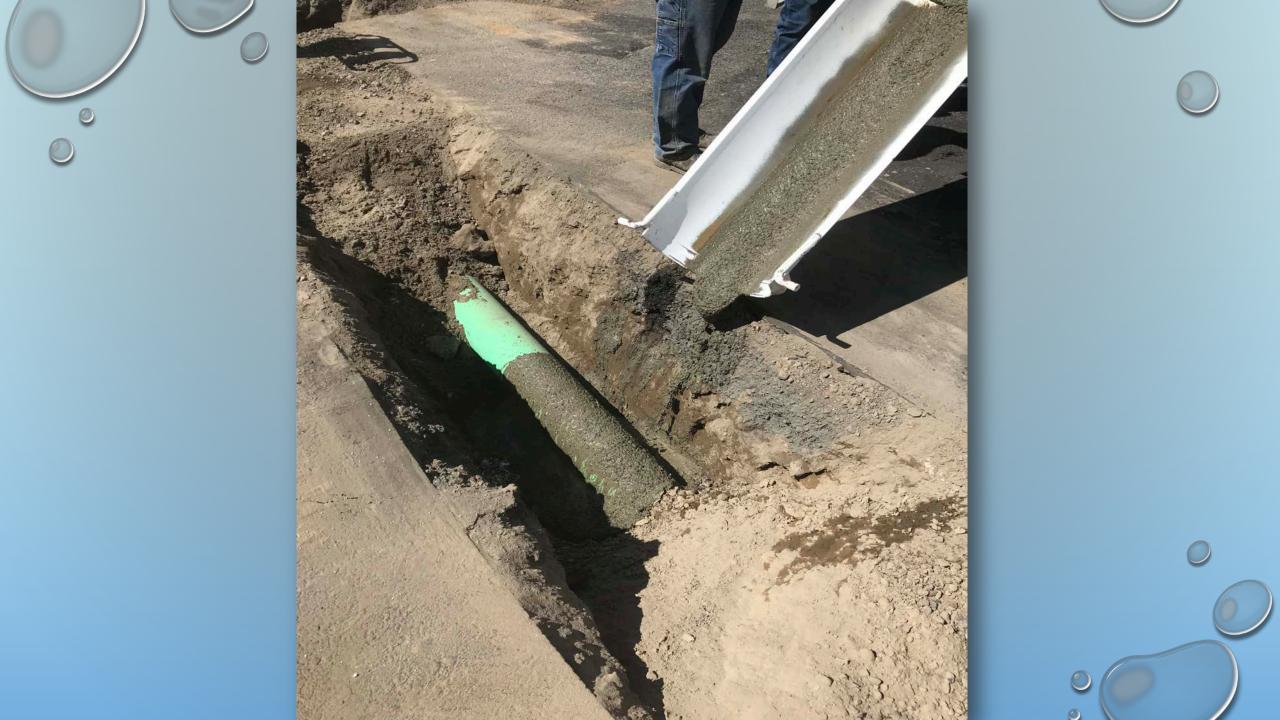
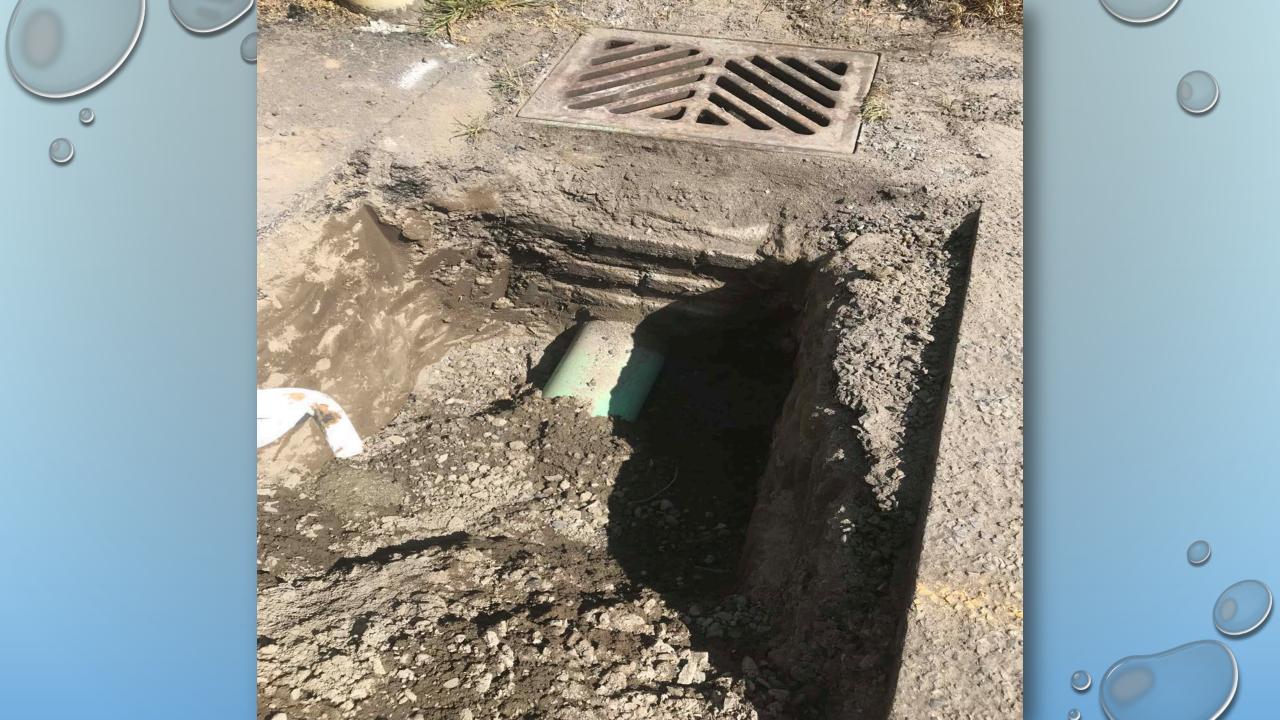
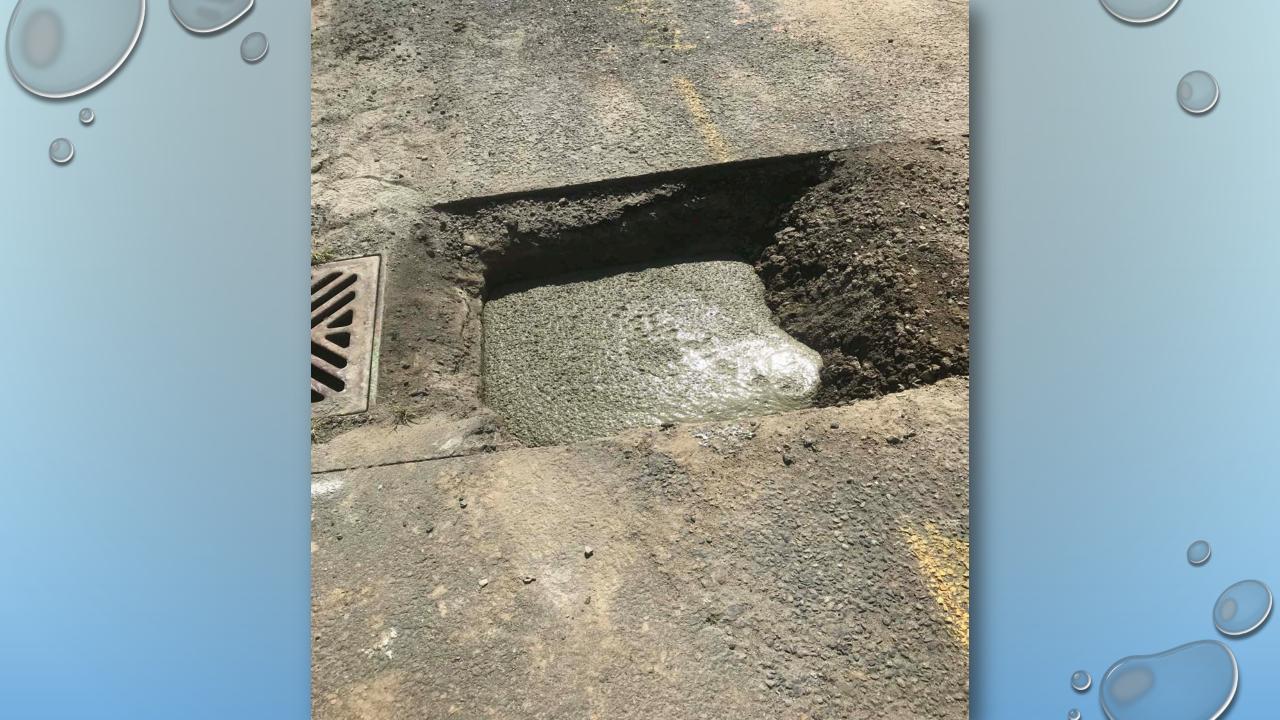
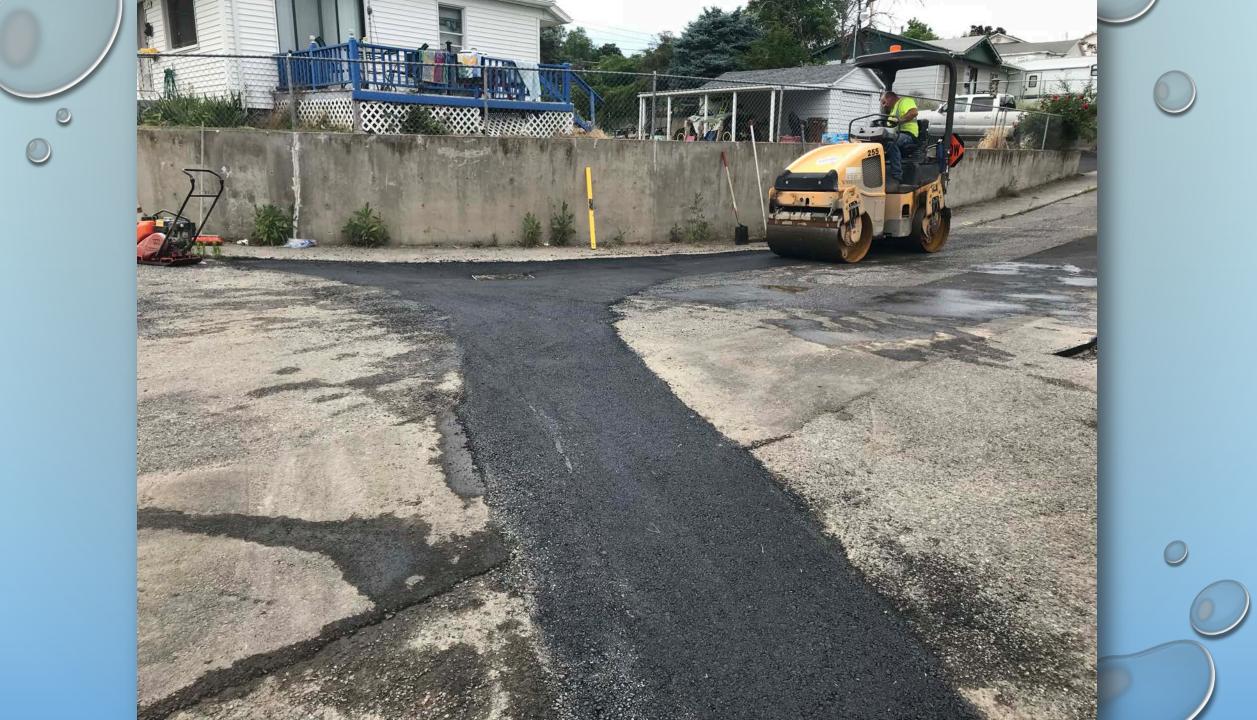
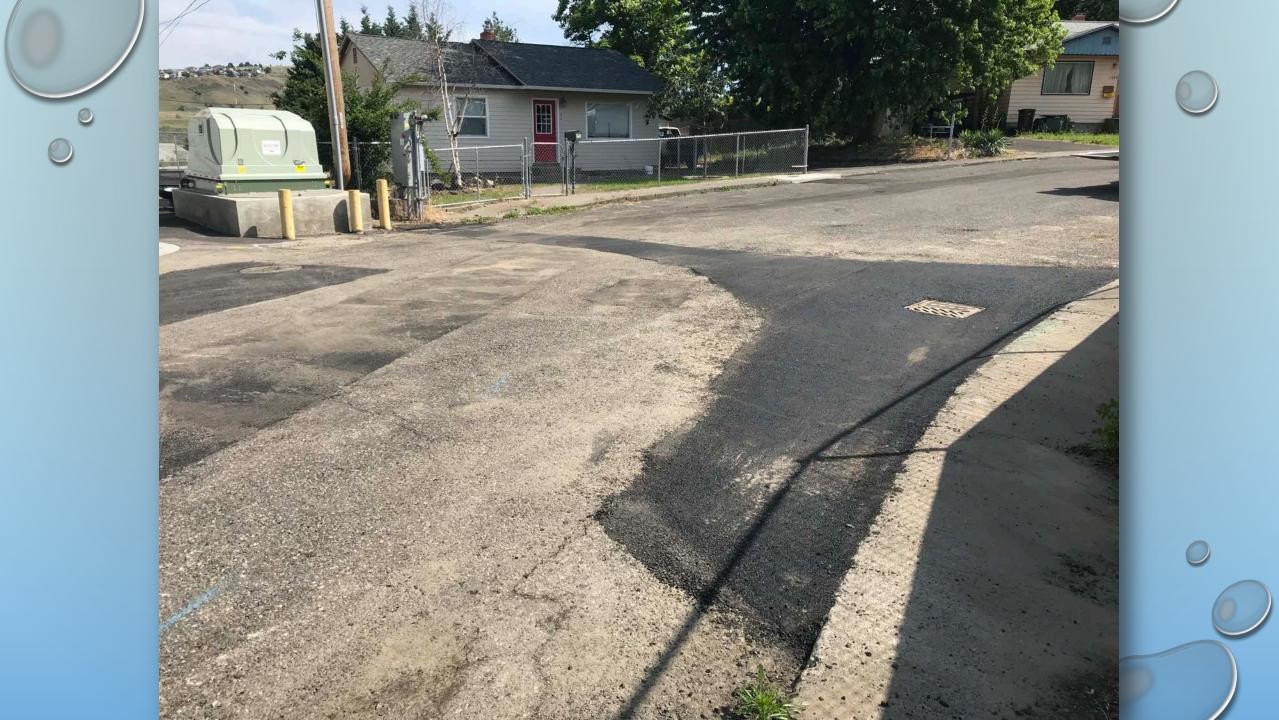
# SUNRISE DRIVE

PIPE WAS PATCHED YEARS AGO AND ALLOWED FOR INSUFFICIENT FLOW , ALSO PONDING BY BASIN BECAUSE ORIGINAL BASIN WAS SET TO HIGH.

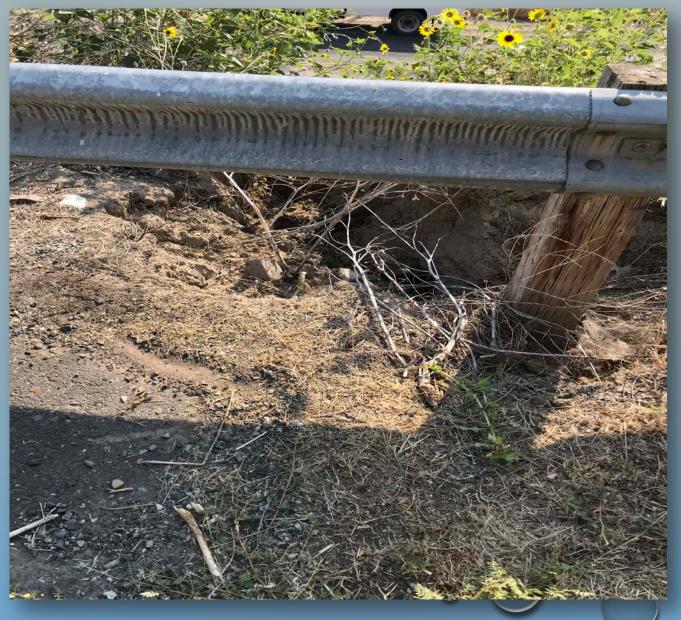
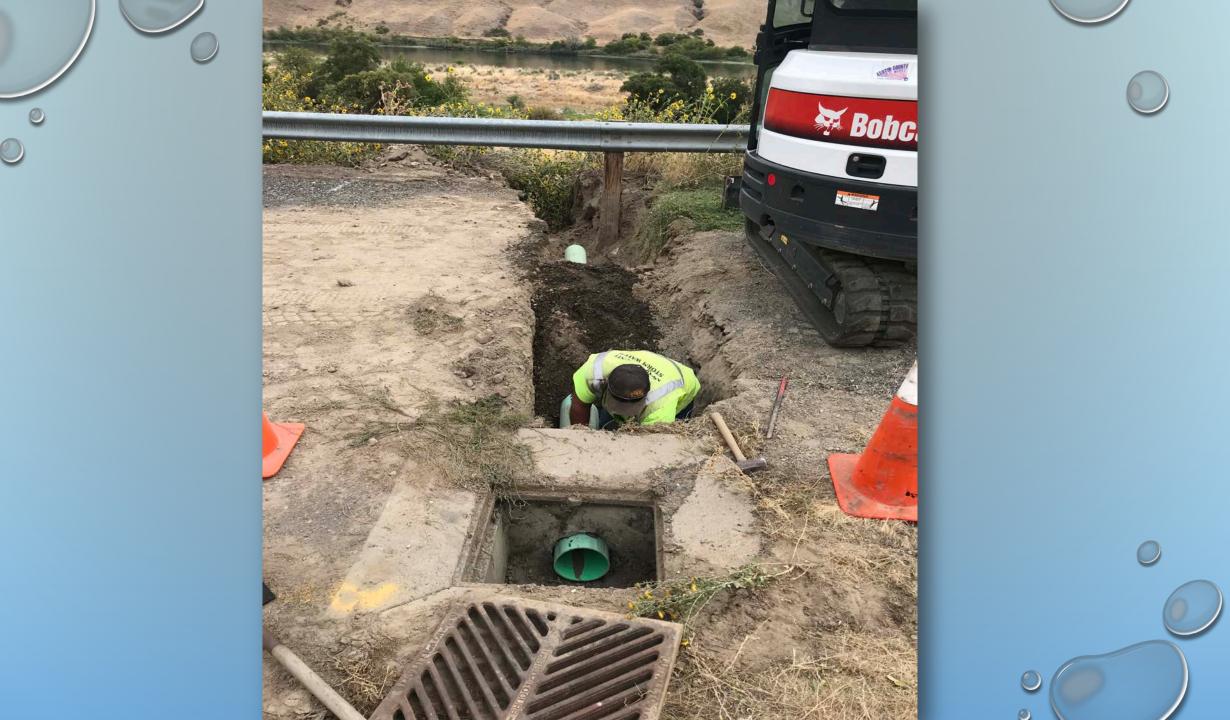
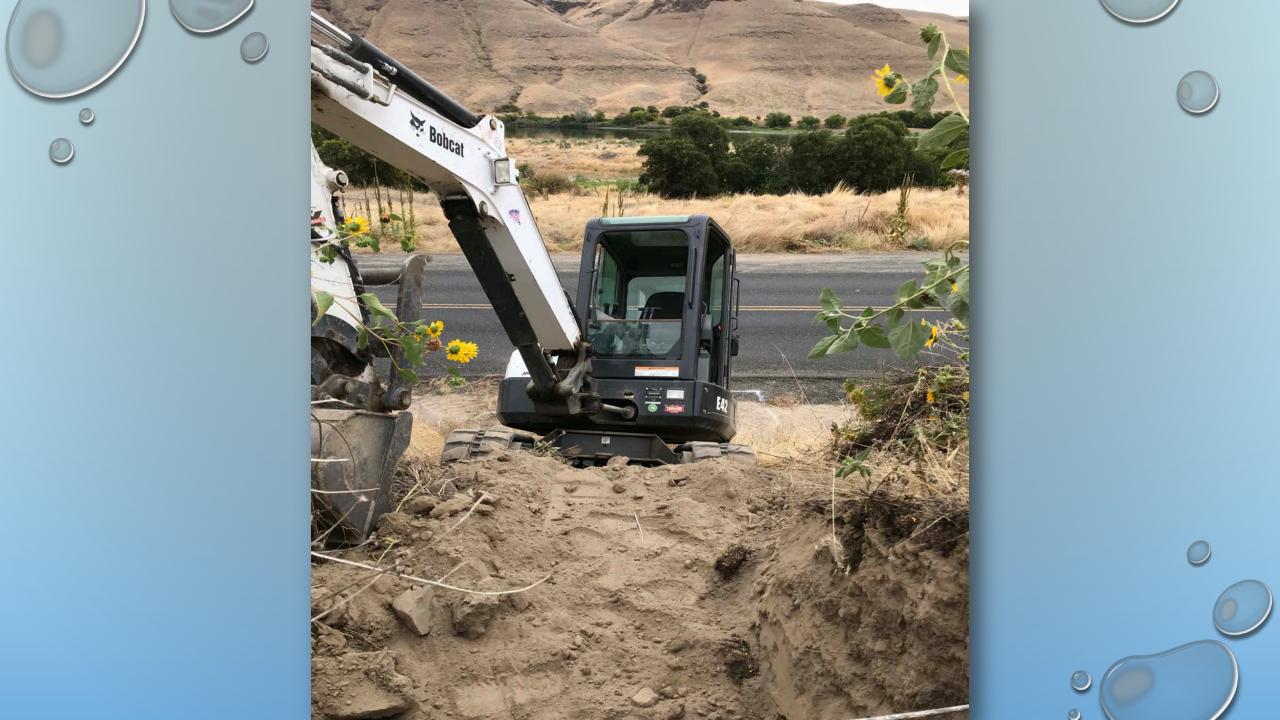
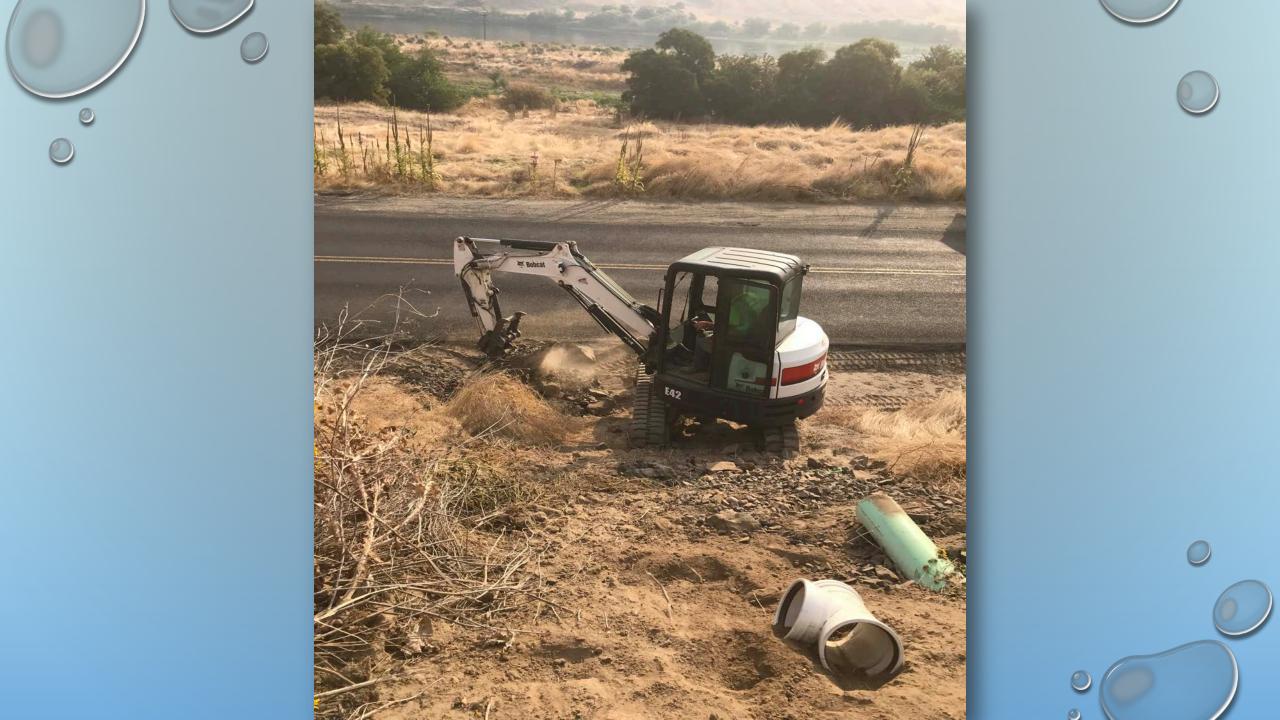
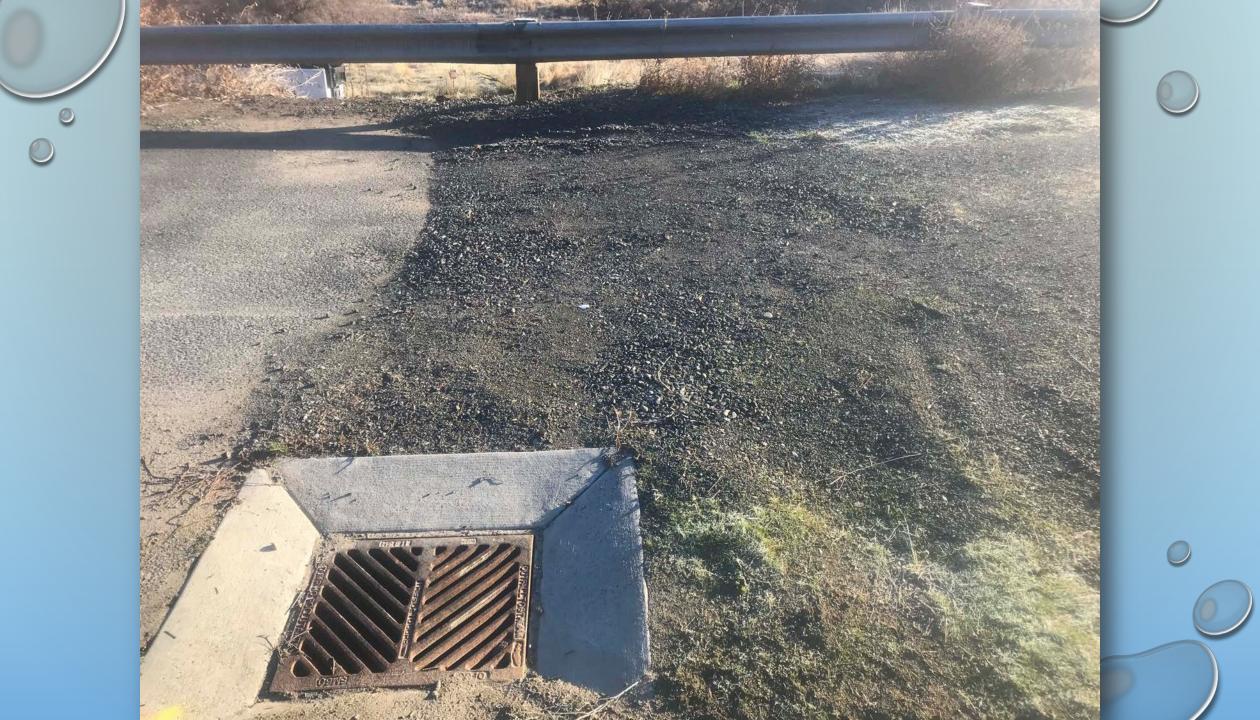
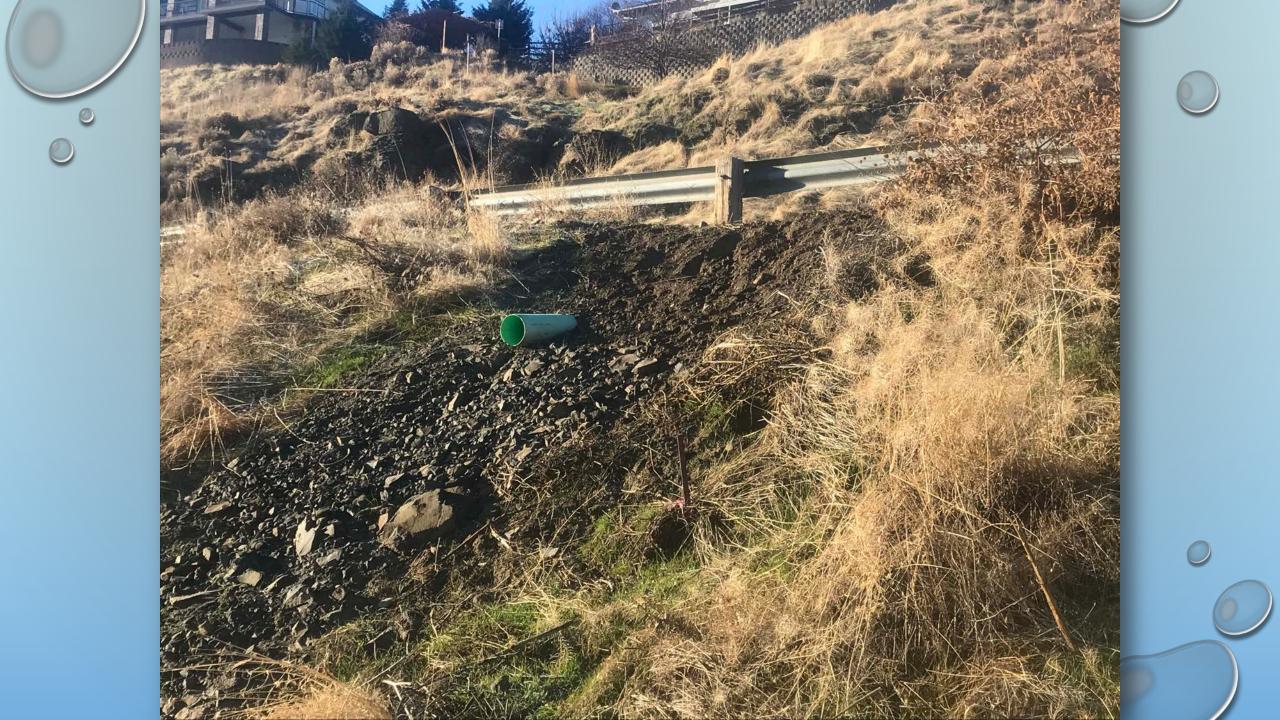
## 22 SNAKE RIVER ROAD

## GUARDRAIL POST WAS DRIVEN THROUGH PIPE , CAUSING EROSION
