# 2018 REGIONAL STORMWATER

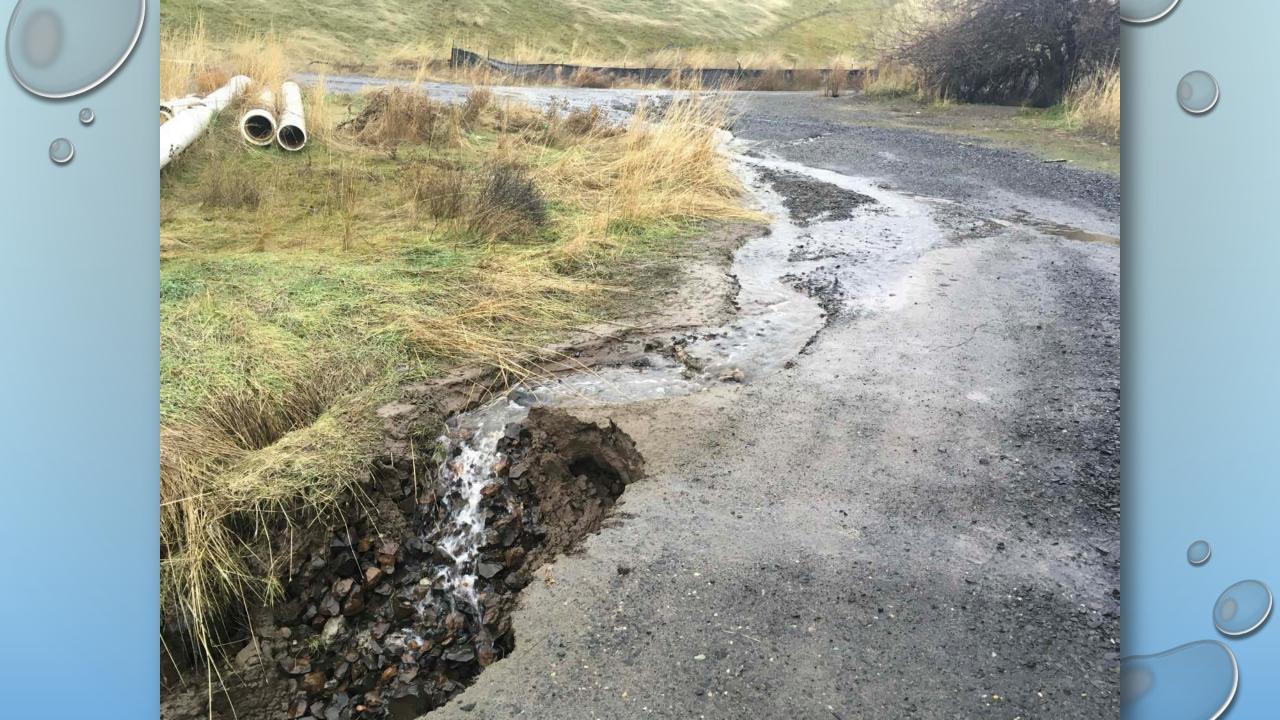
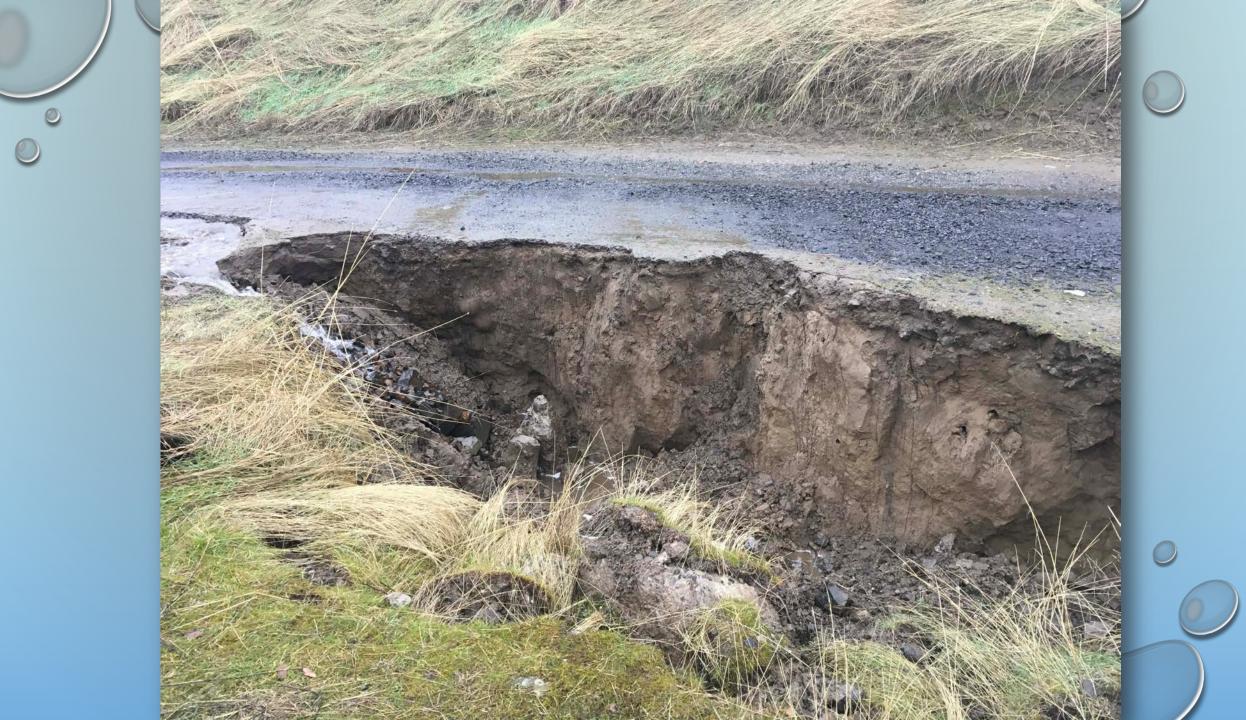
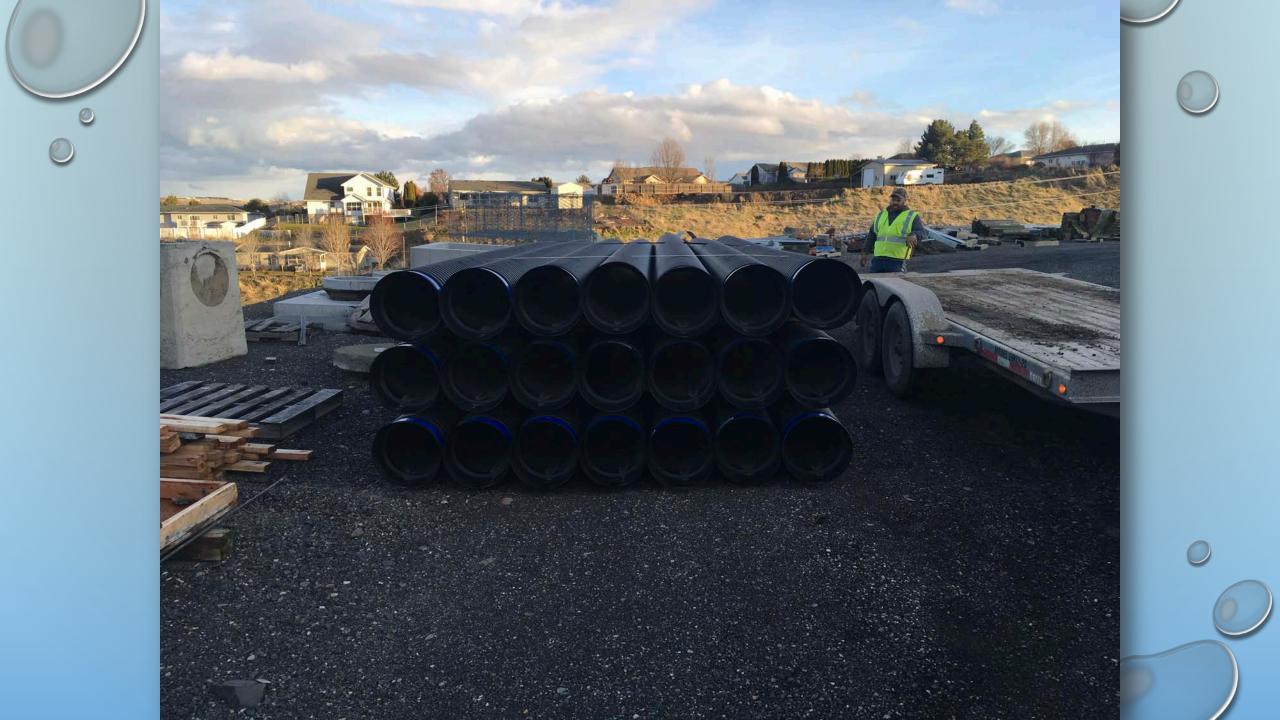
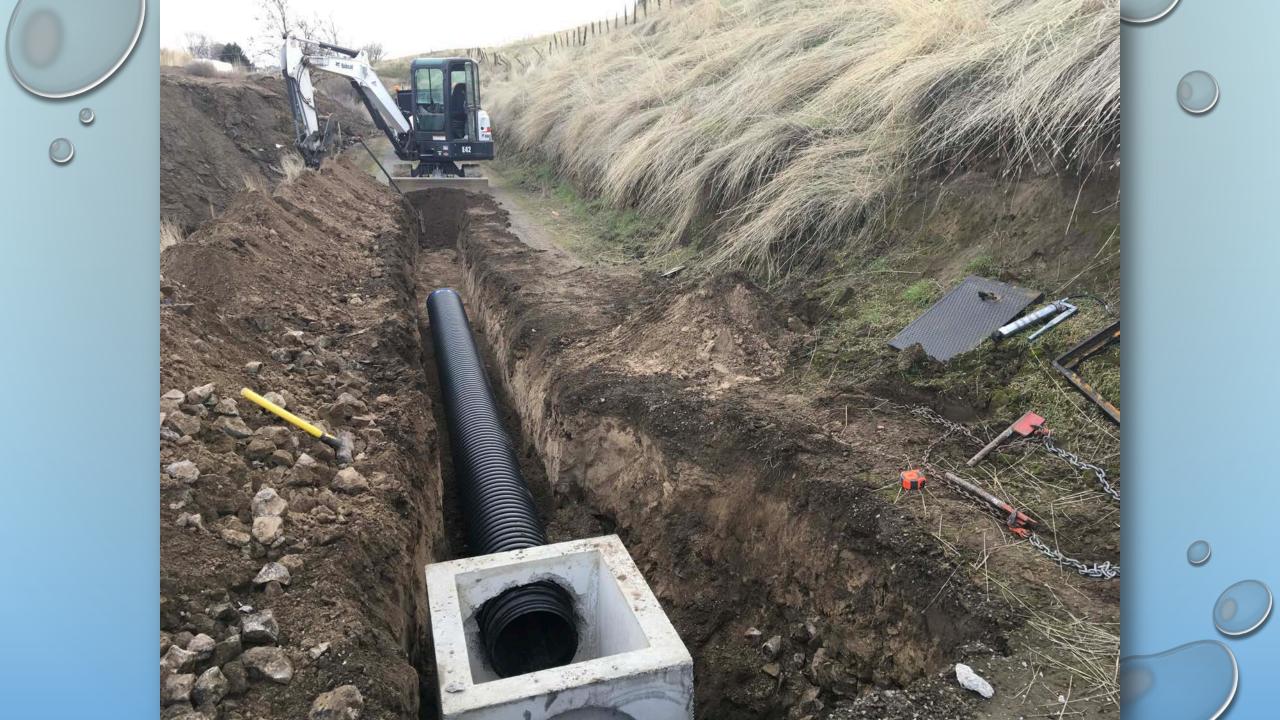
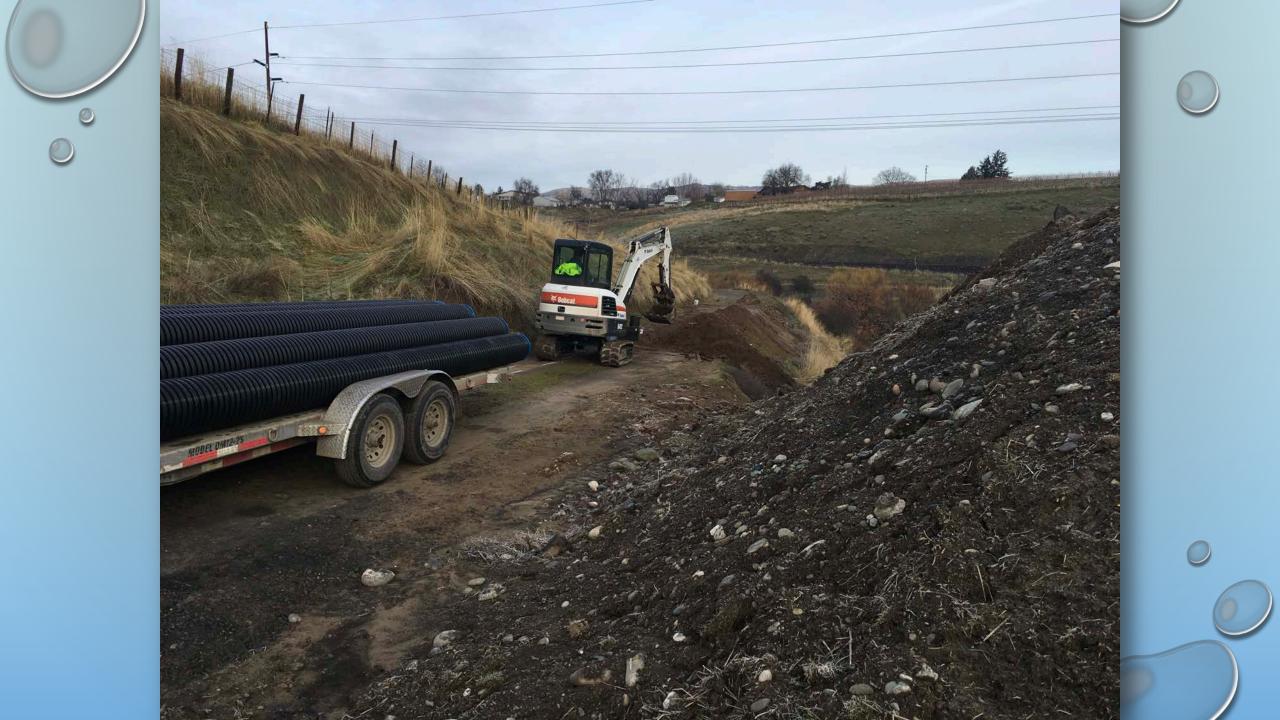
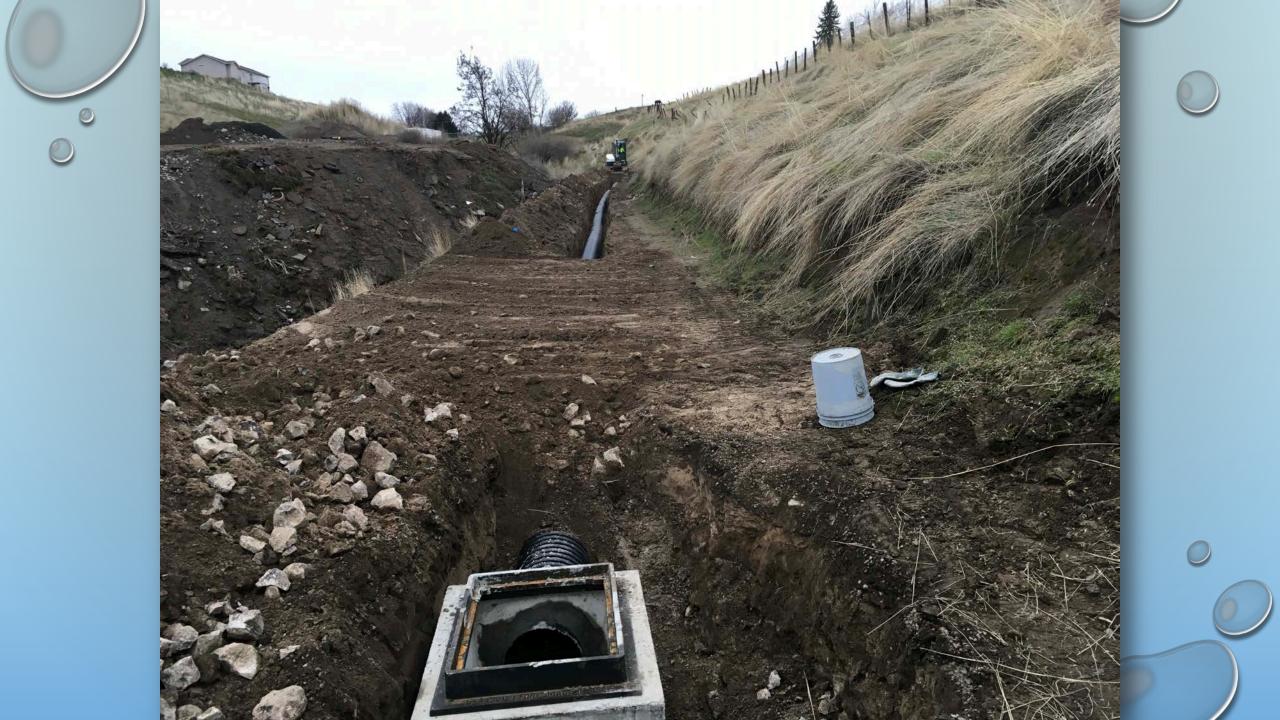
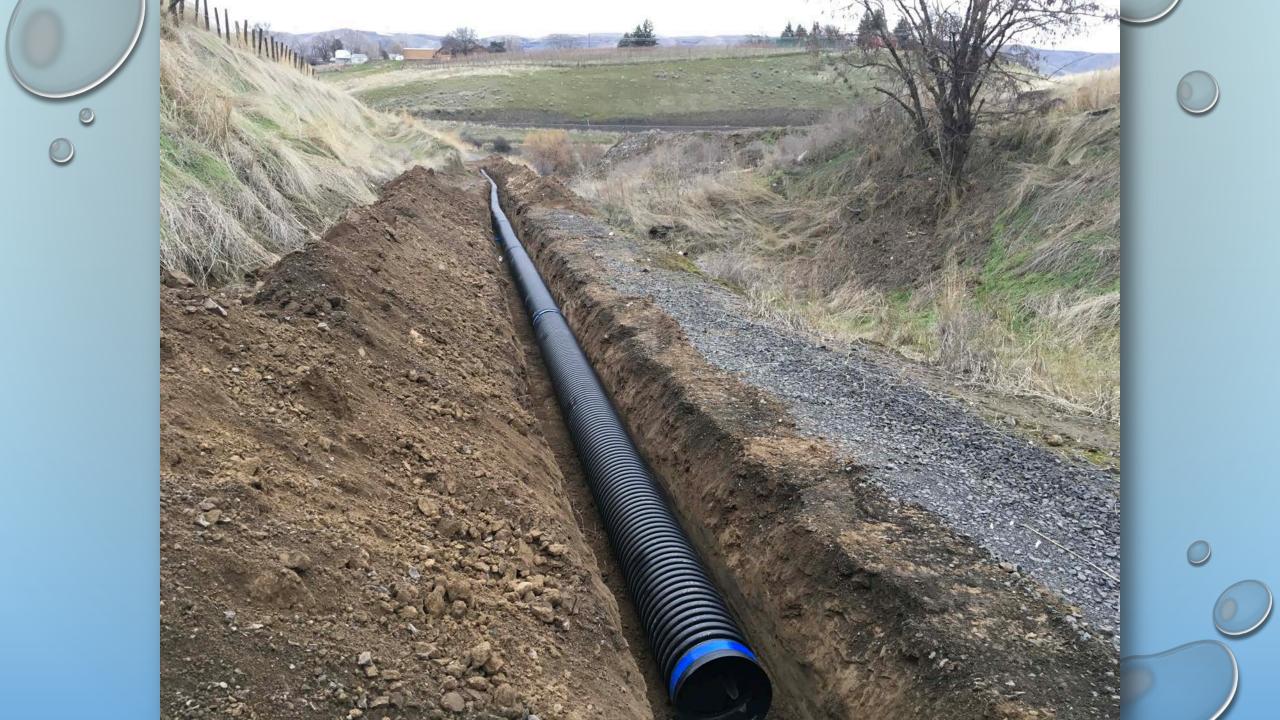
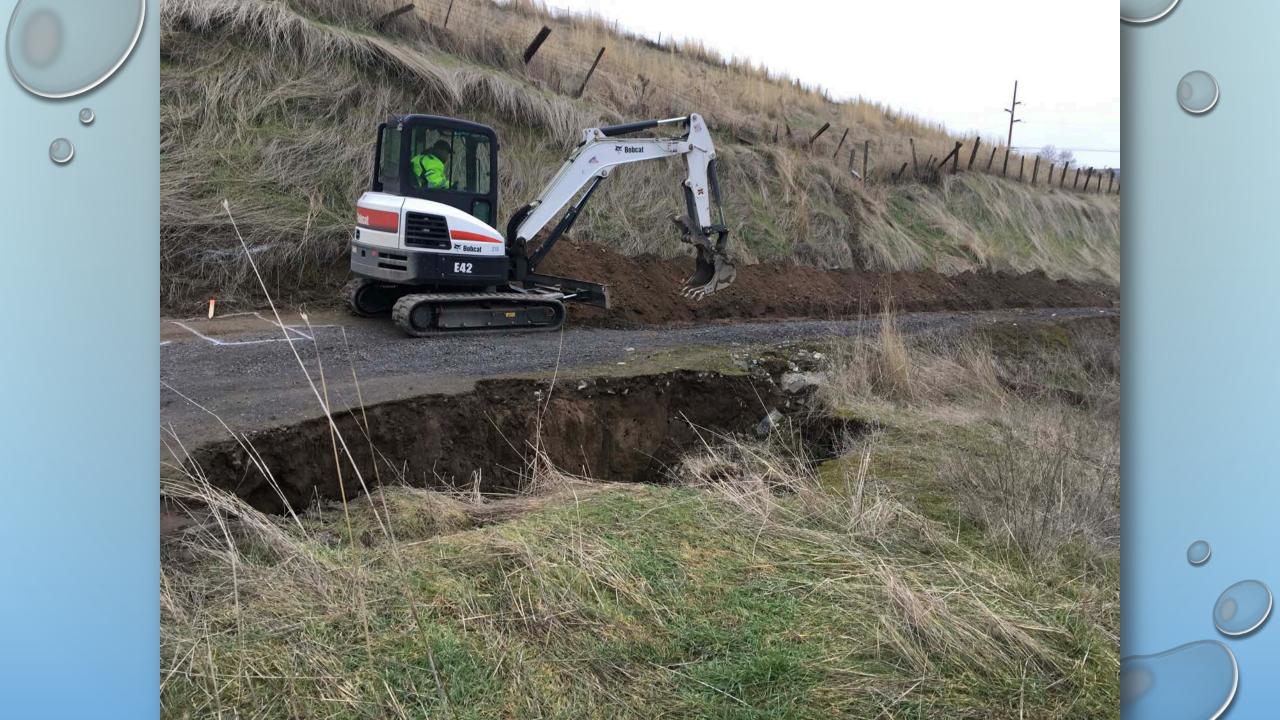
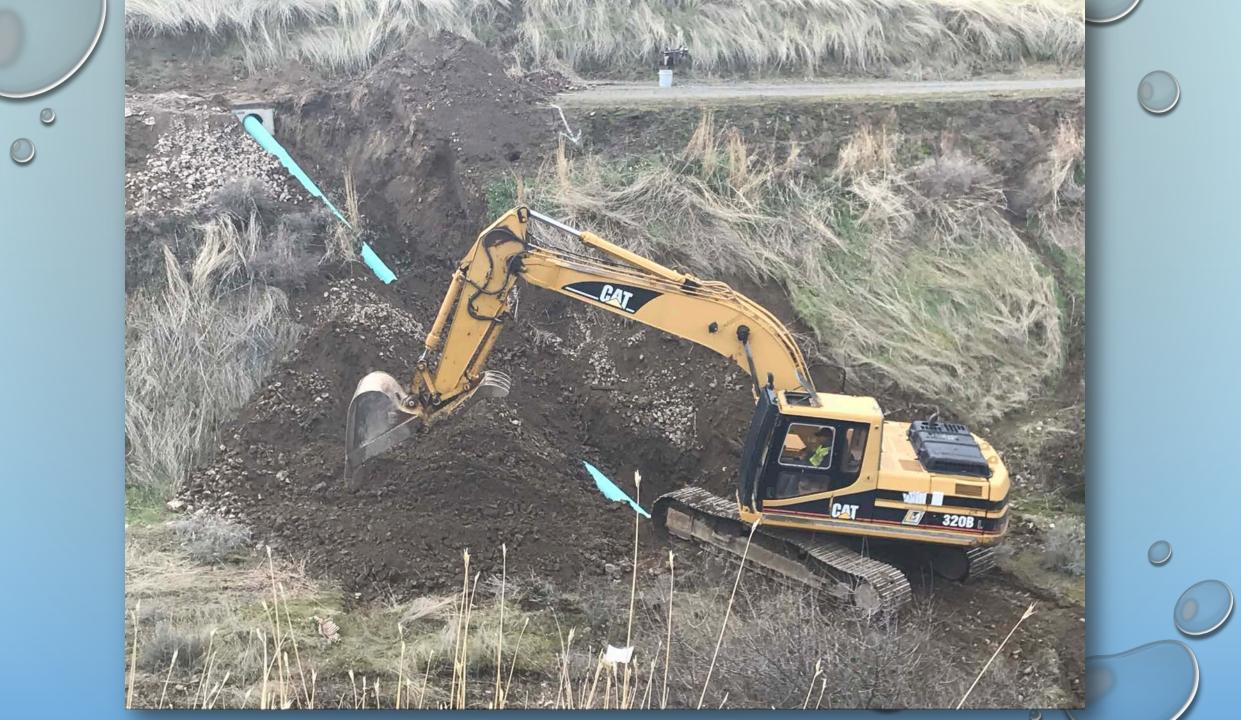
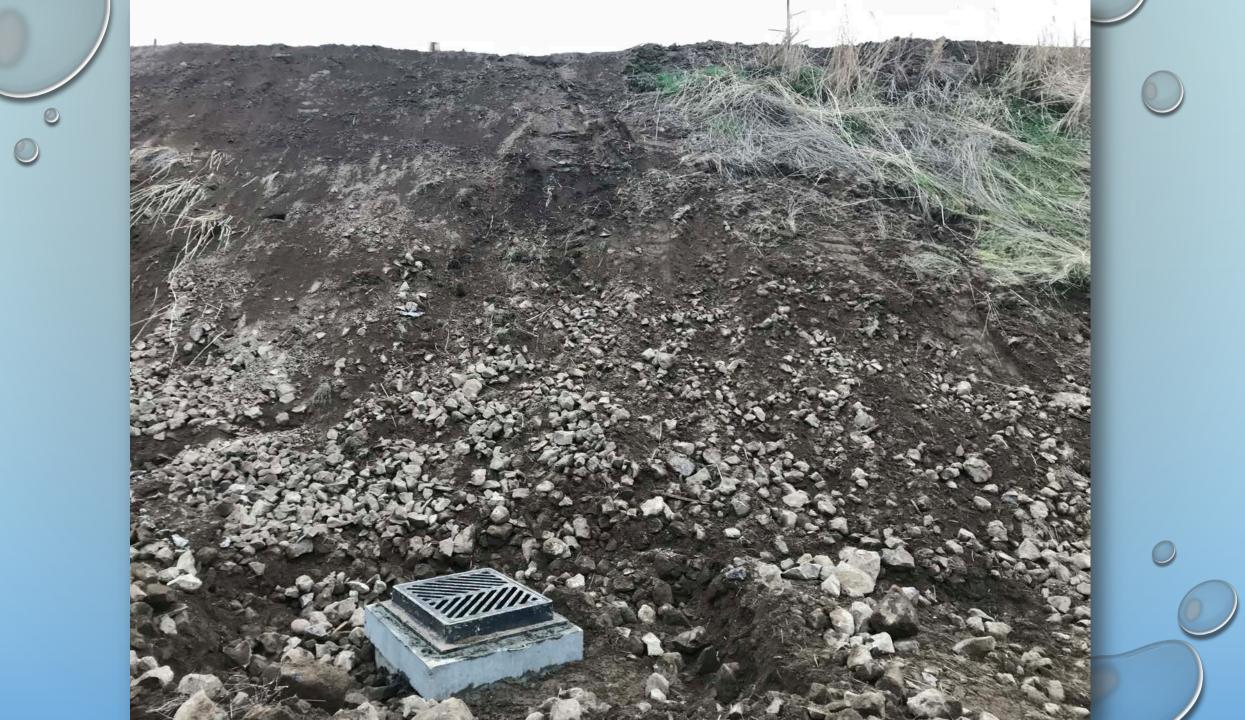
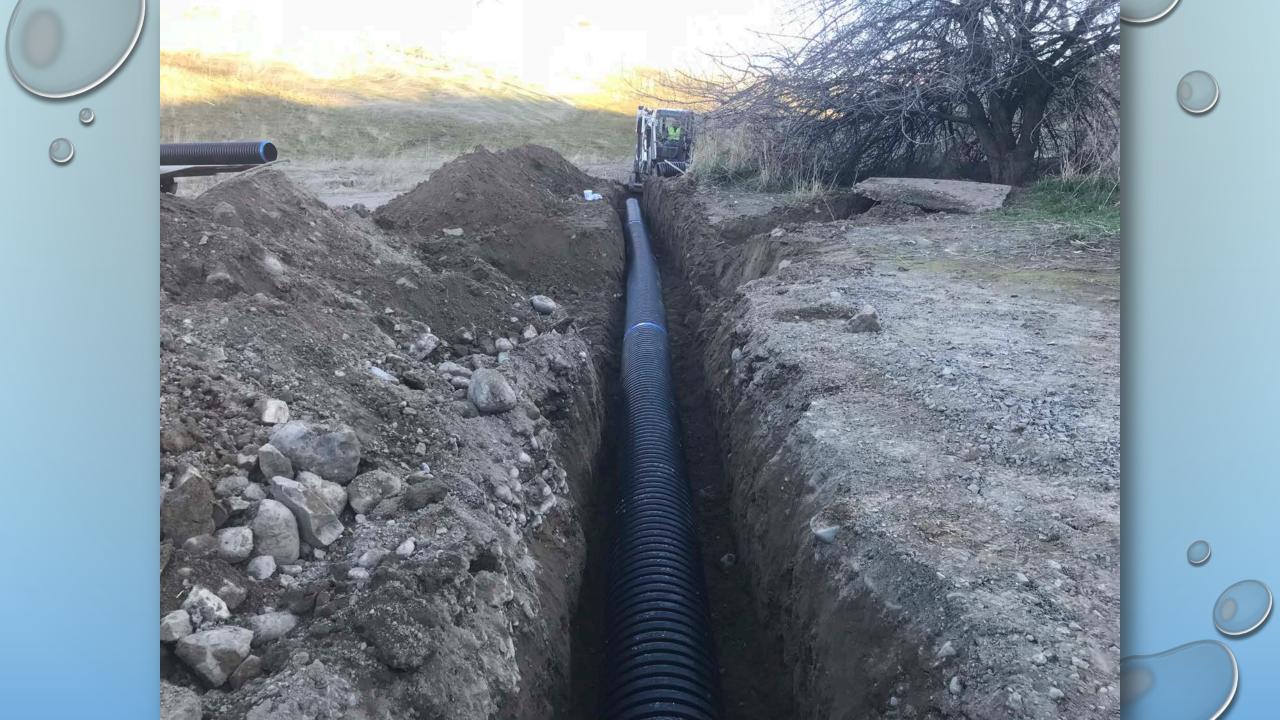
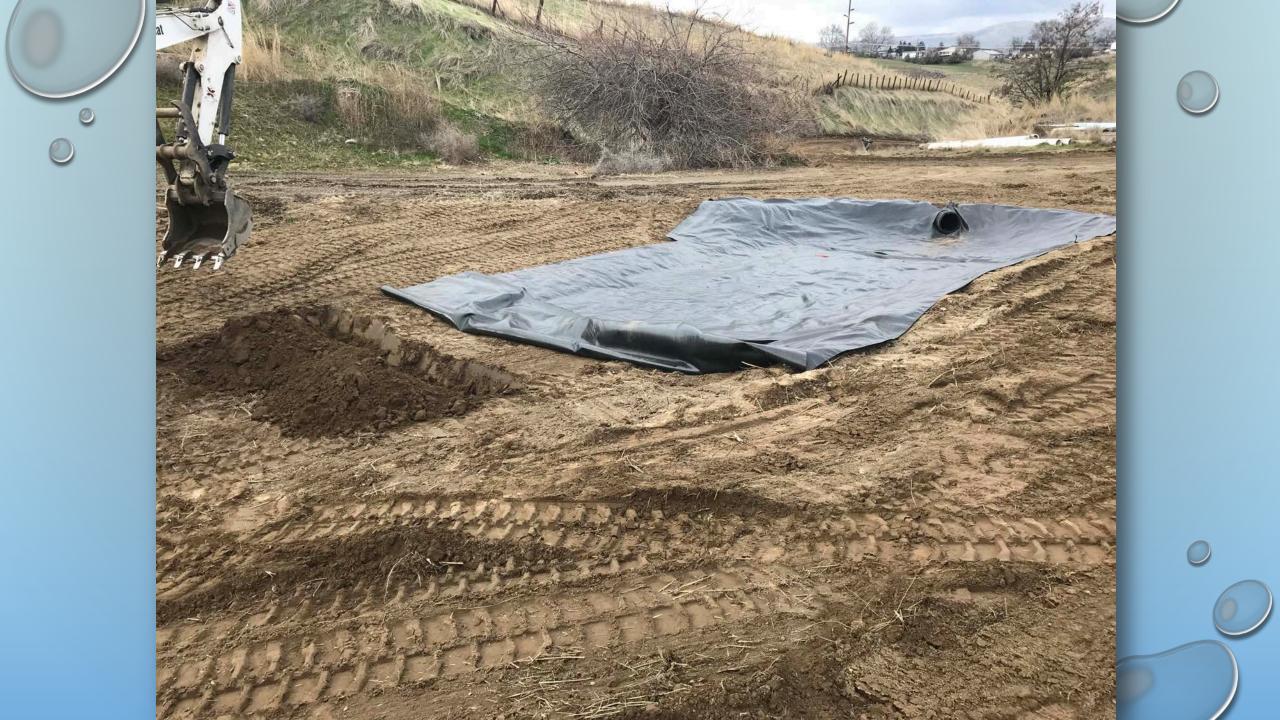
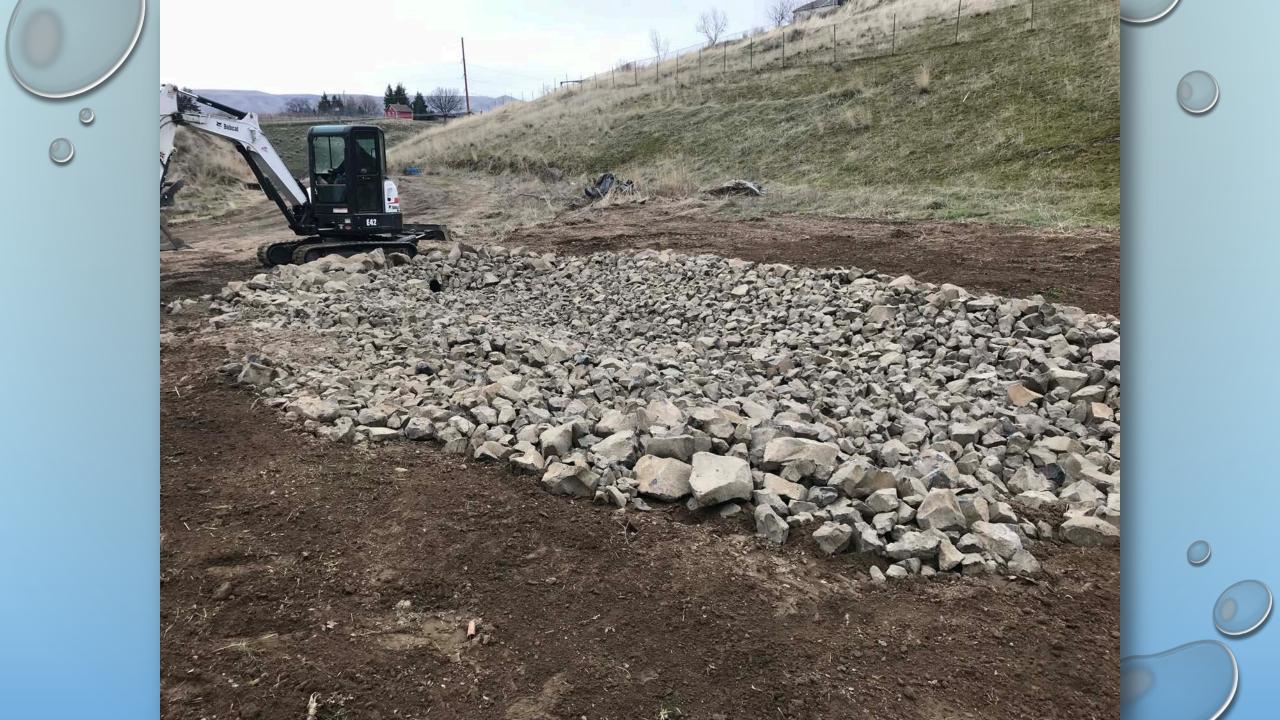
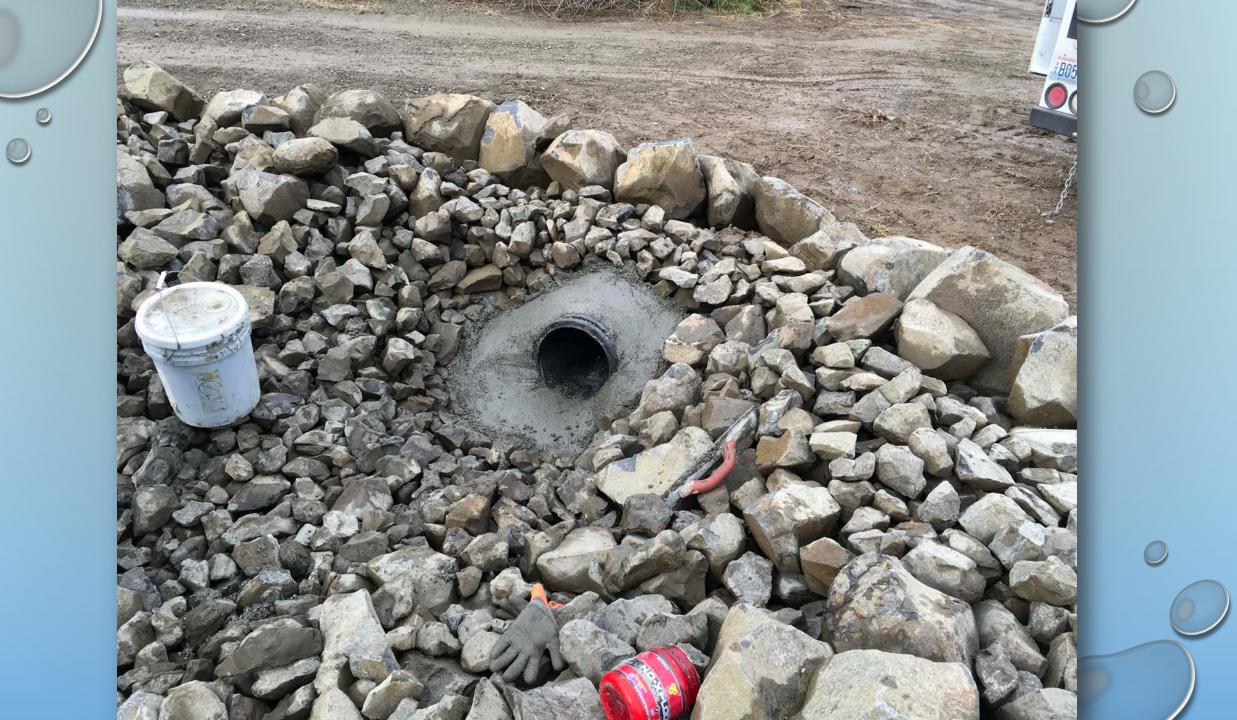
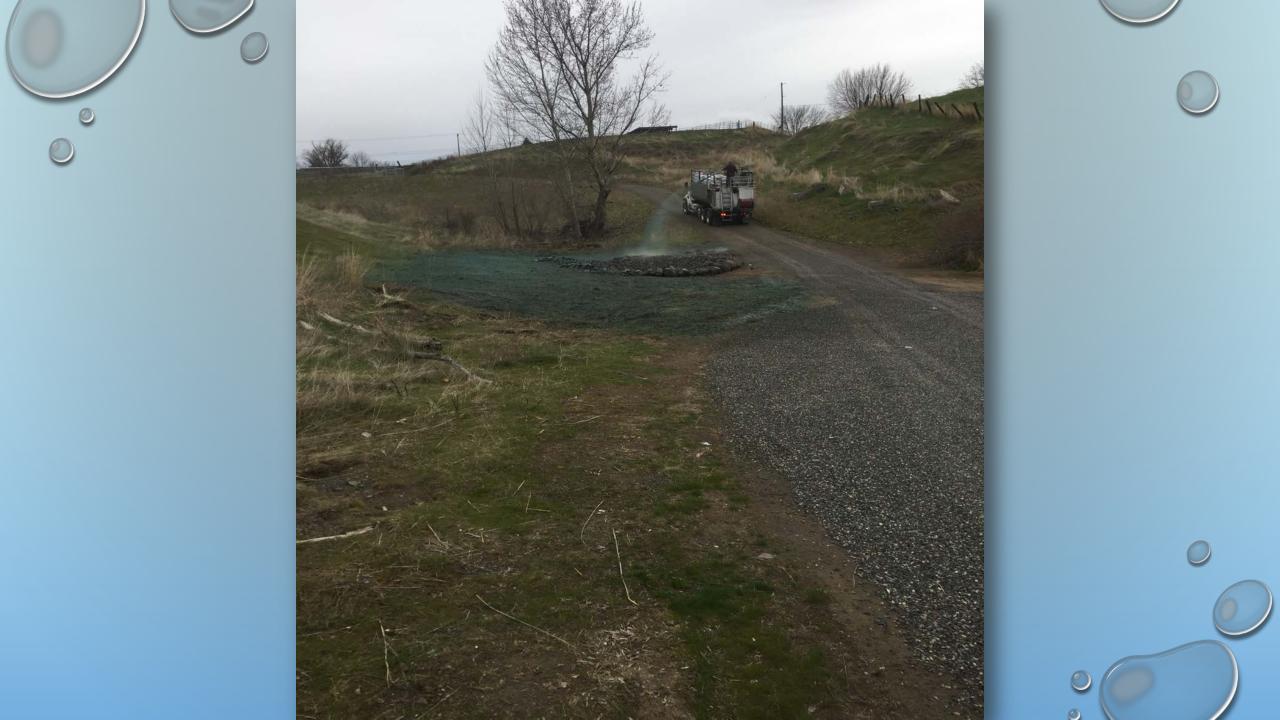
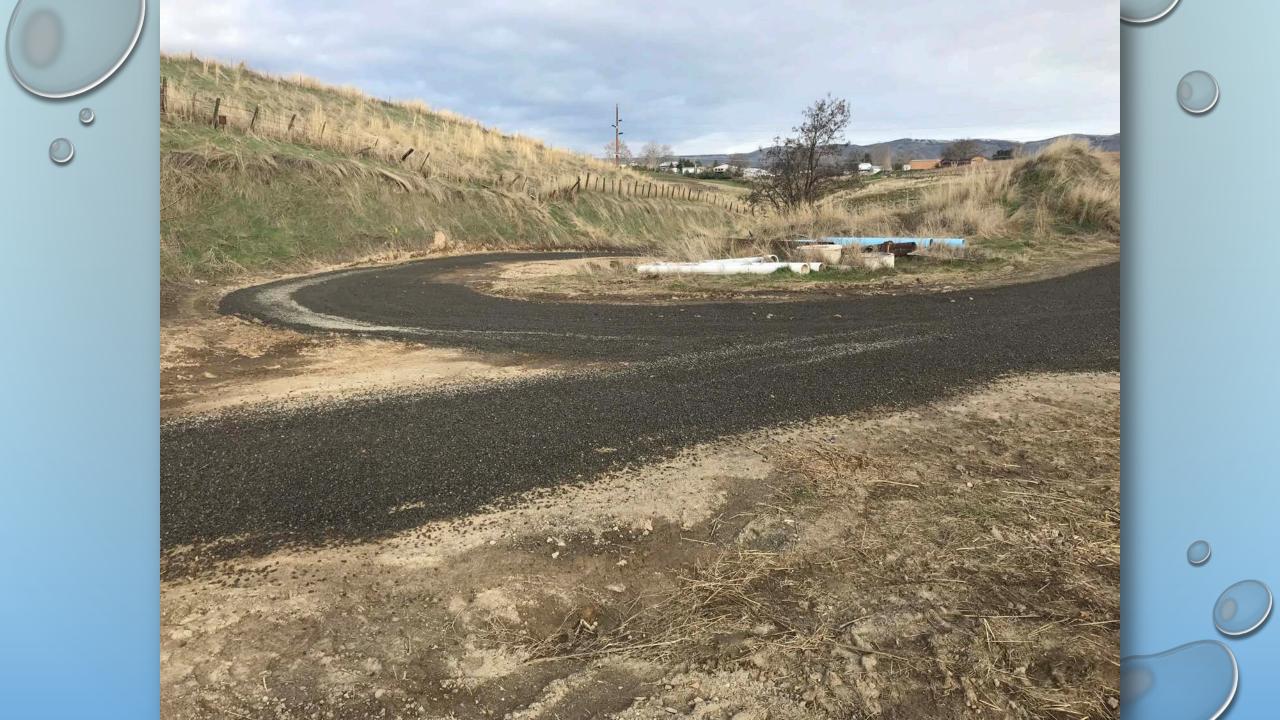
# RIDGEVIEW ACCESS ROAD

POND OVERFLOW WATER FROM ABOVE CAUSING MAJOR EROSION, WITH NO SYSTEM BELOW TO CONVEY THE WATER

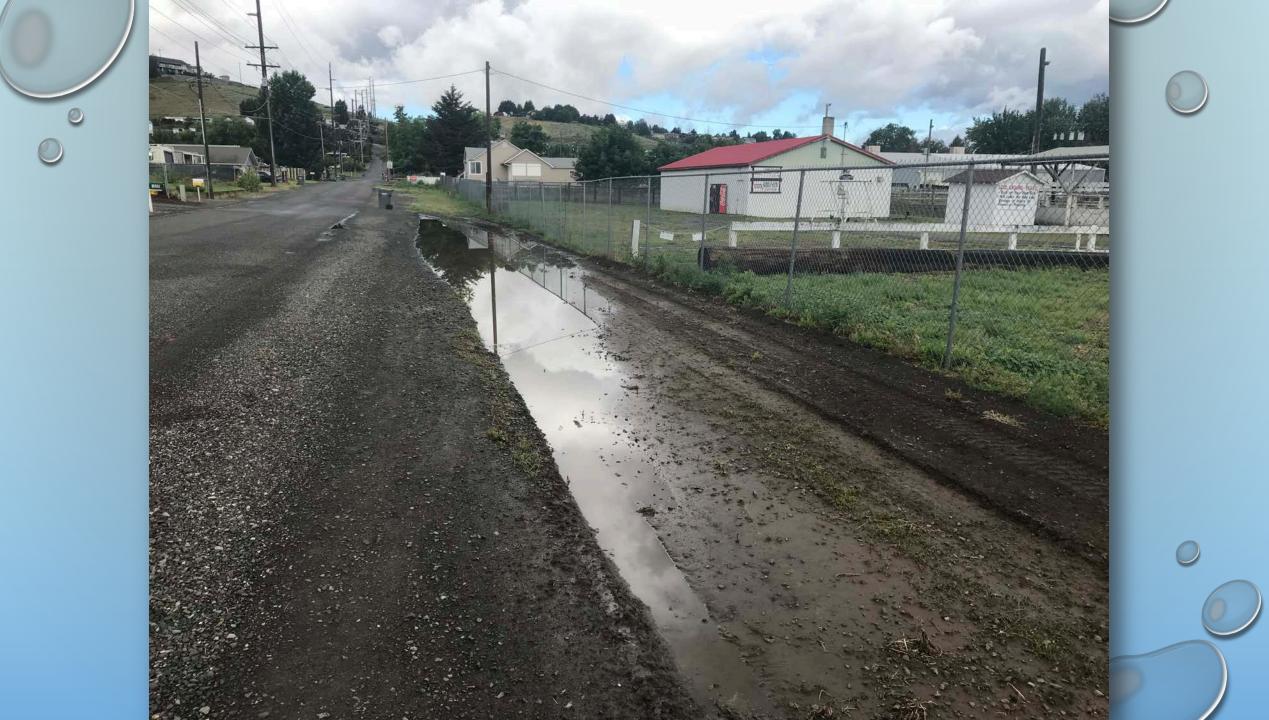
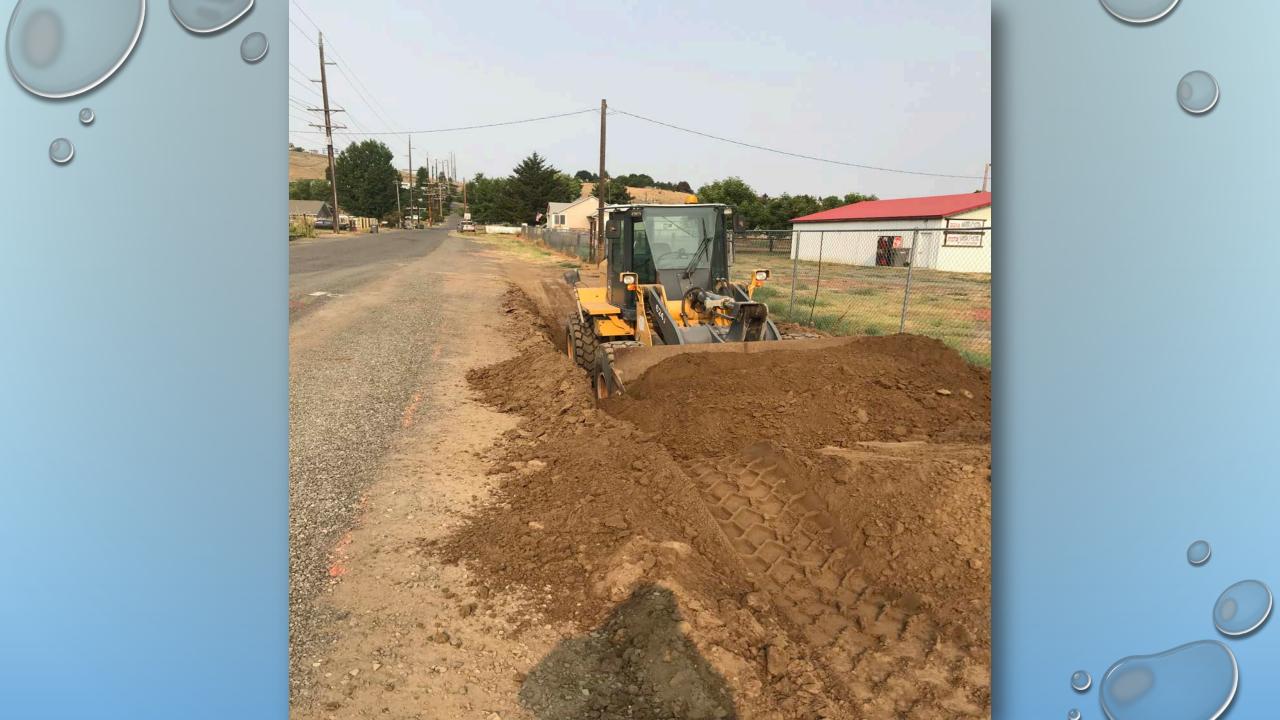
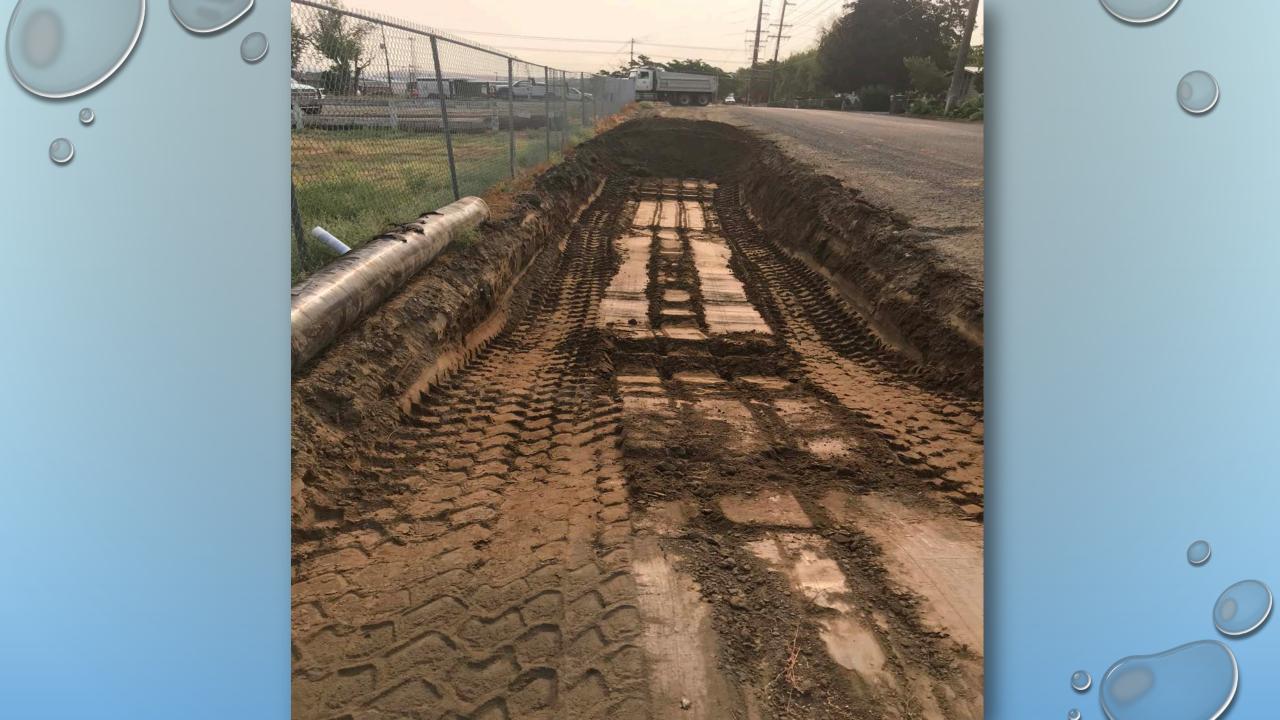
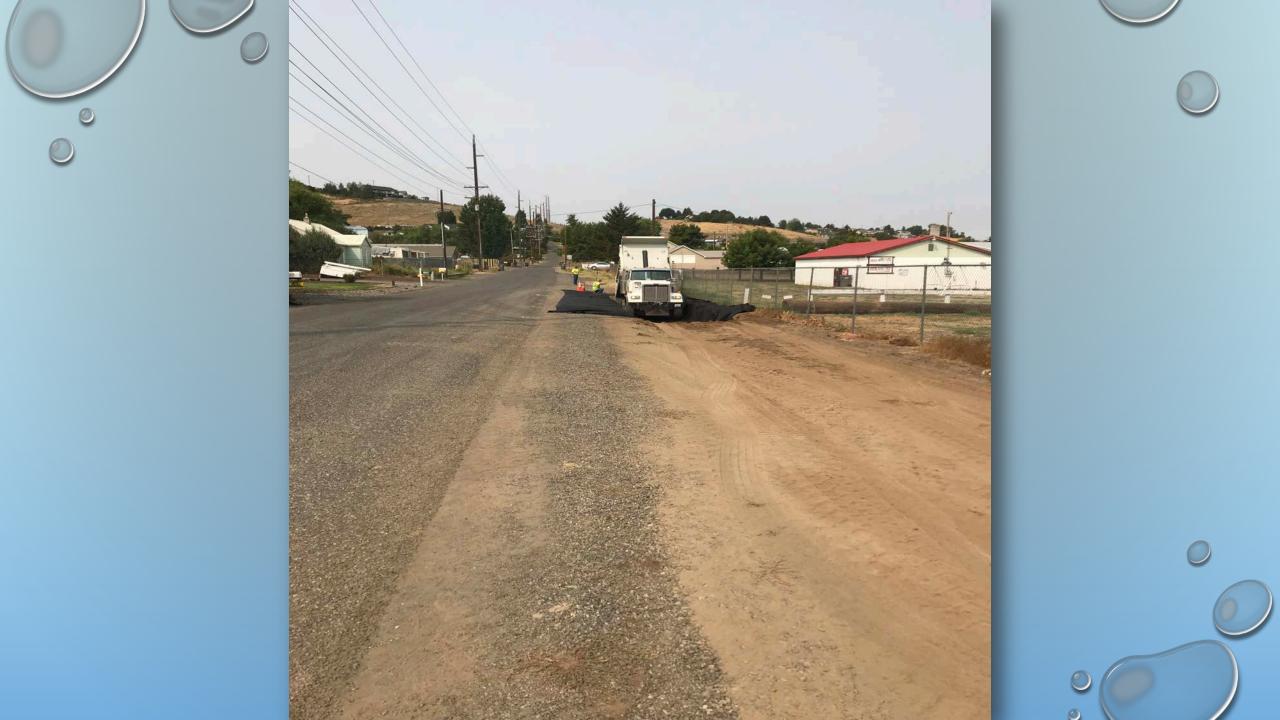
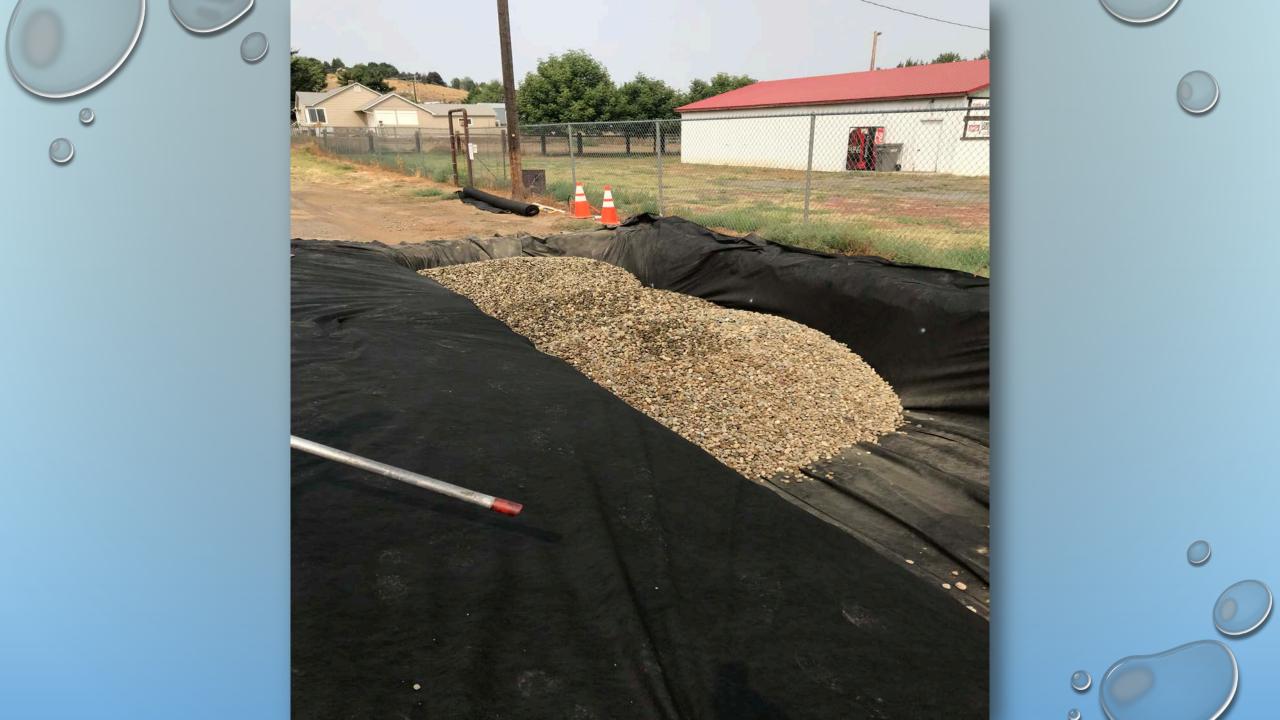
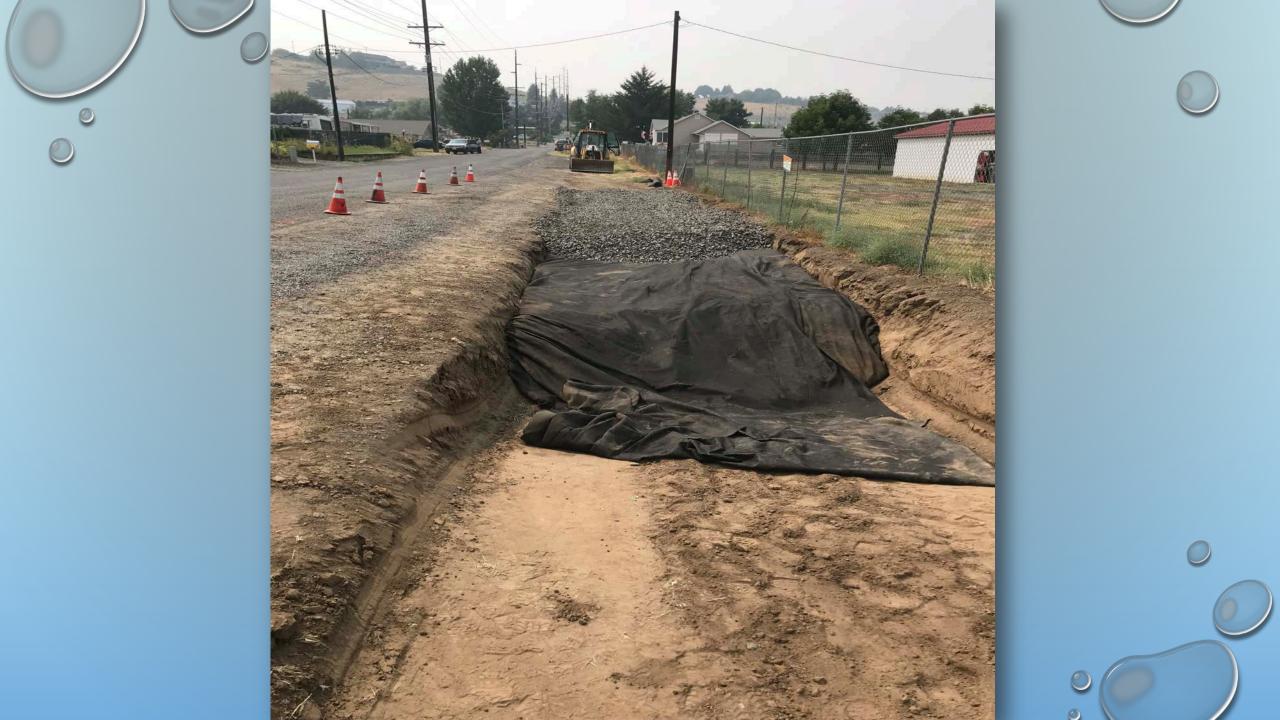
## POUND LANE SADDLE CLUB

WATER FROM ROADWAY PONDING AND FLOODING ADJACENT PROPERTY, WITH NO STORM SYSTEM IN PLACE.

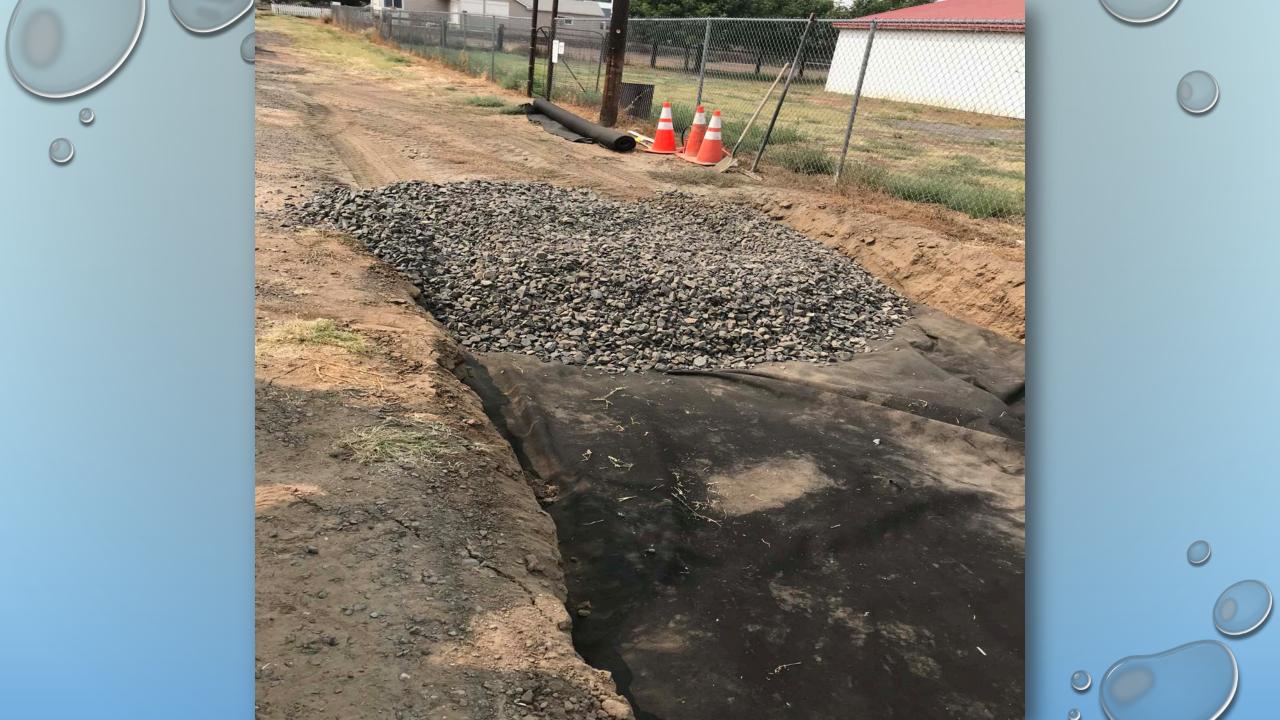
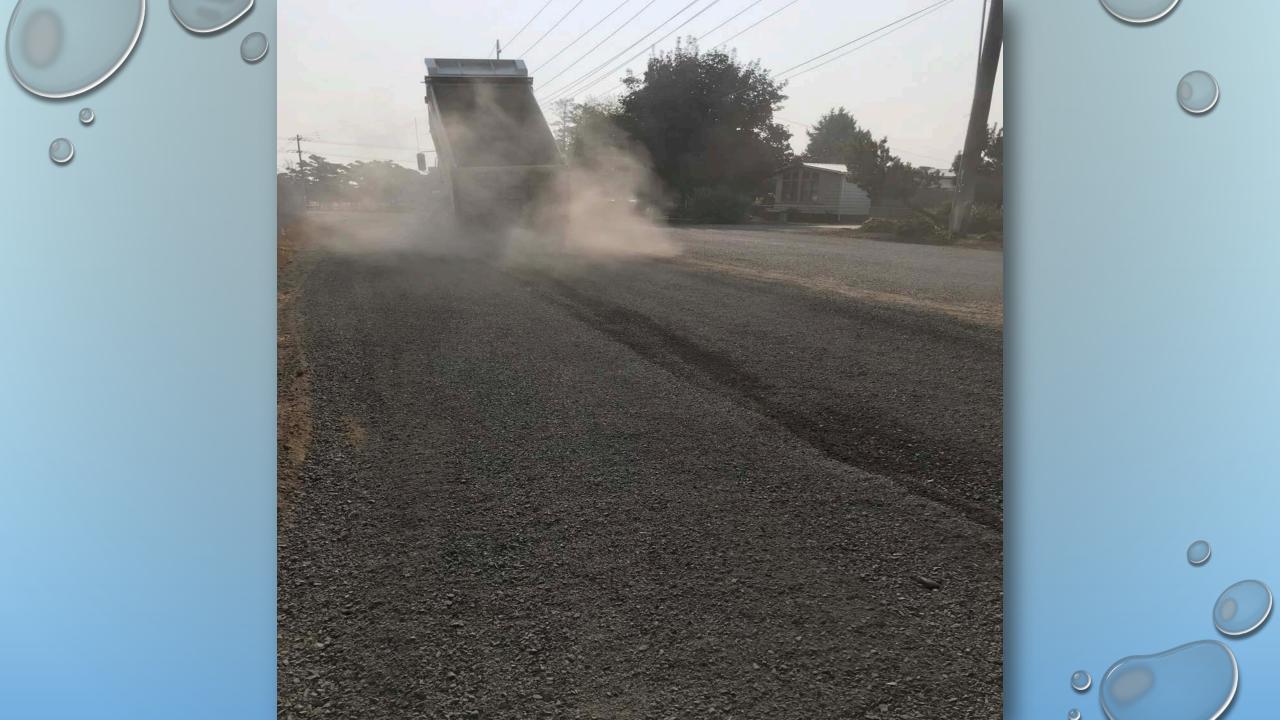
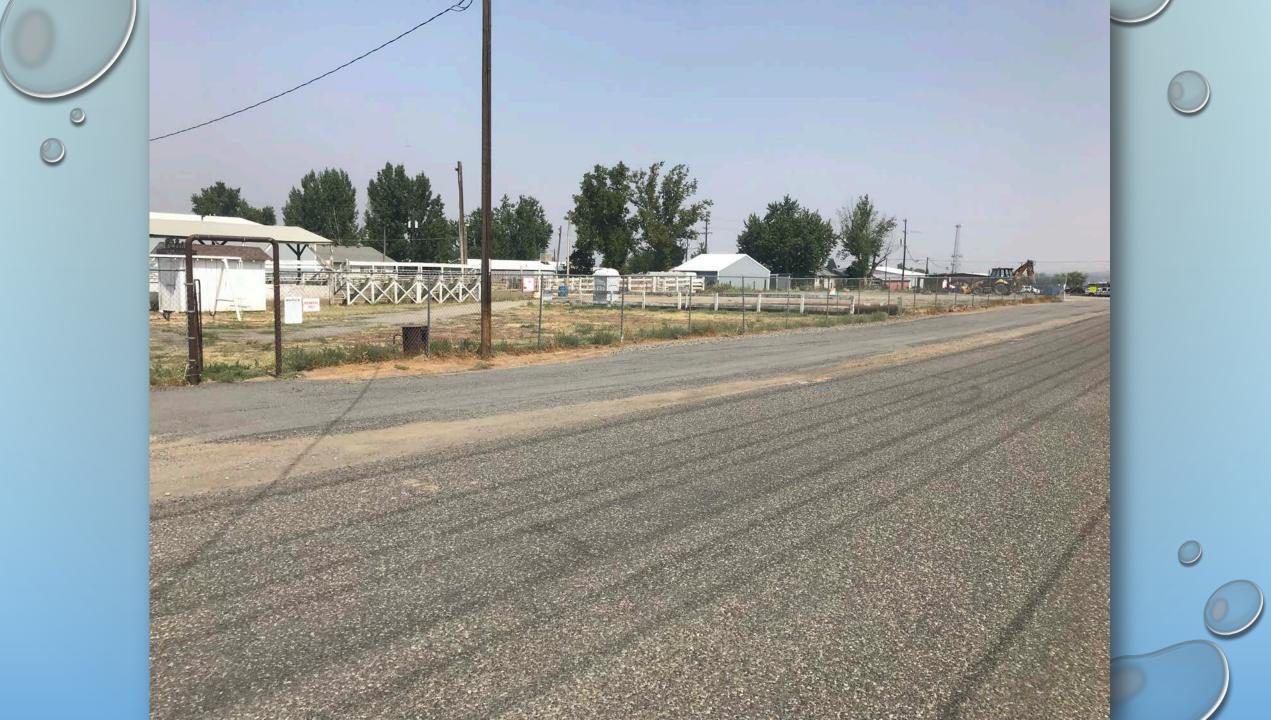
## 16<sup>TH</sup> AND POPLAR

WATER FROM ROADWAY WAS FLOODING ADJACENT PROPERTIES WITH NO STORM SYSTEM IN PLACE.
