# 2018 REGIONAL STORMWATER

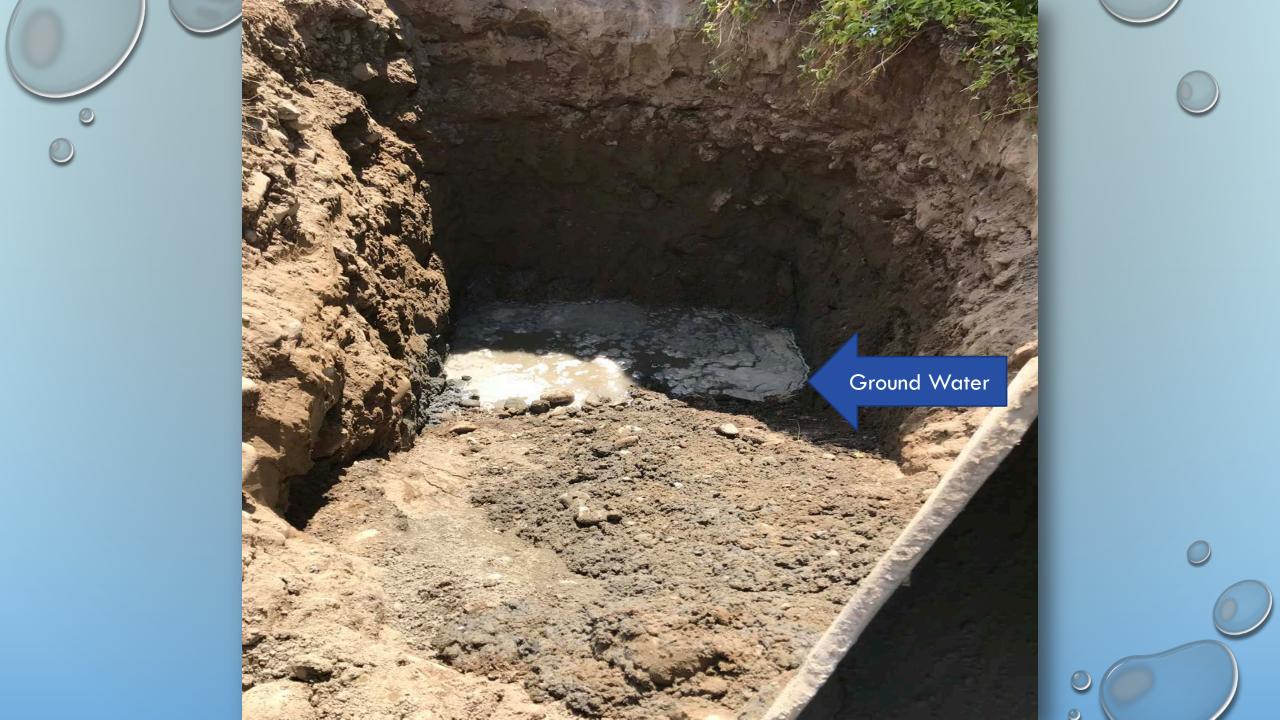
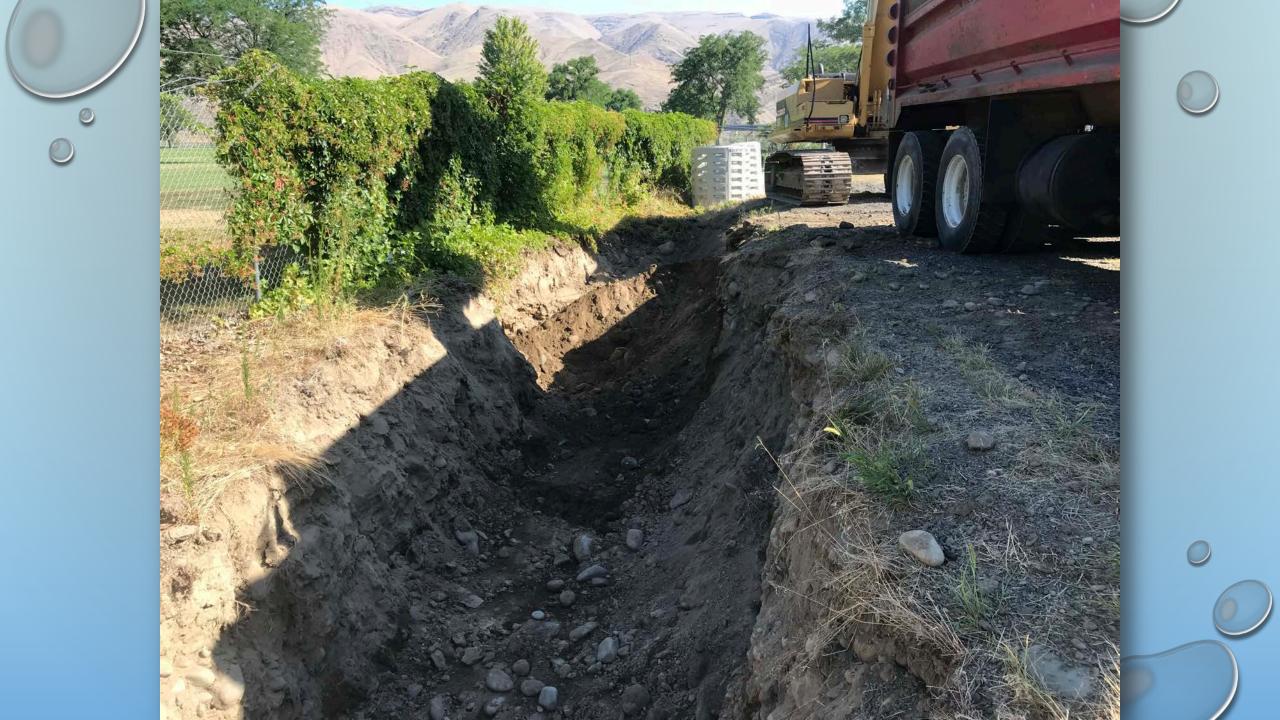
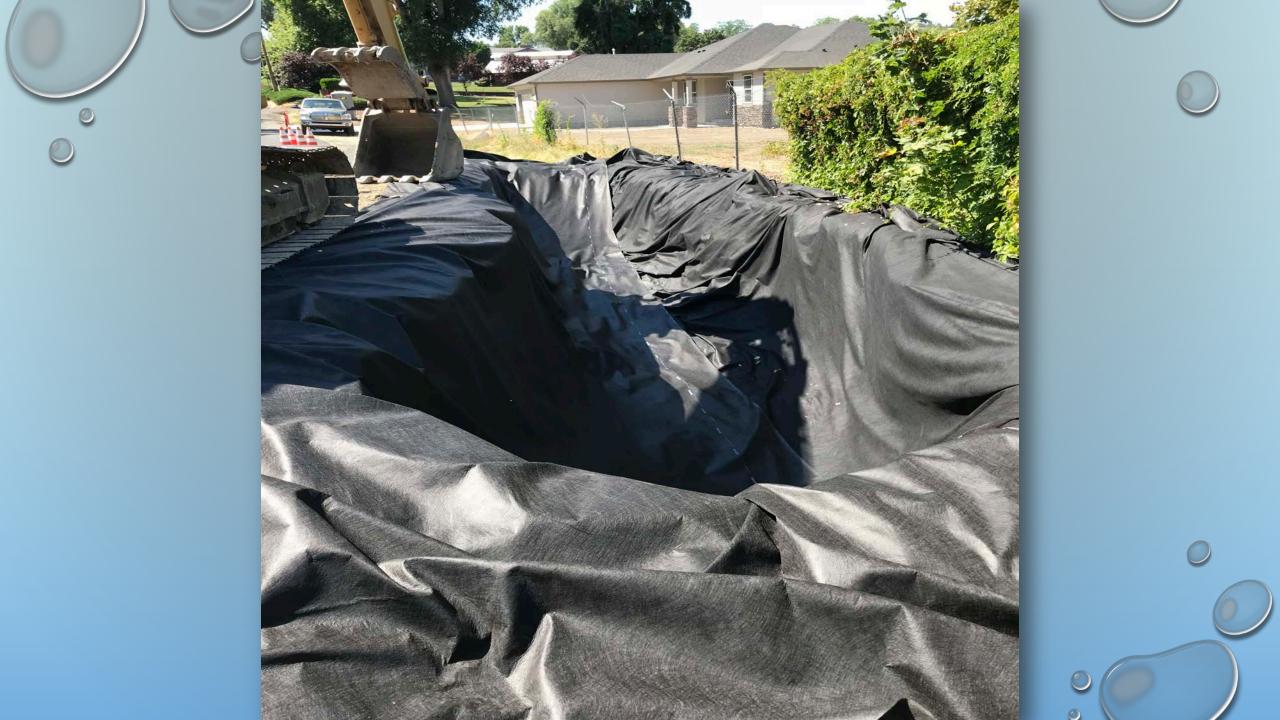
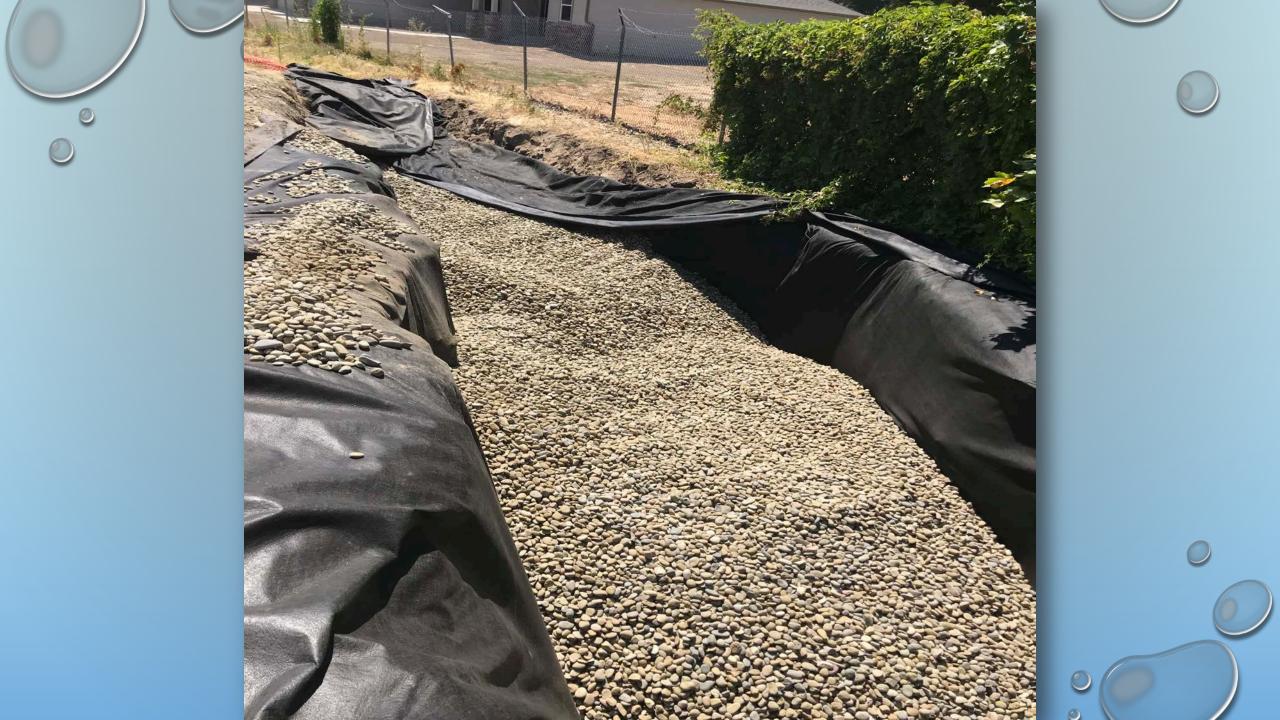
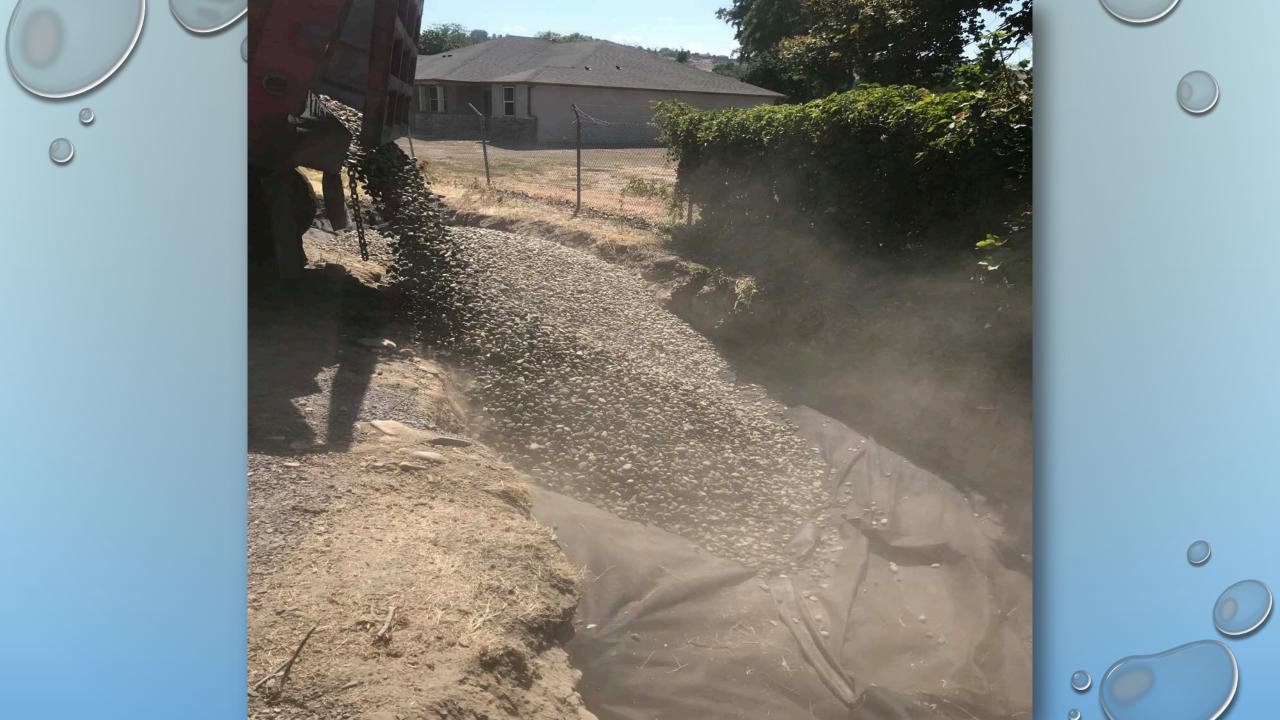
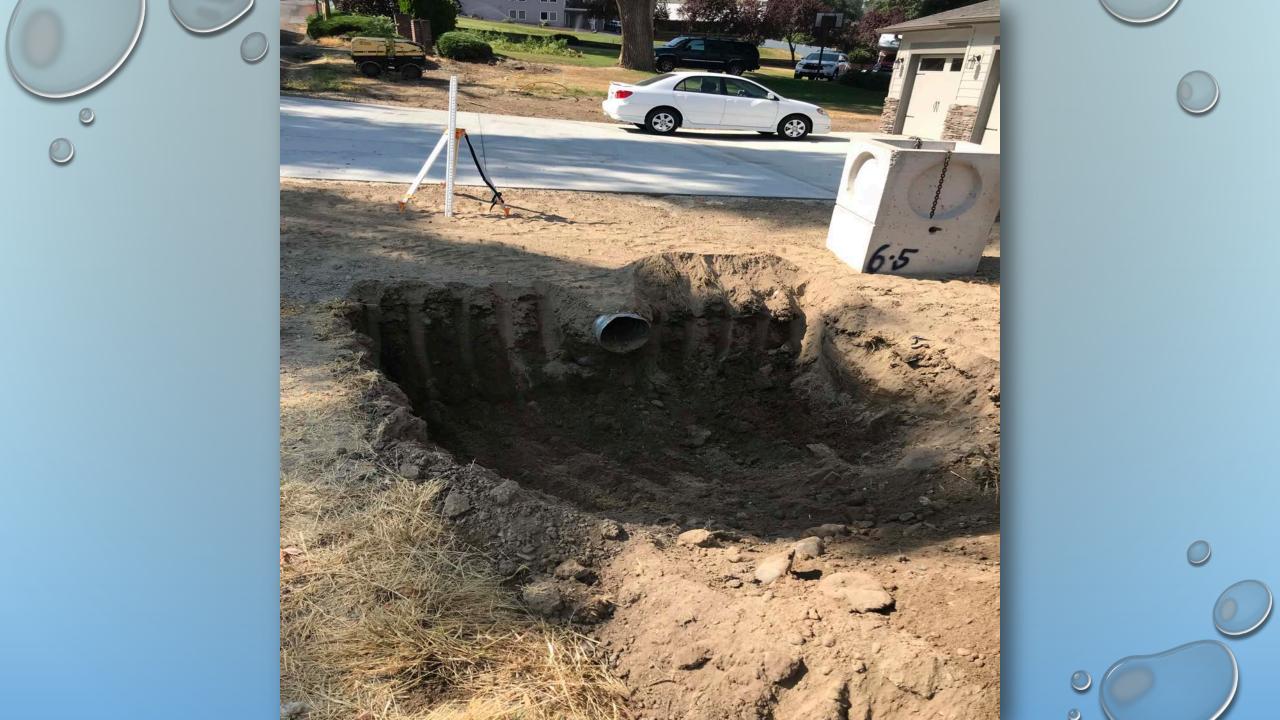
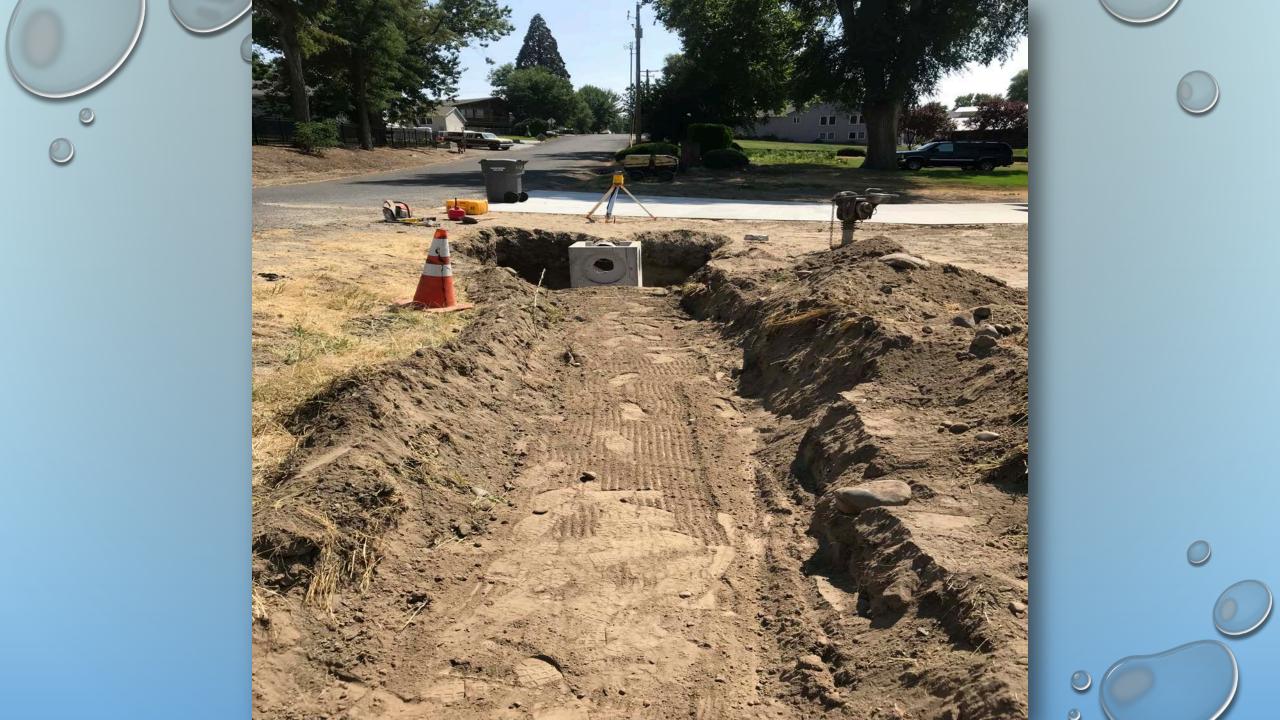
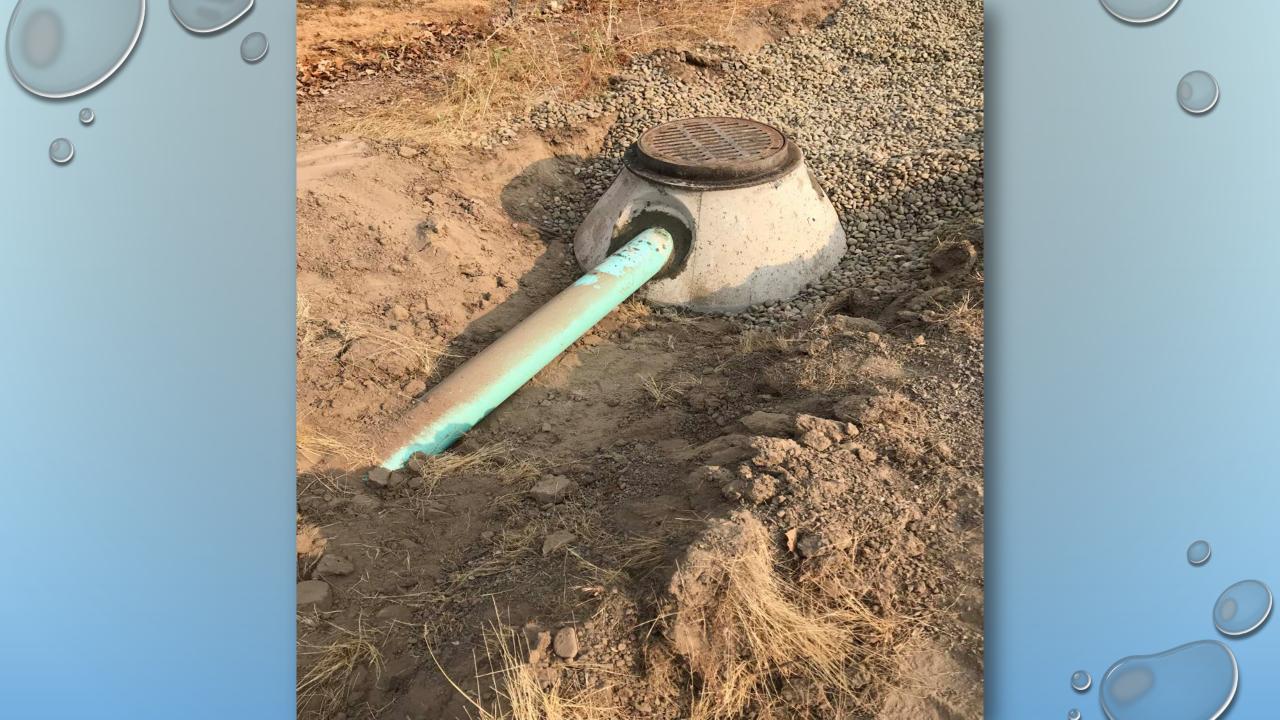
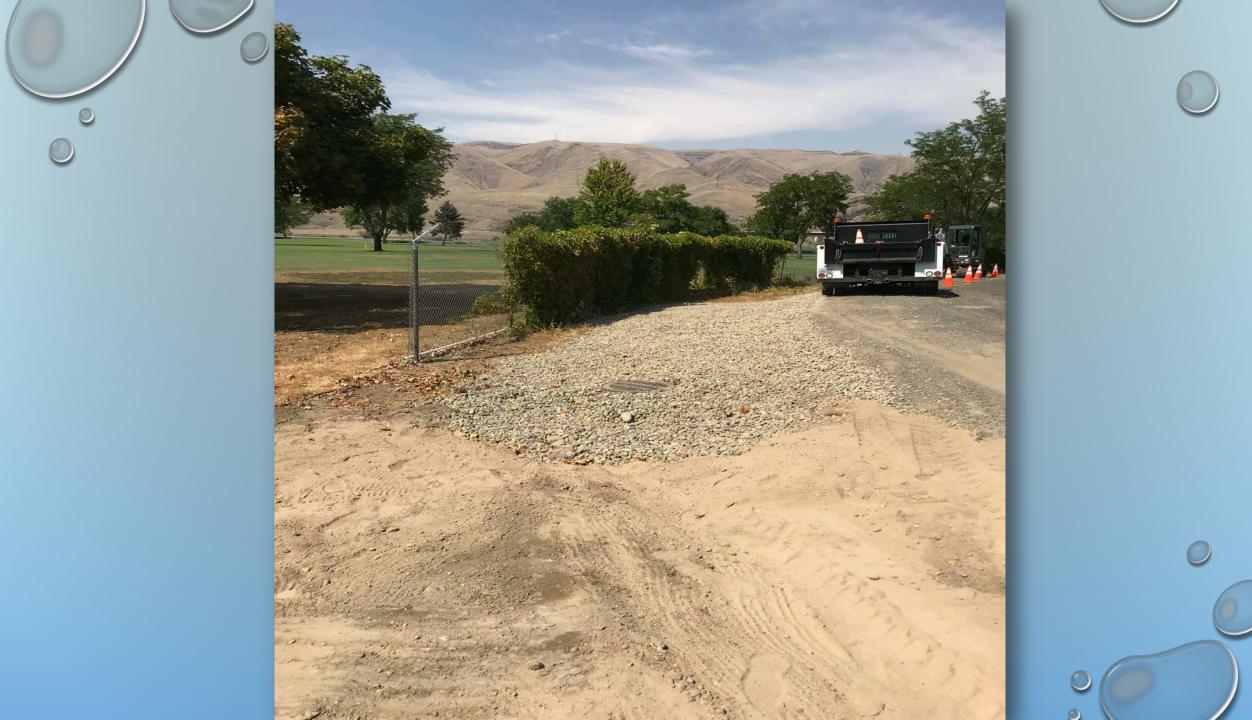
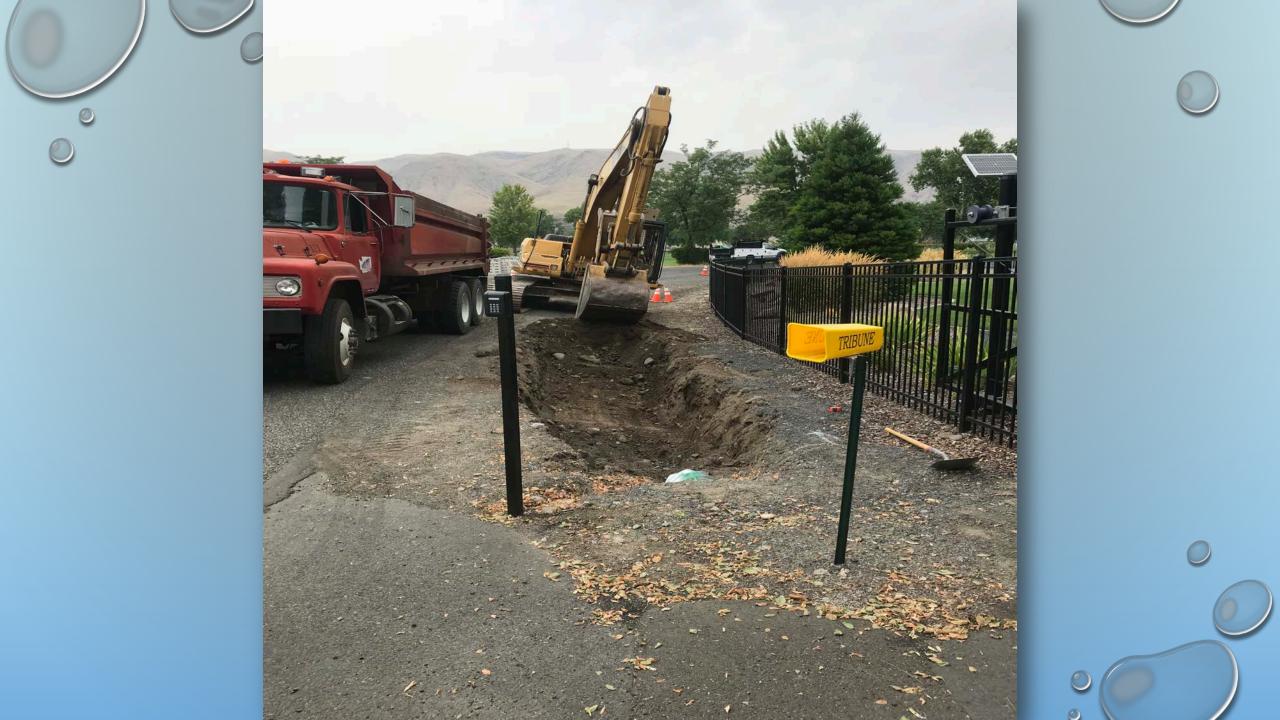
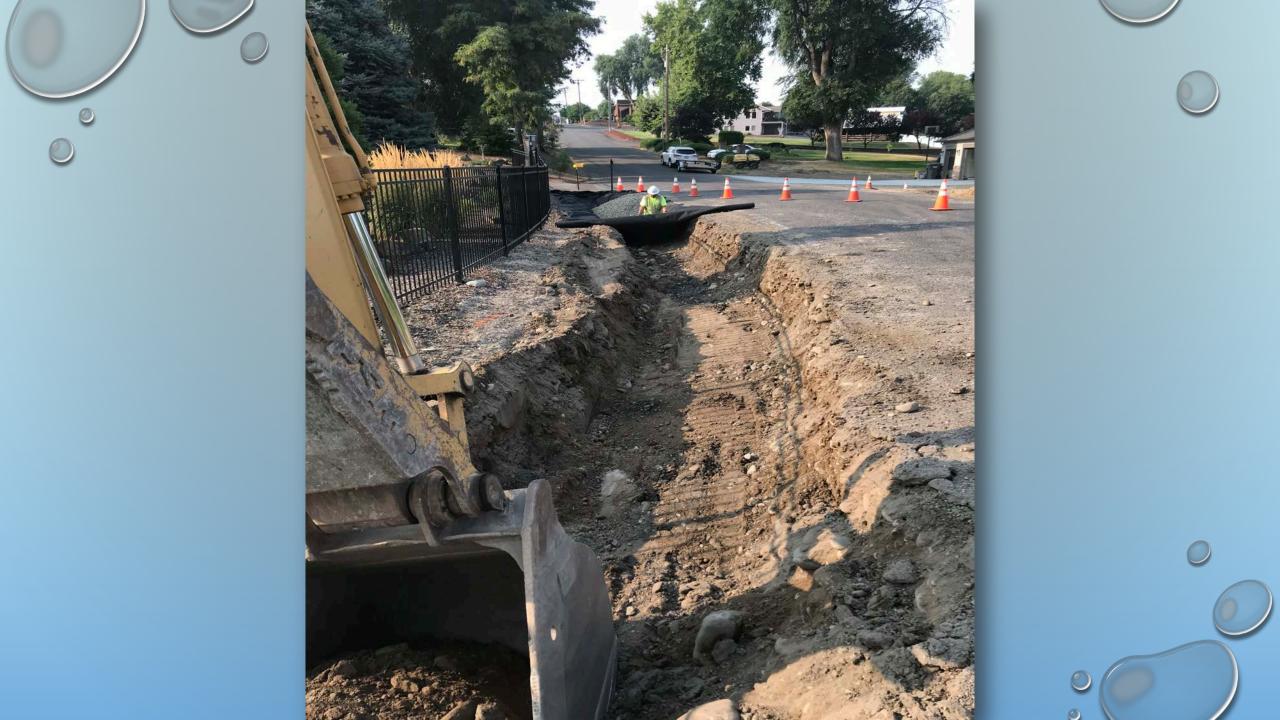
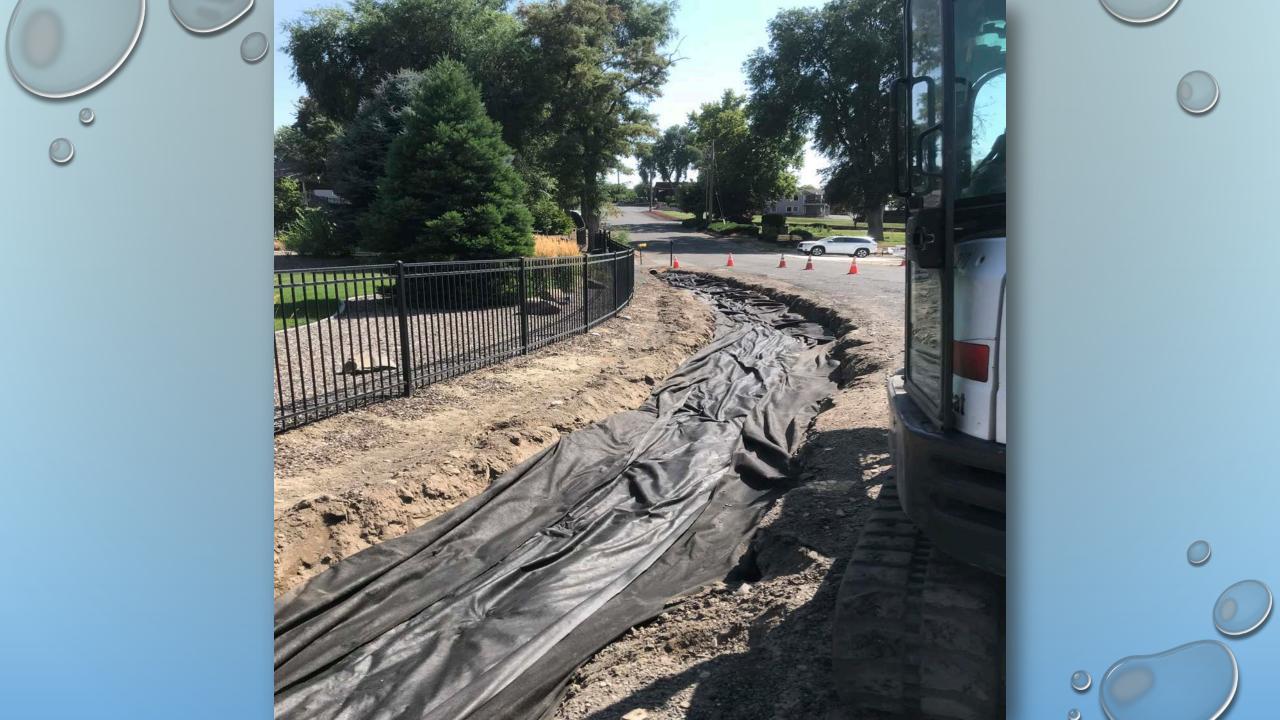
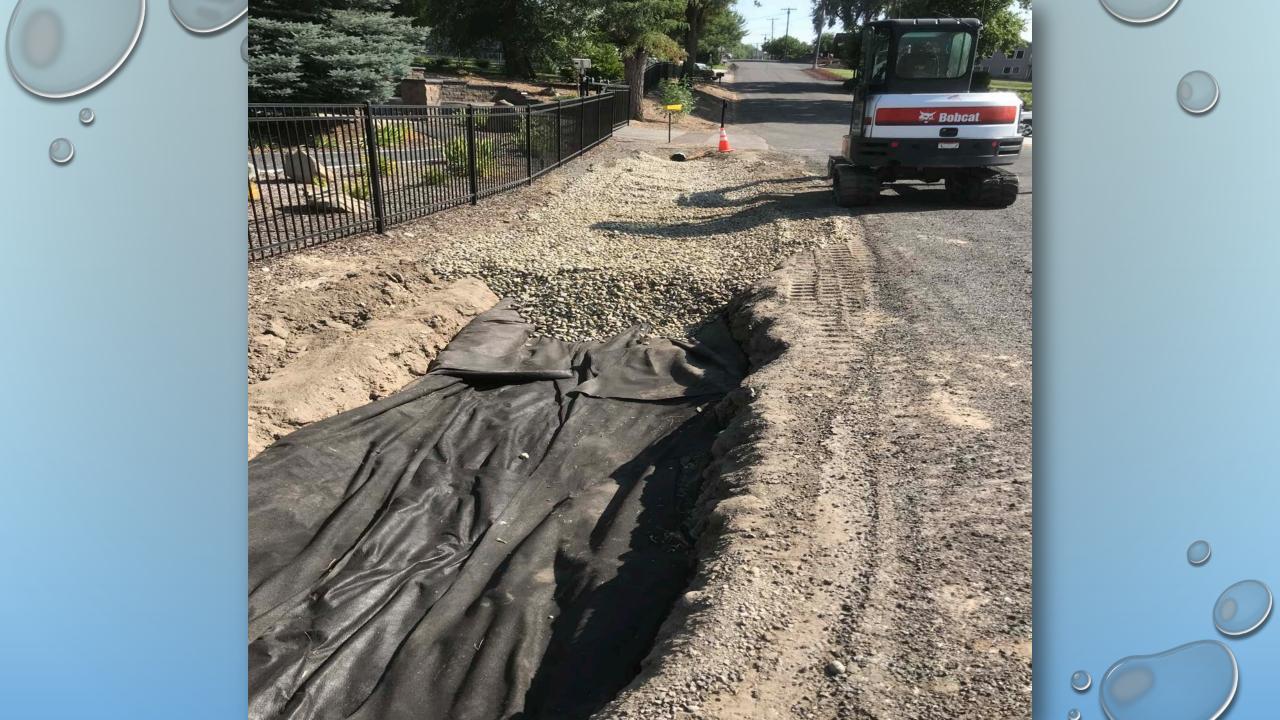
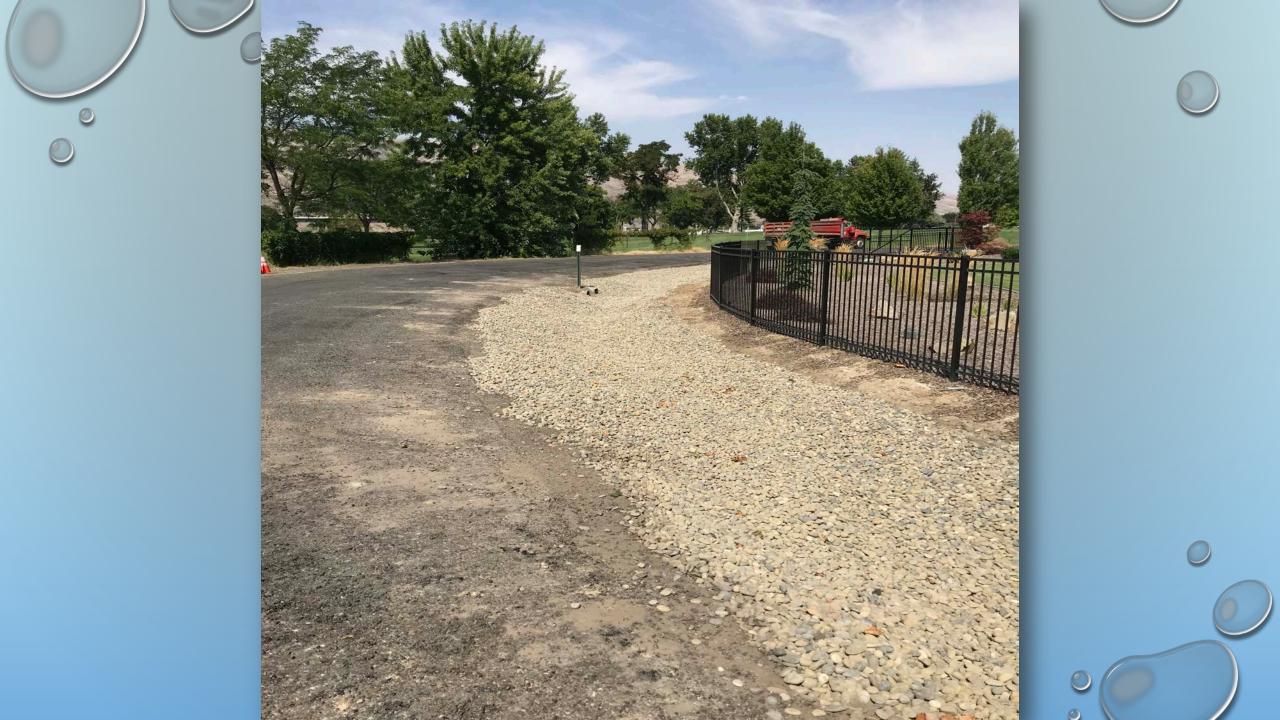
## FAIRGROUNDS MUD SLIDE

DRAIN-GRATE BECAME CLOGGED WITH DEBRIS AND WATER WAS NOT ABLE TO FLOW INTO STORM SYSTEM.
